APPENDIX E:

Site Restoration Plans for High Priority Stormwater Mitigation Sites

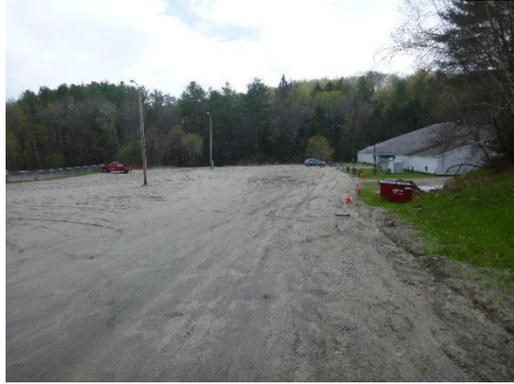
Project: LI-6 & LI-7		Site Restoration Plan
Location:	Parking area for the Fenton Chester Arena

Latitude:	44.5363 N	
Longitude:	-72.0157 W	
Land Ownership:	Town (Maintained by Lyndon Institute)	
Drainage Area (acres)	2.4	
Impervious (acres)	1.6	
<p>Site Description: Runoff from the large gravel parking lot drains south and is collected by a water bar and directed to a small buffer strip on top of a steep bank leading down to a stream. Deep rills are visible on the parking surface in concentrated flow areas, and several small gullies have formed along the steep bank. The buffer strip provides some potential for sediment removal, however the sediment loading to the stream channel is extremely high. A catchbasin by the arena entrance collects runoff from a portion of the parking lot (0.5 acres), and the outlet is piped directly to the stream.</p>		
<p>Proposed Scope of Work</p>		
Install BMP	<ul style="list-style-type: none"> • Install sediment trap along edge of parking lot along existing flow path. • Retrofit the existing catch basin to include a small BMP with a water level control structure as necessary.

Improve Site Drainage	<ul style="list-style-type: none"> • Install water bars to collect flow along the southern edge of the parking lot and direct all runoff to the BMP installations. 	
Stabilize Flow Path	<ul style="list-style-type: none"> • Stabilize the overflow from the BMP with a rock lined swale extending to ordinary high water (OHW) along the stream. 	
Improve Winter Maintenance	<ul style="list-style-type: none"> • Work with the Town and Lyndon Institute to create a snow plowing and snow stockpiling plan that will protect the drainage and BMP features and reduce sediment loading to the stream. 	
<p>Additional Design/Permitting Requirements: Some additional survey and modeling is required to correctly size the catch basin BMP and the water bars along the parking lot. VTANR should be notified of this project that will require work within 100ft of a stream channel, however we do not expect any additional permitting requirements. We estimate that design and permitting efforts will cost \$1,500 - \$2,500 to cover a design-build arrangement similar to the LI and LSC projects completed by North Woods.</p>

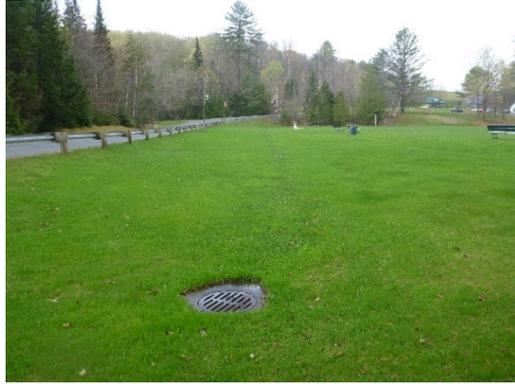
Project: LSC-2		Site Restoration Plan
Location:	LSC Varsity Field

Latitude:	44.5324N	
Longitude:	-72.0256 W	
Land Ownership:	Lyndon State College	
Drainage Area (acres)	2.5	
Impervious (acres)	0.25	
<p>Site Description: A mowed grass swale along the south edge of the varsity field collects runoff from the field and a small portion of College Road. The swale drains to a catchbasin which flows directly to Dragon Pond. The underlying soils are very heavy and wet and portions of the field close to the swale are problematic for field maintenance. Fertilizer application to the field likely results in excess nutrient loading to the pond. LSC Public Safety is interested in adding a pedestrian footpath along College Road through this area, and the swale restoration will not interfere with this potential project.</p>		
<p>Proposed Scope of Work</p>		
Install Bio-swale BMP	<ul style="list-style-type: none"> • Widen and deepen the existing swale to increase water retention and improve field drainage • Wetland seed mix and shrub plantings within swale

Site Maintenance	<ul style="list-style-type: none"> • Mowing along the swale only under dry soil conditions • Bio-swale may require intermittent weeding and cleanout 	
<p>Additional Design/Permitting Requirements: The site has hydric soils and was likely a historic wetland; however, the site is not currently functioning as a wetland and should not require any additional permits, however VTANR wetland ecologist Julie Follensbee should be notified of the project to confirm this assumption. A site visit should be completed to better inform swale layout and grading. We anticipate that design efforts will cost less than \$1,000.</p>		
<p>Next Steps:</p> <ul style="list-style-type: none"> • Confirm project support with Lyndon State College • Determine available footprint for project (discuss with athletic coordinator) • No technical oversight is necessary during project implementation 		
<p>Project Benefits: This project is designed to improve drainage along the playing field and enhance the existing grassed swale to improve nutrient retention. The site is likely a significant nutrient source to Dragon Pond.</p>

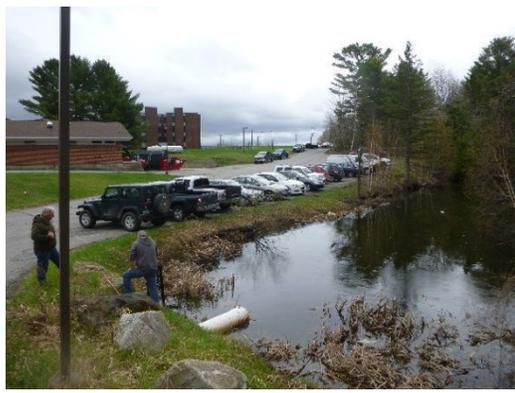
Project: LSC-4		Site Restoration Plan
Location:	McGoff Hill at Stevens Dining Hall

Latitude:	44.5335 N	
Longitude:	-72.0243 W	
Land Ownership:	Lyndon State College	
Drainage Area (acres)	0.8	
Impervious (acres)	0.5	
<p>Site Description: Runoff from McGoff Hill is causing erosion along the road edges and flows directly in to Dragon Pond near the outlet. Winter plowing along the road and parking lot is likely a significant sediment source to the pond.</p>		
<p>Proposed Scope of Work</p>		
Install Ditch	<ul style="list-style-type: none"> • Install a grassed ditch between the edge of pavement and slope to the pond 	
Install BMP	<ul style="list-style-type: none"> • Install a gravel wetland or similar treatment feature with a sediment trap forebay at the bottom of the slope near the pond outlet <ul style="list-style-type: none"> ○ This will require the loss of up to 4 parking spaces 	
Drainage Retrofit	<ul style="list-style-type: none"> • May be possible to redirect pipe from catchbasin along road to new BMP

Improve Winter Maintenance	<ul style="list-style-type: none"> • Work with the LSC maintenance staff to create a snow management plan that will prevent plowing directly into the pond, protecting the ditch and BMP. 	
<p>Additional Design/Permitting Requirements: Additional survey and modeling is required to correctly size the treatment BMP and to work around the design constraints at the site. VTANR should be notified of this project that will require work within 100ft of a waterbody, however we do not expect any additional permitting requirements. We estimate that design and permitting efforts will cost \$3,000 - \$5,000.</p>		
<p>Next Steps:</p> <ul style="list-style-type: none"> • Confirm project support and site changes (loss of parking spaces) with Lyndon State College • Complete site survey and modeling • We recommend 2 days of technical field oversight during construction to assist with BMP sizing, location, layout, grading, and outlet structure configuration.

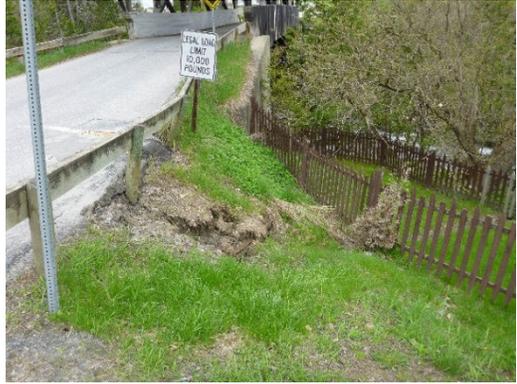
Project: LY-4		Site Restoration Plan
Location:	Chamberlain Bridge

Latitude:	44.5163N	
Longitude:	-72.0166 W	
Land Ownership:	Town/Private	
Drainage Area (acres)	0.25	
Impervious (acres)	0.25	
<p>Site Description: A small drop inlet grate on the southeast approach to the covered bridge is not situated at the low point along the road edge. Runoff is flowing off of the road approximately 10ft south of the inlet and has eroded a large gully down the embankment and through the lawn of the adjacent house. The gully is actively eroding and is contributing sediment and nutrients directly into South Wheelock Branch. Previous attempts to reconfigure the inlet and to add an asphalt curb along the road edge have failed to address the issue.</p>		
<p>Proposed Scope of Work</p>		
Reconfigure Drop Inlet	<ul style="list-style-type: none"> • Lower the drop inlet approximately 6 inches and/or raise the adjacent roadway elevation and rebuild the asphalt curb to protect the gully area <ul style="list-style-type: none"> ○ It may be feasible to move the drop inlet to the current low point at the head of the gully.

Reduce Runoff Volume	<ul style="list-style-type: none"> • Lower the grassed strip along the north edge of York St to allow for sheetflow down the steep forested bank, reducing runoff to the drop inlet 	
Site Maintenance	<ul style="list-style-type: none"> • Ensure that drop inlet is cleaned on a regular basis • Protect curb during plowing 	
<p>Additional Design/Permitting Requirements: Additional site assessment is required to inform design options. We expect that a design-build approach with the Town Highway Department will be appropriate for this project. We estimate that additional assessment and design efforts will cost \$1,000 to \$2,000.</p>		
<p>Next Steps:</p> <ul style="list-style-type: none"> • Confirm project support with private landowner • Assess the size and location of existing drop inlet • Limited technical oversight may be necessary depending on the preferred alternative 		
<p>Project Benefits: This project is designed to address an ongoing erosion issue that also threatens the long-term stability of a Town road shoulder. The gully drains directly in to the South Wheelock Branch and is likely a significant sediment and nutrient source. The project should be relatively simple to implement and will not require increased maintenance.</p>

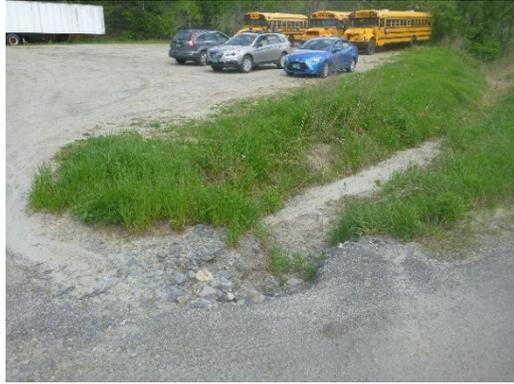
Project: LY-6		Site Restoration Plan
Location:	Butlers Bus Service (Red Village Rd)

Latitude:	44.5437 N	
Longitude:	-71.9856 W	
Land Ownership:	Town and Private	
Drainage Area (acres)	2.0	
Impervious (acres)	1.6	
<p>Site Description: A large gravel parking area and rooftop drain to a roadside ditch with severe gullying along several flow paths. The ditch is filled with sediment and drains directly into a side channel of the Passumpsic River.</p>		
<p>Proposed Scope of Work</p>		
Culvert Improvements	<ul style="list-style-type: none"> • Replace the two 12" driveway culverts with 18" culverts • Stabilize the embankment at the inlet and outlet of the driveway culverts 	
Install Check Dams	<ul style="list-style-type: none"> • Install stone check dams in the roadside ditch to trap sediment and facilitate cleanout 	
Improve Flow Paths	<ul style="list-style-type: none"> • Install water bars to direct runoff to new sediment traps

Install Sediment Traps	<ul style="list-style-type: none"> • Install sediment traps near each driveway culvert <ul style="list-style-type: none"> ○ Overflow from the sediment traps should be directed to the existing grassed filter strip ○ Provide a rock lined spillway to the ditch ○ Ensure that sediment traps are routinely inspected and cleaned 	
<p>Additional Design/Permitting Requirements: Some additional survey and design work is recommended to inform sediment trap location, design, and sizing. We estimate that design and permitting efforts will cost \$1,500 to \$2,500.</p>		
<p>Next Steps:</p> <ul style="list-style-type: none"> • Confirm project support with the private landowner • Complete site survey and drainage area mapping • Hydraulic analysis and sediment trap designs • We recommend 2 days of technical field oversight during construction to assist with sediment trap sizing, location, layout, grading, and overflow configuration.

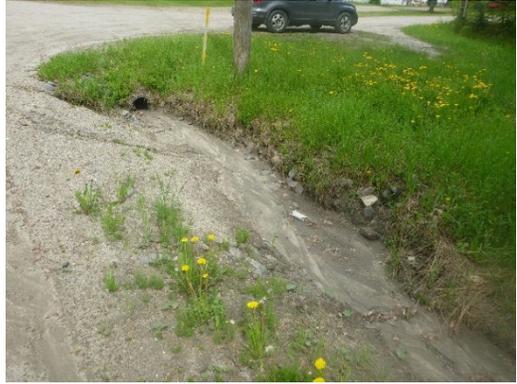
Project: LY-8		Site Restoration Plan
Location:	Lily Pond Road

Latitude:	44.5198 N	
Longitude:	-71.9931 W	
Land Ownership:	Town	
Drainage Area (acres)	7.5	
Impervious (acres)	2.0	
<p>Site Description: The ditch along the east side of the road is badly eroded and is sending large volumes of sediment into the adjacent intermittent stream. Several areas of gully erosion along the road edge upslope. The cross-culvert outlet is unstable and has a large gully along the road edge.</p>		
<p>Proposed Scope of Work</p>		
Improve Ditch	<ul style="list-style-type: none"> • Excavate and enlarge the existing ditch and establish grass cover • Install a stone lined ditch for the short section upslope of the cross-culvert • Install rock to stabilize flow paths from Steve St., Kate St., and the driveway 	
Install BMP	<ul style="list-style-type: none"> • Install check dams to trap sediment for easier removal 	
Stabilize Culvert	<ul style="list-style-type: none"> • Install an outlet header and armor the steep bank with heavy stone armor

Improve Maintenance	<ul style="list-style-type: none"> • Work with the Highway Department to improve grading practices to minimize disturbance of the grass-lined ditch and ensure appropriate sediment cleanout. 	
<p>Additional Design/Permitting Requirements: We do not anticipate any additional design or permitting requirements.</p>		
<p>Next Steps:</p> <ul style="list-style-type: none"> • Verify culvert sizes and contributing drainage area • Identify any additional erosion areas that require stabilization 		
<p>Project Benefits: This project is designed to address a major sediment source piped directly into an intermittent stream along Lily Pond Road. Improving the shape and capacity of the ditch and establishing grass will reduce erosion within the ditch. We also recommend installing a series of stone check dams to help trap additional sediment from the road and the neighborhoods. Check dams will concentrate sediment deposits and facilitate cleanup. Stabilizing the culvert outlet will further reduce sediment runoff and maintenance requirements.</p>

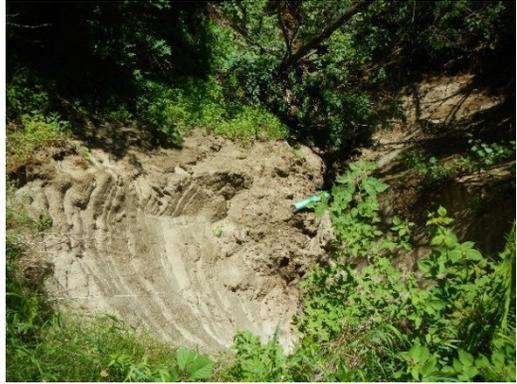
Project: LY-12		Site Restoration Plan
Location:	South Prospect St

Latitude:	44.5167 N	
Longitude:	-72.0100 W	
Land Ownership:	Town and Private	
Drainage Area (acres)	1.0	
Impervious (acres)	0.5	
<p>Site Description: A very large and steep gully has formed along the steep valley wall leading down to an intermittent stream. The gully is actively advancing into the slope and is threatening a large shed. A stormwater pipe from a recently installed catchbasin at the end of South Prospect St is likely contributing to erosion along the toe of the gully. We did not observe any significant surface flow paths to the gully.</p>		
<p>Proposed Scope of Work</p>		
Non-Structural BMP Implementation	<ul style="list-style-type: none"> • Assess opportunities for rooftop disconnection • Improve existing swales to increase infiltration <ul style="list-style-type: none"> ○ May require some grading and/or excavation of compacted soils

Install Infiltration BMP	<ul style="list-style-type: none"> • Tie in to existing pipe from catchbasin • Utilize existing catchbasin as pre-treatment sediment trap • Assess BMP options for underground infiltration • BMP within Town ROW 	
Stabilize Gully	<ul style="list-style-type: none"> • Slope stability should be assessed following infiltration improvements <ul style="list-style-type: none"> ○ Assess alternatives for stabilization ○ May require moving the shed 	
<p>Additional Design/Permitting Requirements: Professional survey is required to determine drainage area to the site. Hydrologic modeling and soil infiltration testing will be required to inform BMP selection and sizing. We do not anticipate any additional permitting requirements for the infiltration practices. We estimate that design and permitting efforts will cost \$3,000 to \$5,000.</p>		
<p>Next Steps:</p> <ul style="list-style-type: none"> • Confirm parcel boundaries • Confirm project support with adjacent private landowners • Complete site survey and drainage area mapping • Assess opportunities for non-structural BMP implementation • Hydrologic analysis and BMP selection/design • We recommend 2 days of technical field oversight during project implementation to assist with structural and non-structural BMP layout and implementation. Significant additional design and engineering time will be required for any slope stabilization considerations.

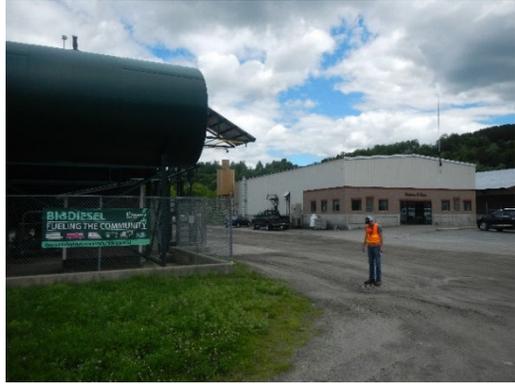
Project: LY-15		Site Restoration Plan
Location:	Commercial Complex on Raymond St

Latitude:	44.5360N	
Longitude:	-72.0011 W	
Land Ownership:	Private	
Drainage Area (acres)	2.5	
Impervious (acres)	2.5	
<p>Site Description: A large industrial/commercial complex with large dirt parking areas partially drains to the southwest corner of the property along the railroad tracks. Drainage infrastructure is not mapped for this area and all catchbasins on the site appear to be filled with sediment and non-functioning. The high sediment load and frequent heavy vehicle traffic will require special design and maintenance considerations. We expect that runoff from this site currently flows across Raymond St and into the stormwater pipes that drain into the Passumpsic River.</p>		
<p>Proposed Scope of Work</p>		
Install BMP	<ul style="list-style-type: none"> Assess BMP options based on site constraints, existing drainage infrastructure, and drainage area

Non-Structural BMP	<ul style="list-style-type: none"> Assess options for non-structural BMPs to treat rooftop runoff and driplines and reduce erosion of the gravel parking areas 	
Site Maintenance	<ul style="list-style-type: none"> Review snow management plan Ensure appropriate maintenance interval to preserve BMP effectiveness 	
<p>Additional Design/Permitting Requirements: Professional survey is recommended to determine site grading and the drainage area available for treatment. This information will be used to model the site and inform BMP selection sizing. Soil infiltration rates will likely need to be determined. The existing drainage area should be mapped, this may require a full cleanout of the filled basins and culverts. We do not anticipate any permitting requirements for this project. We estimate that survey and design efforts will cost \$3,000-\$5,000.</p>		
<p>Next Steps:</p> <ul style="list-style-type: none"> Confirm project support with private landowners Determine snow management plan for site Complete site survey and drainage area mapping Determine soil infiltration rates and capacity Alternatives analysis for BMP options We recommend 2-3 days of technical field oversight during project implementation to assist with BMP layout and outlet configuration

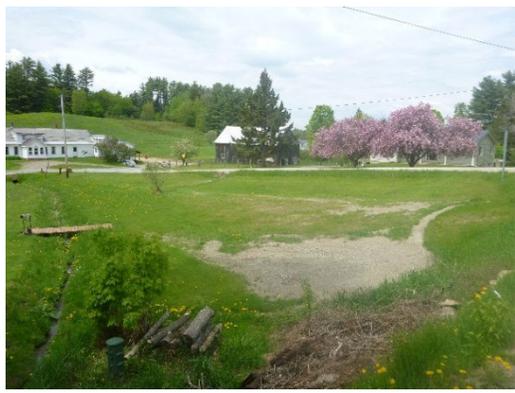
Project: LY-22		Site Restoration Plan
Location:	Finney Hill Neighborhood

Latitude:	44.5437 N	
Longitude:	-71.9856 W	
Land Ownership:	Town and Private	
Drainage Area (acres)	2.5	
Impervious (acres)	0.75	
<p>Site Description: Large volumes of gravel road material are deposited on the lawn adjacent to an intermittent stream channel. Sediment is coming from the outlets of two cross-culverts and from severe gully erosion where concentrated runoff from the road is carving into the steep embankment. Additional erosion was observed at the inlet and outlet of the 30" culvert under Strawberry Hill Road.</p>		
<p>Proposed Scope of Work</p>		
Culvert Improvements	<ul style="list-style-type: none"> • Replace the two 15" cross-culverts with larger structures (18" and 24") • Add a new 18" cross-culvert to carry ditch flow from new Finney Dr culvert • Stabilize the steep embankment at the inlet and outlet of the conveyance culvert <ul style="list-style-type: none"> ○ The outlet needs a stacked stone header and additional stone armor

Ditch Improvements	<ul style="list-style-type: none"> • Excavate and enlarge the existing ditch and establish grass cover or line with 12" minus stone where needed • Install a new ditch along Finney Dr. and line with 12" minus stone 	
Install BMP	<ul style="list-style-type: none"> • Install sediment traps at the cross-culvert outlets <ul style="list-style-type: none"> ○ Provide a level spreader outlet berm onto lawn area ○ Ensure that sediment traps are routinely inspected and cleaned 	
Remove Grader Berm	<ul style="list-style-type: none"> • Remove the grader berm to facilitate sheetflow onto grass area, stabilize any existing gully erosion locations 	
<p>Additional Design/Permitting Requirements: Some additional survey and design work is recommended to inform culvert sizing and sediment trap design and sizing. Sanitary Sewer lines are mapped near the sediment traps, these need to be located and may require design adjustments. We estimate that design and permitting efforts will cost \$1,000 to \$2,500.</p>

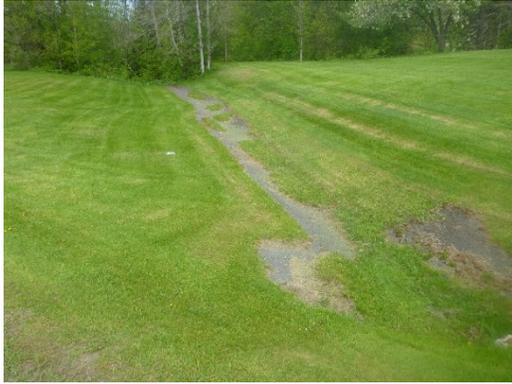
Project: LY-23 & LY-24 **Site Restoration Plan**

Site Description: The roadside ditch along Lily Pond Road drains a long stretch of the road and receives runoff from the southern portion of the School property. Portions of the runoff from the School are filtered by a forested wetland. The wetland is partially drained by a narrow ditch through the grassed area that drains into the roadside ditch. The roadside ditch crosses under Lily Pond Road and then flows through an asphalt lined swale for approximately 50' to a steep embankment down to the second order stream. Some erosion was visible along the steep embankment. Overall, we did not observe any significant sediment sources, however the drainage area does have close to 2 acres of impervious surfaces.

Restore Wetland	<ul style="list-style-type: none"> • Fill/widen the ditch to create a sinuous swale • Implement a no-mow buffer and plant wetland vegetation/seed mix as needed
Install BMP	<ul style="list-style-type: none"> • Remove the asphalt swale and compacted underlying soils • Install a gravel lined infiltration trench • Install a rock lined forebay to dissipate flow and trap coarse sediment
Stabilize Flow Path	<ul style="list-style-type: none"> • Install rock armor along the flow path to the stream

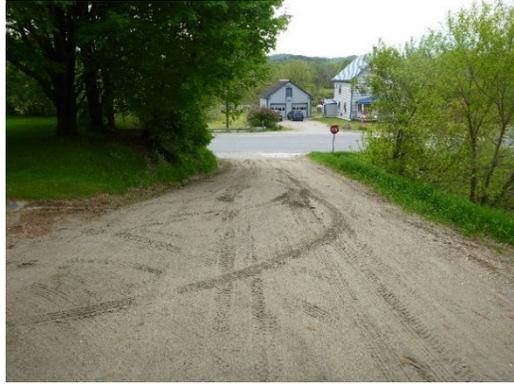
Project: LY-34 & LY-35		Site Restoration Plan
Location:	Shores Hill

Latitude:	44.5436N	
Longitude:	-72.0097 W	
Land Ownership:	Town	
Drainage Area (acres)	1.0	
Impervious (acres)	0.25	
<p>Site Description: Large volumes of sediment are washing off both sides of the approximately 500ft long road. The road does not have established ditches and the road bed is relatively soft and sandy. The eastern end of the road drains directly into a wetland with a poorly functioning sediment trap. The western end of the road drains directly into a catchbasin situated below the road grade and is piped into a dredged channel leading to the wetland. The middle portion of the road has limited areas for sheetflow down the forested bank. The road is narrow, and the adjacent banks are very steep.</p>		
<p>Proposed Scope of Work</p>		
Install Ditches	<ul style="list-style-type: none"> • Install narrow ditches and line with 12" minus stone

Remove Grader Berms	<ul style="list-style-type: none"> • Two areas of grader berms are limiting sheetflow to south side of the road down the forested slope to the wetland • Some areas of erosion are likely along the road shoulder and should be stabilized with rock 	
Install Sediment Traps	<ul style="list-style-type: none"> • Improve the existing sediment trap on the eastern end of the road • Install a sediment trap with a stable outlet to the existing catchbasin 	
<p>Additional Design/Permitting Requirements: The wetland along the south side of the road is likely Class II and may require permitting for the eastern sediment trap. No additional design is required for the project. If wetlands clearances are required, we estimate that wetland delineation and permitting efforts will cost \$1,000-\$2,000.</p>		
<p>Next Steps:</p> <ul style="list-style-type: none"> • Contact VTDEC Wetlands Ecologist (Julie Follensbee) to discuss concept plan and needed clearances • Delineate wetland and review with VTANR staff (as necessary) • Assess feasibility and cost of paving the road • We do not anticipate the need for any technical field oversight during project implementation

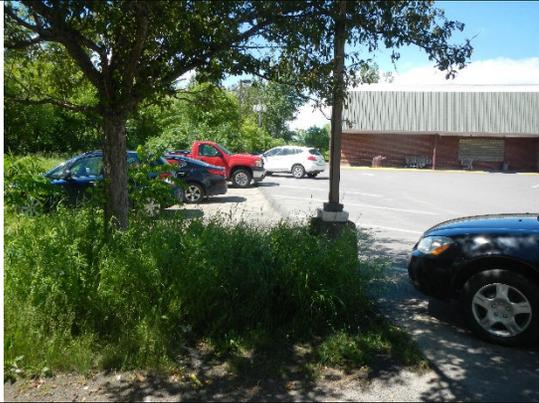
Project: Rt5-2		Site Restoration Plan
Location:	The White Market

Latitude:	44.5196N	
Longitude:	-72.0036 W	
Land Ownership:	Private	
Drainage Area (acres)	1.25	
Impervious (acres)	1.25	
<p>Site Description: The large paved parking area for Whites Market partially drains to the west to a narrow vegetated area. Several small flow paths extend down the steep bank to the Passumpsic River. Much of the vegetated area has been compacted by parked vehicles off the edge of the parking lot. This area is also used for stockpiling snow. There is a large area available for potential treatment features.</p>		
<p>Proposed Scope of Work</p>		
Install BMP	<ul style="list-style-type: none"> • Assess BMP options based on site constraints and drainage area 	
Stabilize Flow Paths	<ul style="list-style-type: none"> • Identify and stabilize any concentrated flow paths with erosion on the river bank 	
Site Maintenance	<ul style="list-style-type: none"> • Construct a barrier (fence) to protect BMP from vehicle damage • Discuss winter maintenance requirements <ul style="list-style-type: none"> ○ Create a maintenance plan that will preserve BMP effectiveness
