STATE OF VERMONT
AGENCY OF TRANSPORTATION

Scoping Report

Barton Village BHF 0286(5)
VT ROUTE 16 (TH 2), Bridge 20 Over Crystal Lake Outlet

December 19, 2012

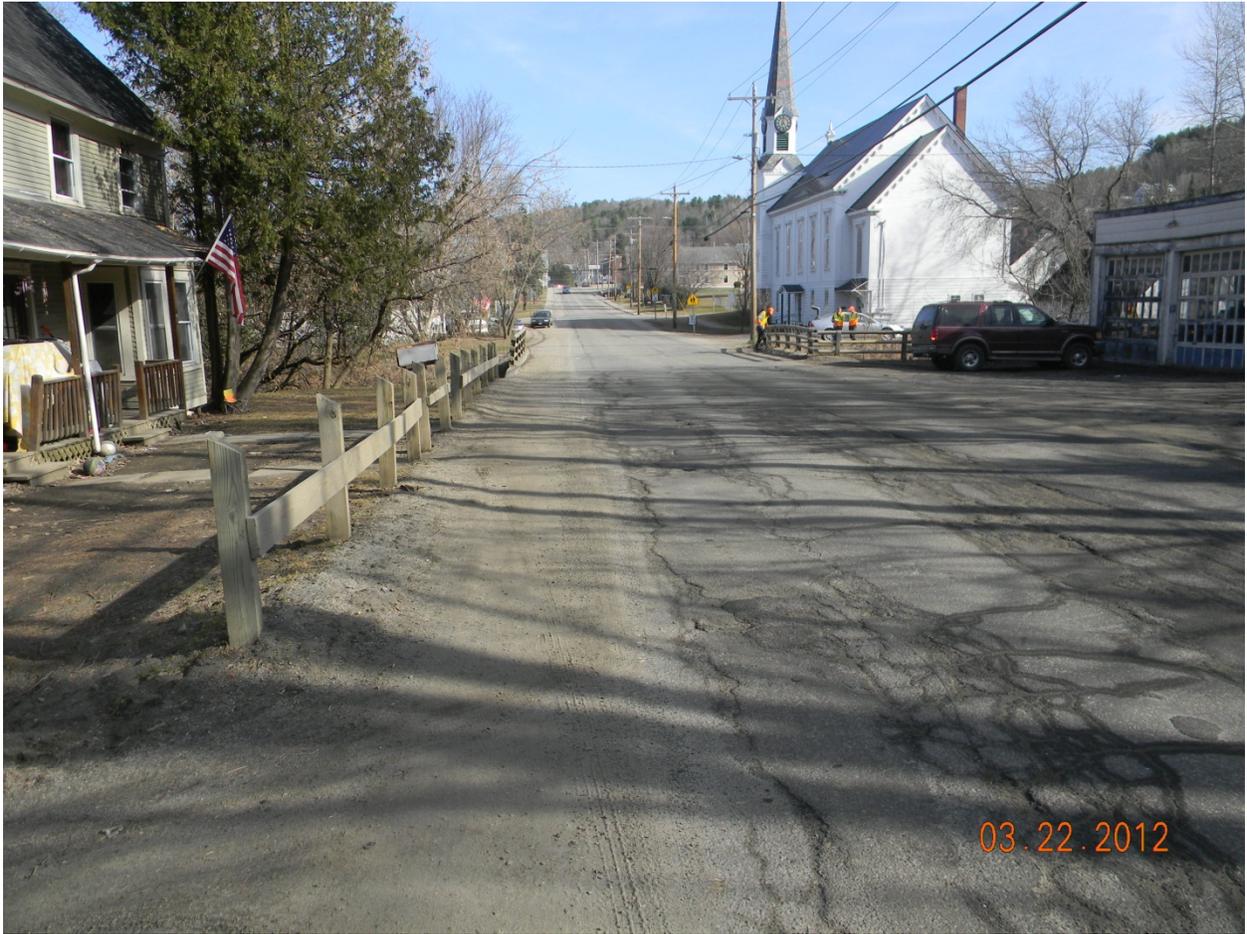
Northbound Approach

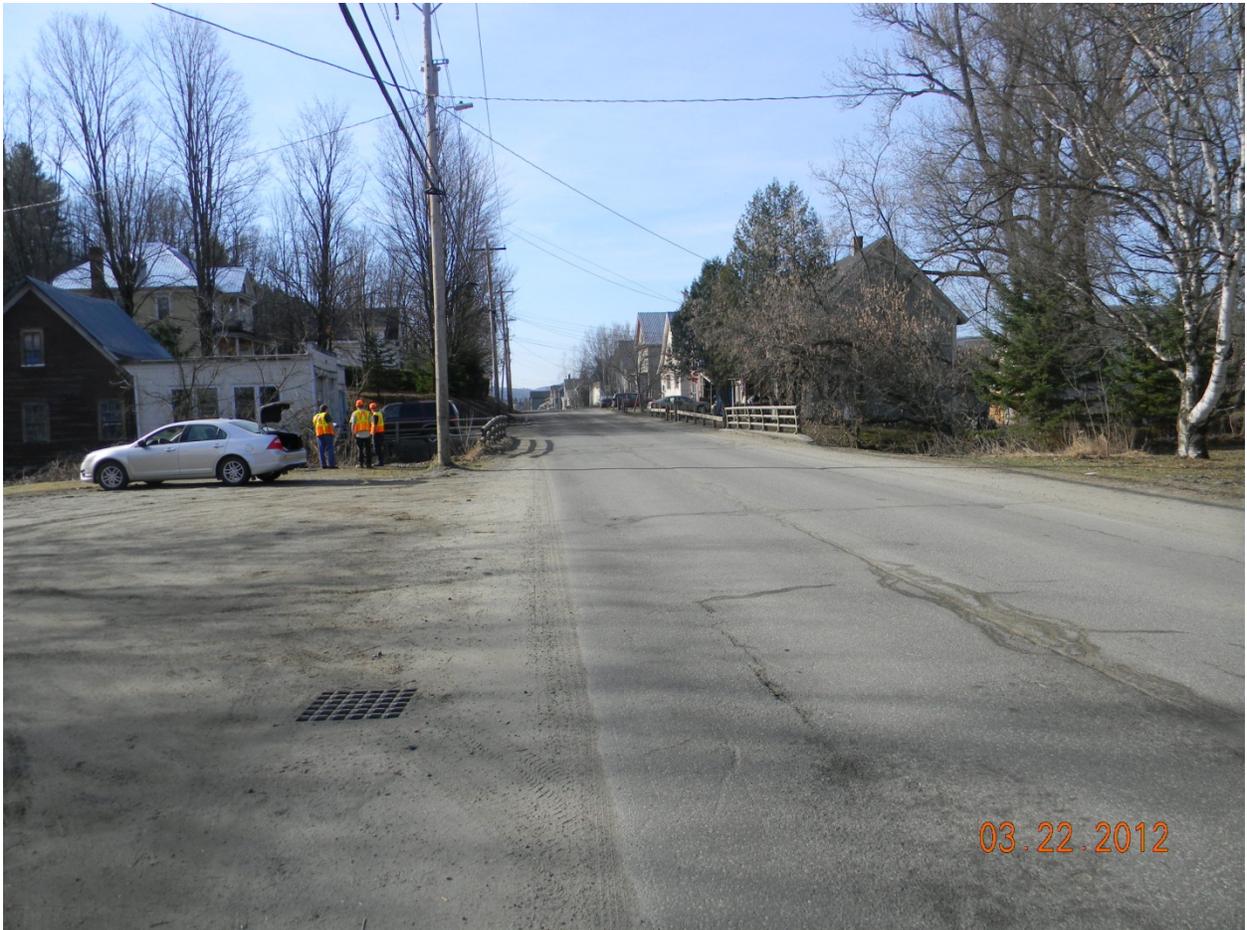
Southbound Approach

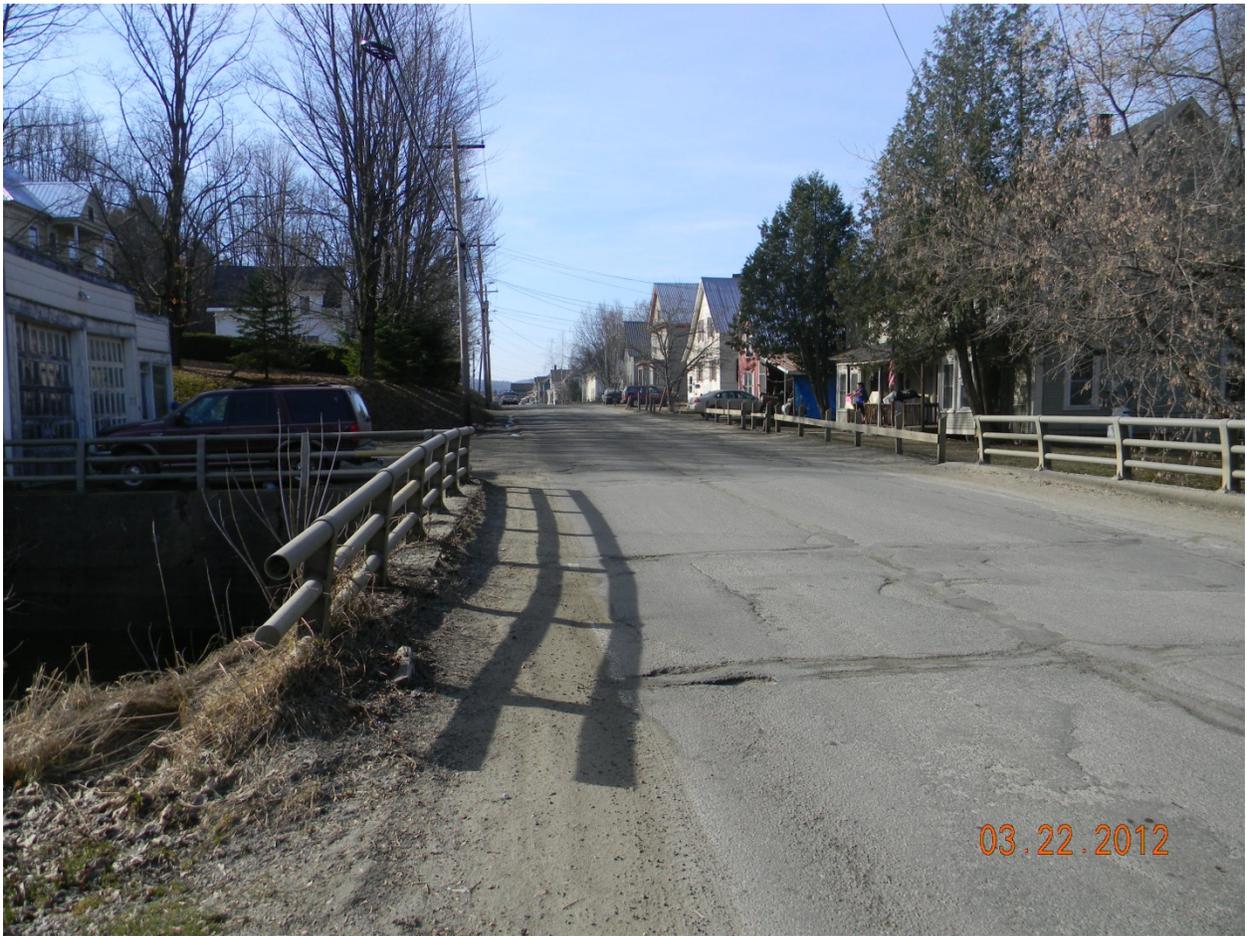
Looking South at Bridge Location

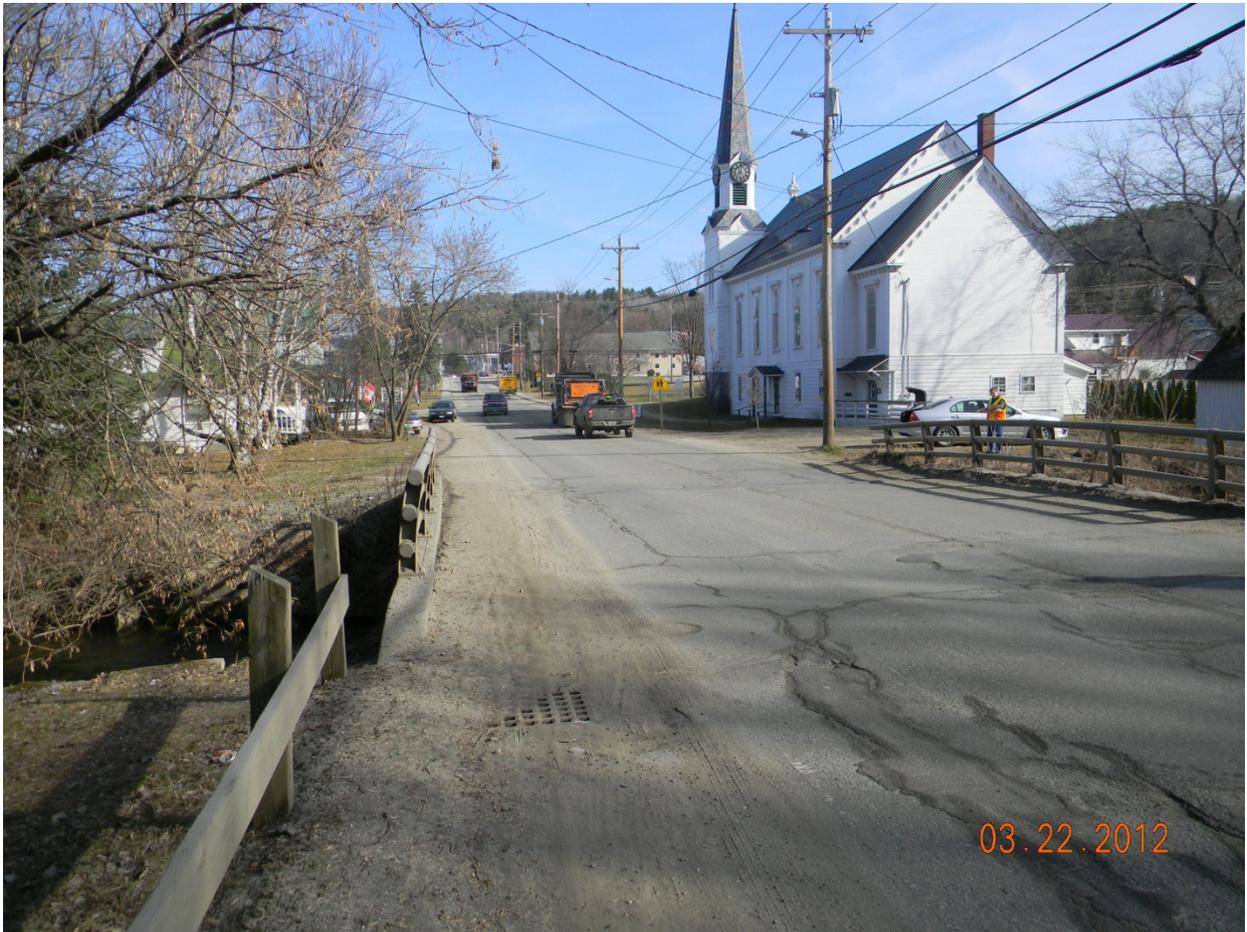
Looking North at Bridge Location

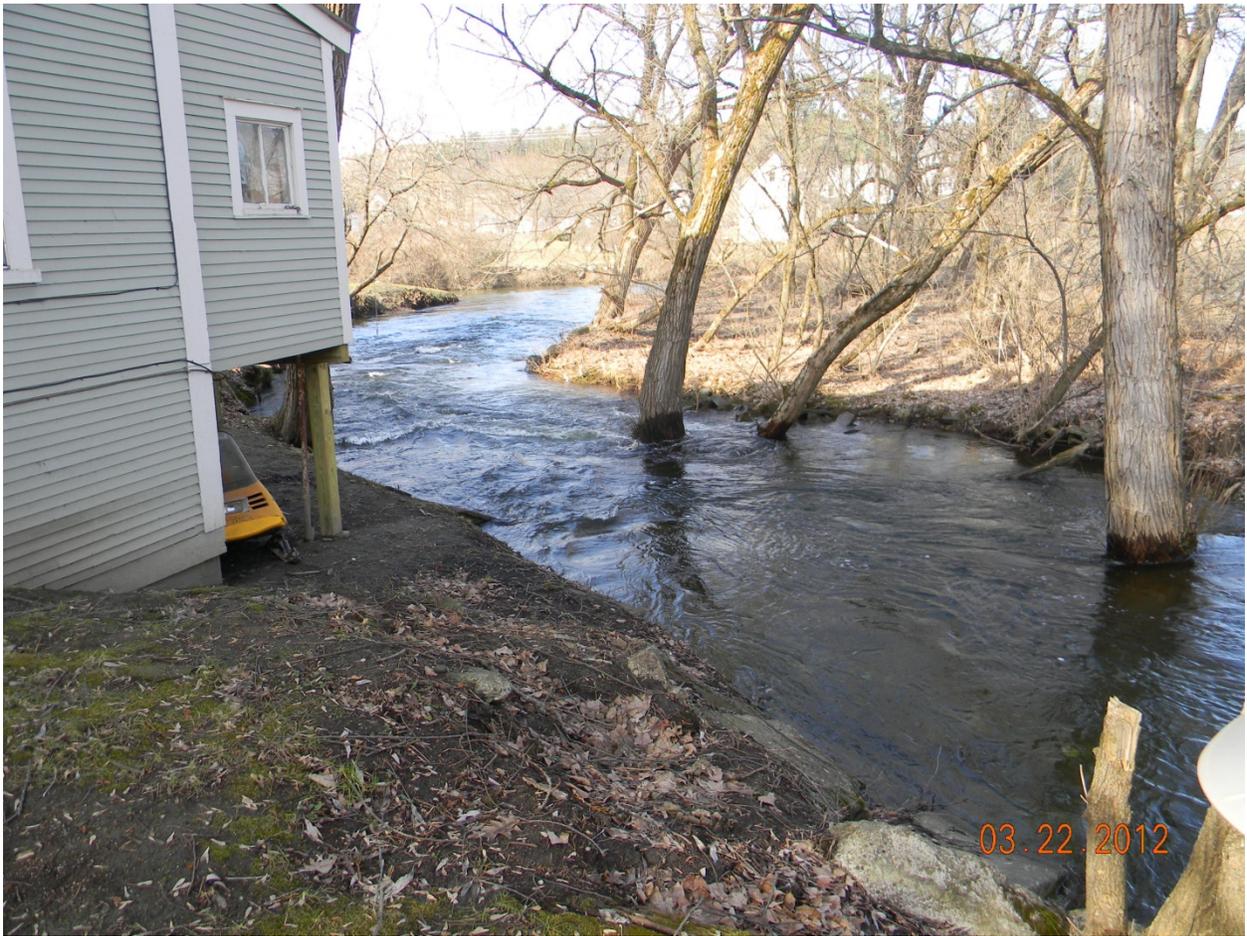
Looking Downstream

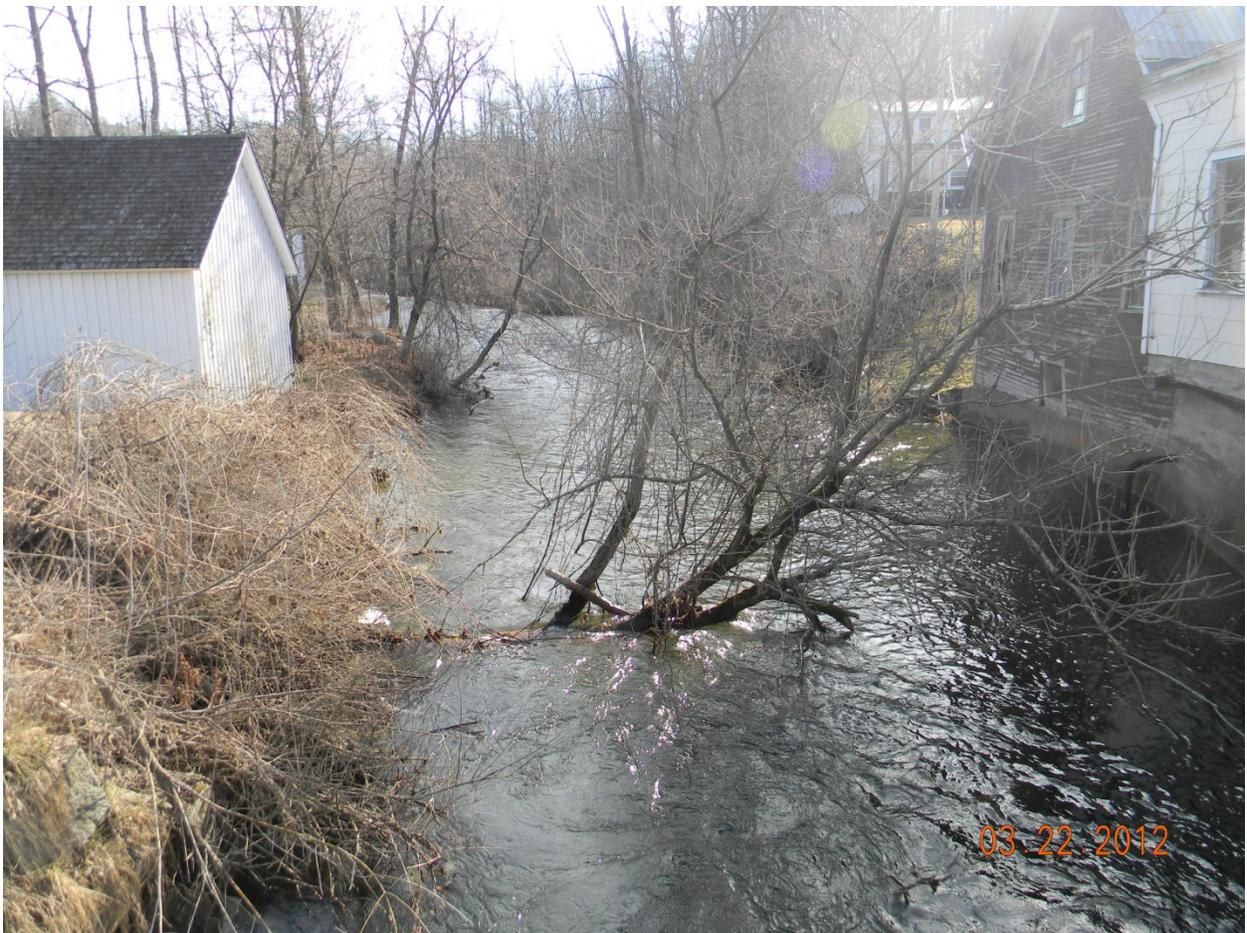
Looking Upstream

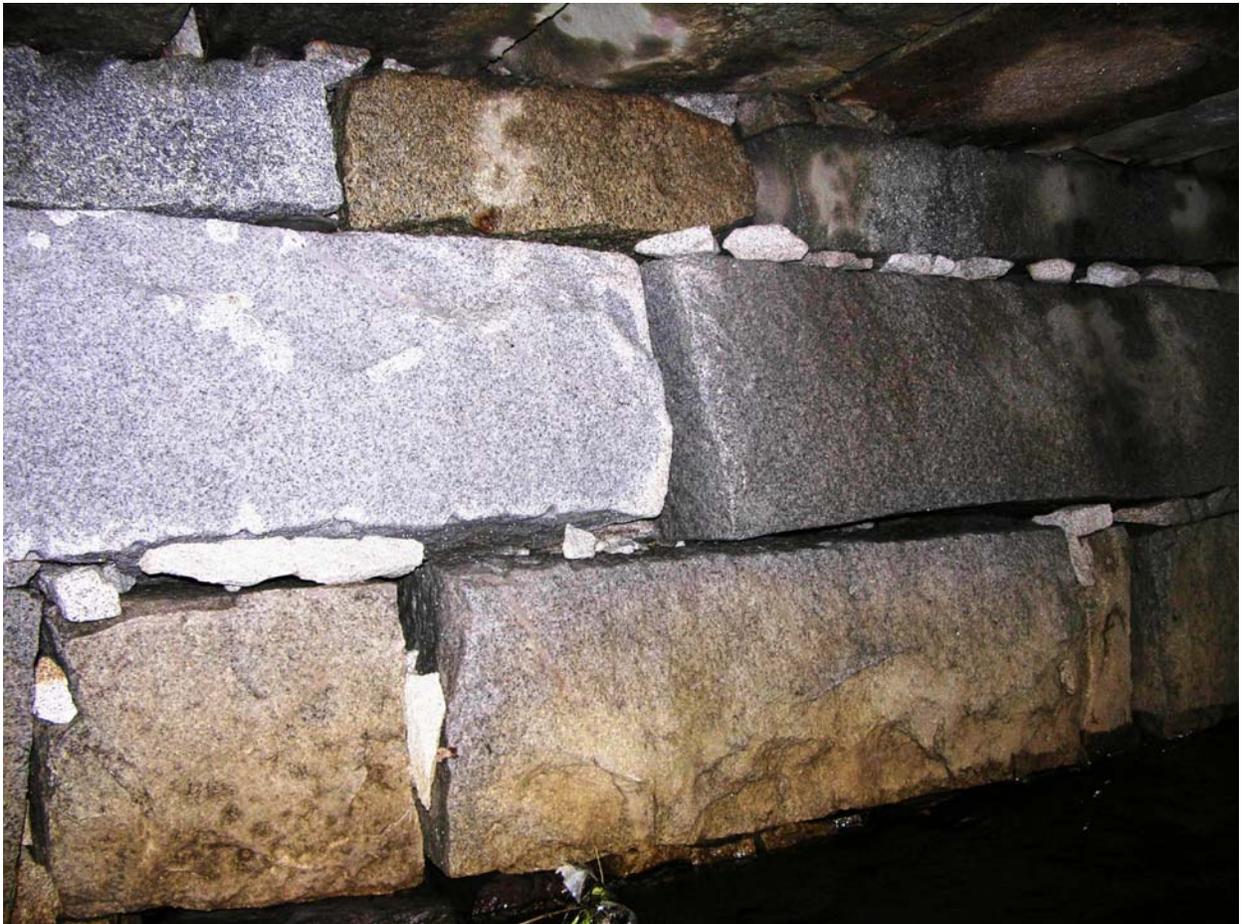
Laid-up Stone Abutment

5/26/2011 – The abutments and piers should be repointed. And the voids between the granite slab units should also be repointed. ~ DCP/FRE

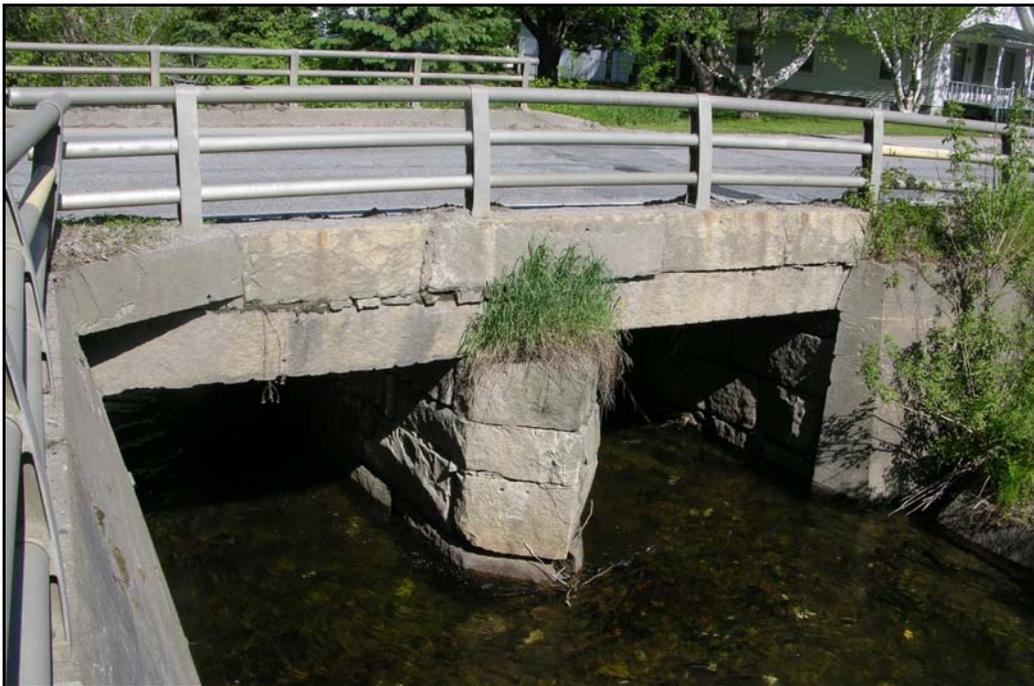
In an effort to assist the Structures Section with their bridge type study, the Soils and Foundations Unit within the Materials and Research Section has completed a review of available geological data for Bridge 20 on VT 16. Bridge 20, see Figure 1, is a two span structure that crosses over the Barton River in Barton, Vermont. This scoping report includes a review of VTrans record plans and bridge boring files, USDA Natural Resources Conservation soil survey records, surficial geology and bedrock maps of the State and the Agency of Natural Resources' water well logs.

Figure 1: VT 16, Bridge 20 over the Barton River

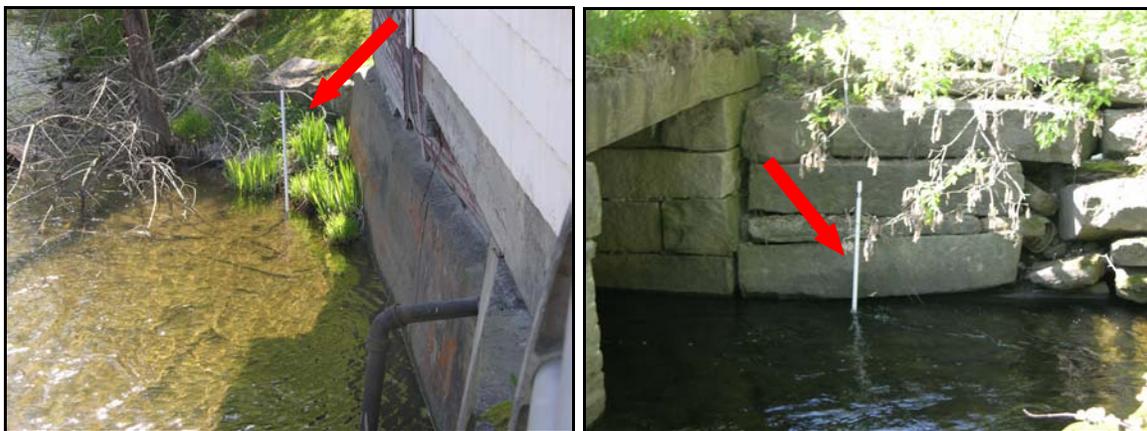
The existing bridge is within a hazardous waste site; identified as Site 20053433 – Redington’s Garage. The site is listed as medium priority without any land use restrictions. More investigation into the nature and disposition of the waste site may be warranted. There were a large number of monitoring wells in the area, see Figures 3 and 4.

Figures 3 and 4: Location of Existing Monitoring Wells

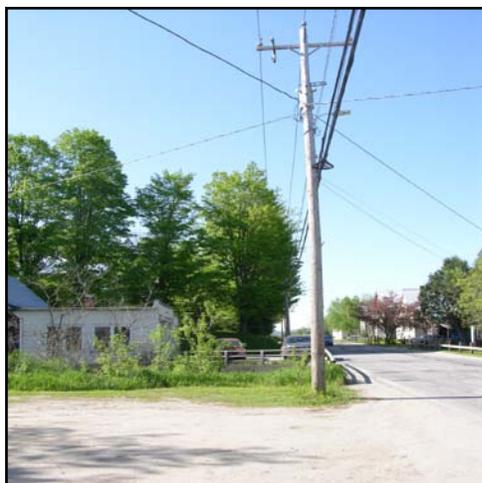
Power lines exist on the east side of VT 16 and cross the road to service local residents. This bridge is in an urban setting and there are storm drains and outlets in the roadway and adjacent to wingwalls. There are also several monitoring well locations in service to monitor the hazardous waste site.

Figure 5: Roadway Profile / Overhead Utility Locations at BR 20
