STATE OF VERMONT
AGENCY OF TRANSPORTATION

Scoping Report

**St. Johnsbury BHO 1447(30)
TH 371, Bridge 46 OVER SLEEPERS RIVER**

January 18, 2013

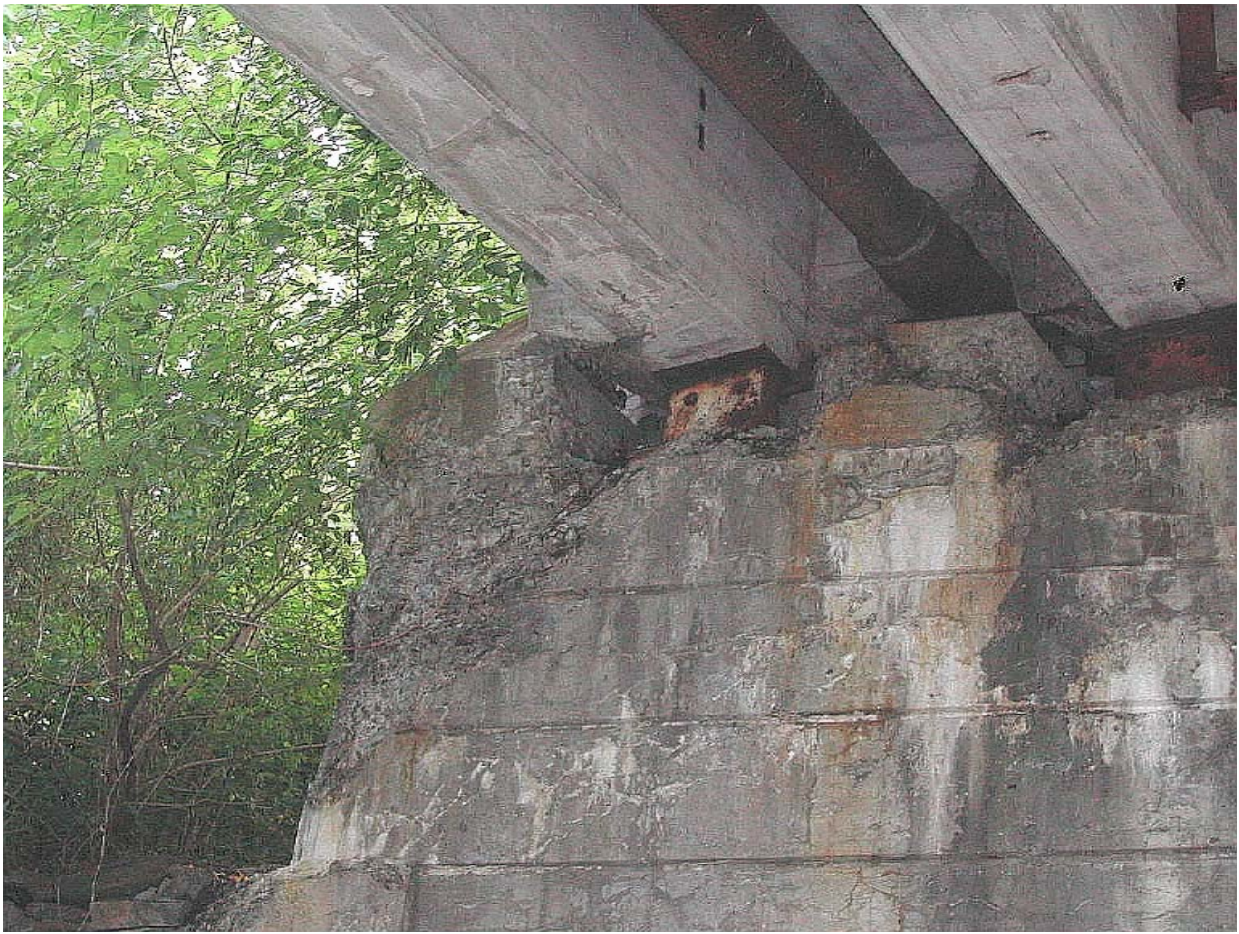
Deteriorating Pier Cap

- New pier caps would likely be poured, as the existing caps have suffered significant deterioration from leaking joints.
- The piers would require concrete repair, especially on the downstream radius end area where they have been exposed to salt corrosion.
- The material that has filled in between each abutment and pier would be removed to reduce loading on the existing piers.

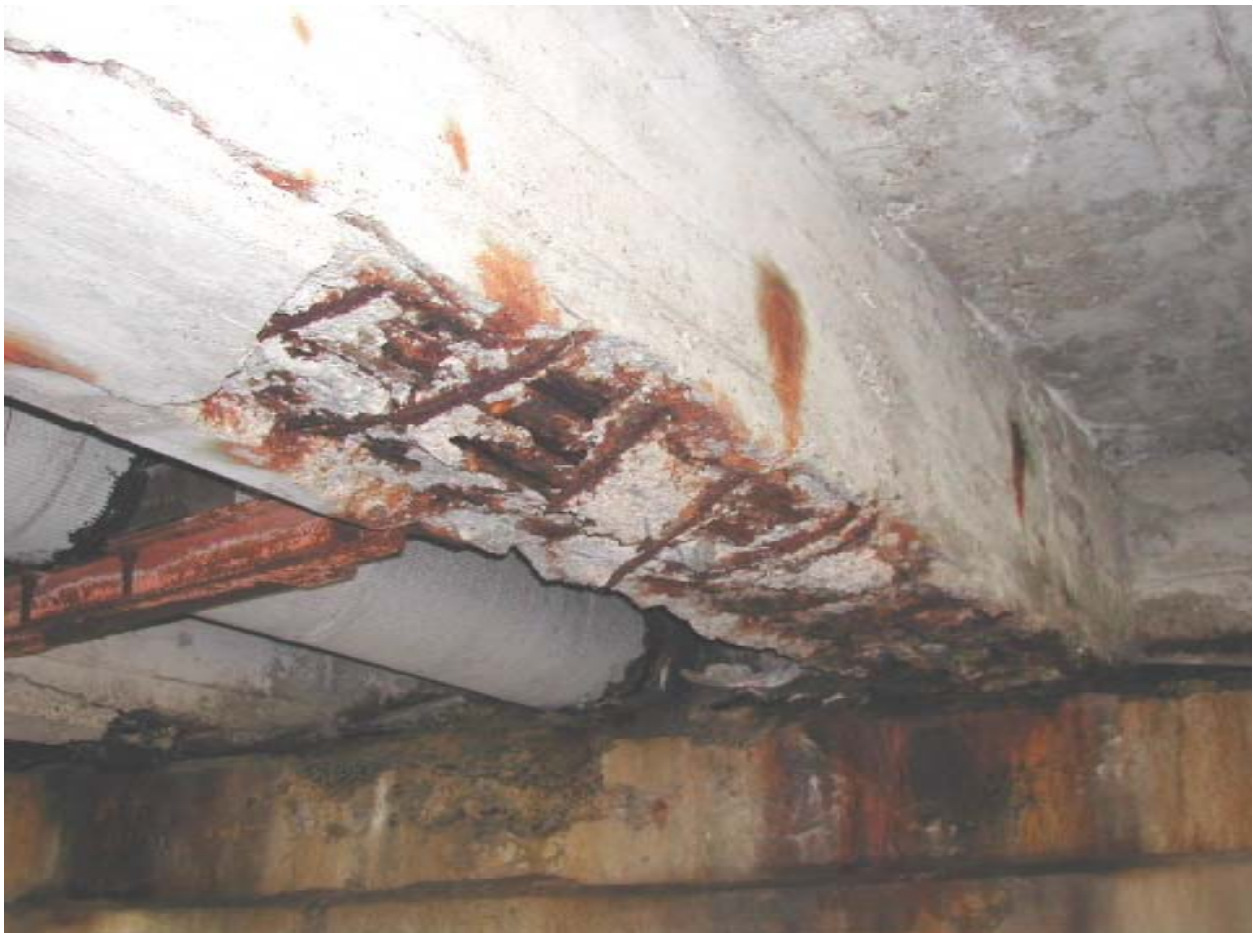
Deteriorating Tee-Beams

1. The deck and superstructure are in fair condition. There are many cracks and potholes in the bridge pavement, which is an indication of deck deterioration. The tee beams are badly deteriorated with a great deal of reinforcing steel exposed, especially at the bearings.
2. The substructure is in fair condition. The piers have been subject to salt attack, with much deterioration. Cracking has also been observed in the piers. The abutments have spalling and hairline cracking with efflorescence present.
3. The bridge rail is in very poor condition. Most of the concrete spindles have deteriorated fully, so that only reinforcing steel is remaining. Additionally, the approach rail does not meet standard.
4. The horizontal curve of the end approach to the bridge does not meet the current standard for minimum radius.

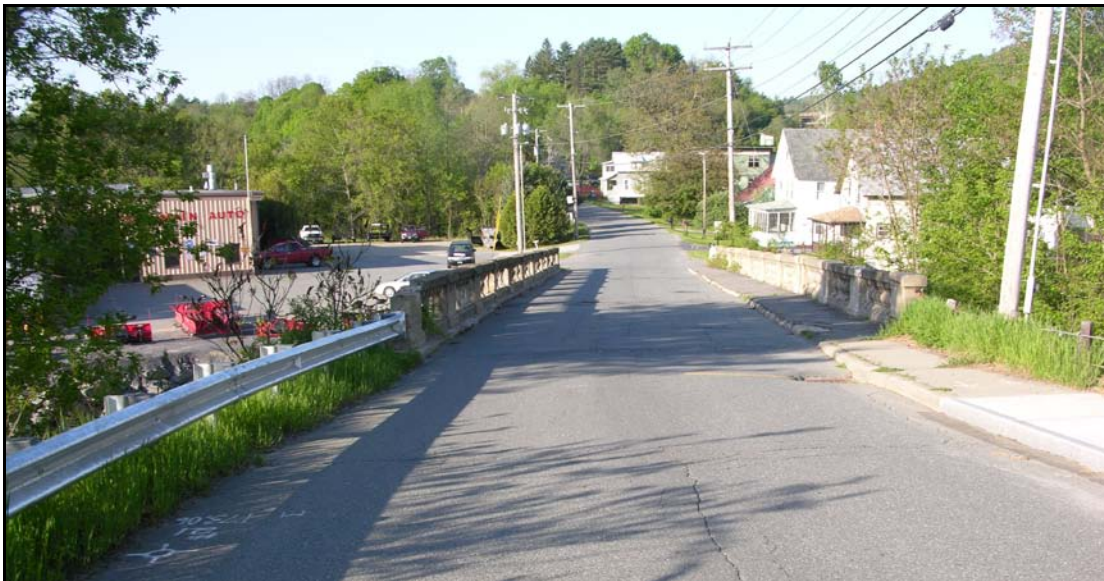
Figure 1: South Main St (TH C3371), Bridge 46 over the Sleepers River

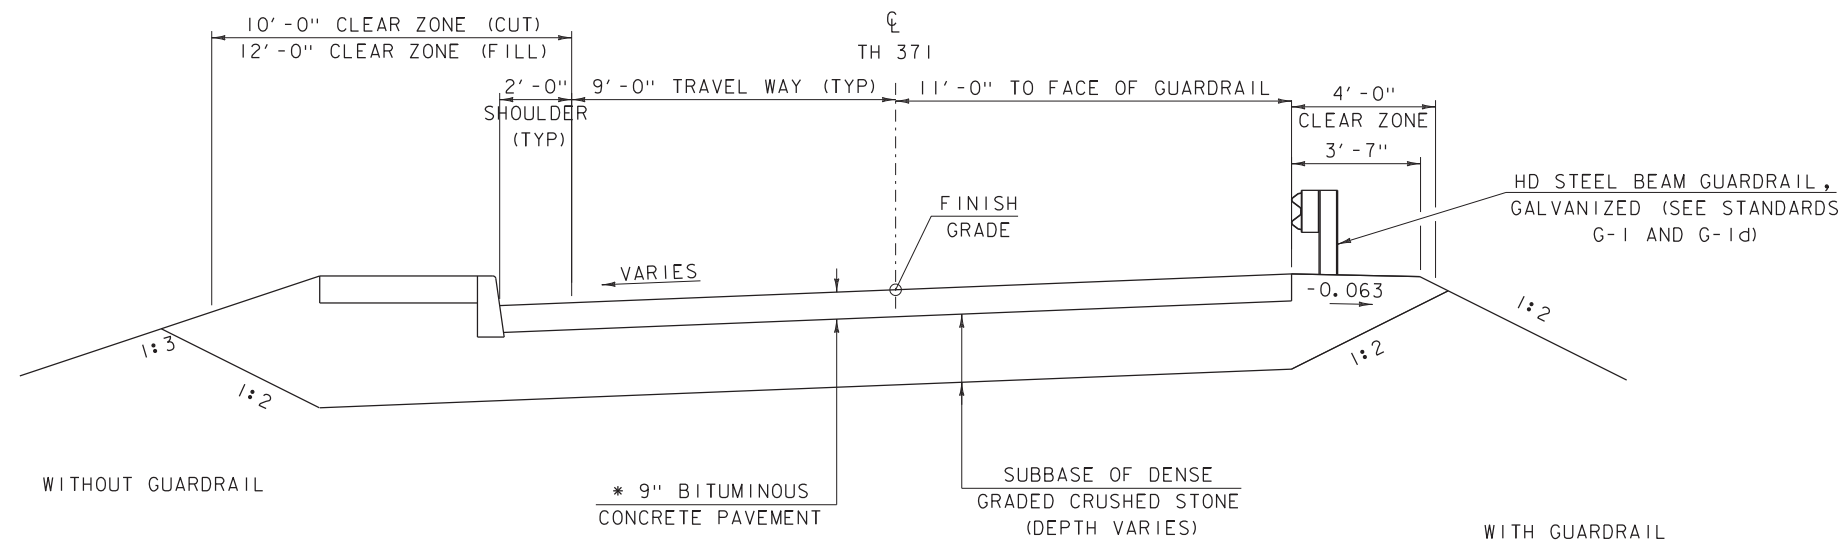
TH 371 ROADWAY TYPICAL SECTION

* 1 1/2" TYPE IVS OVER
 1 1/2" TYPE IVS OVER
 3" TYPE IIS OVER
 3" TYPE IIS

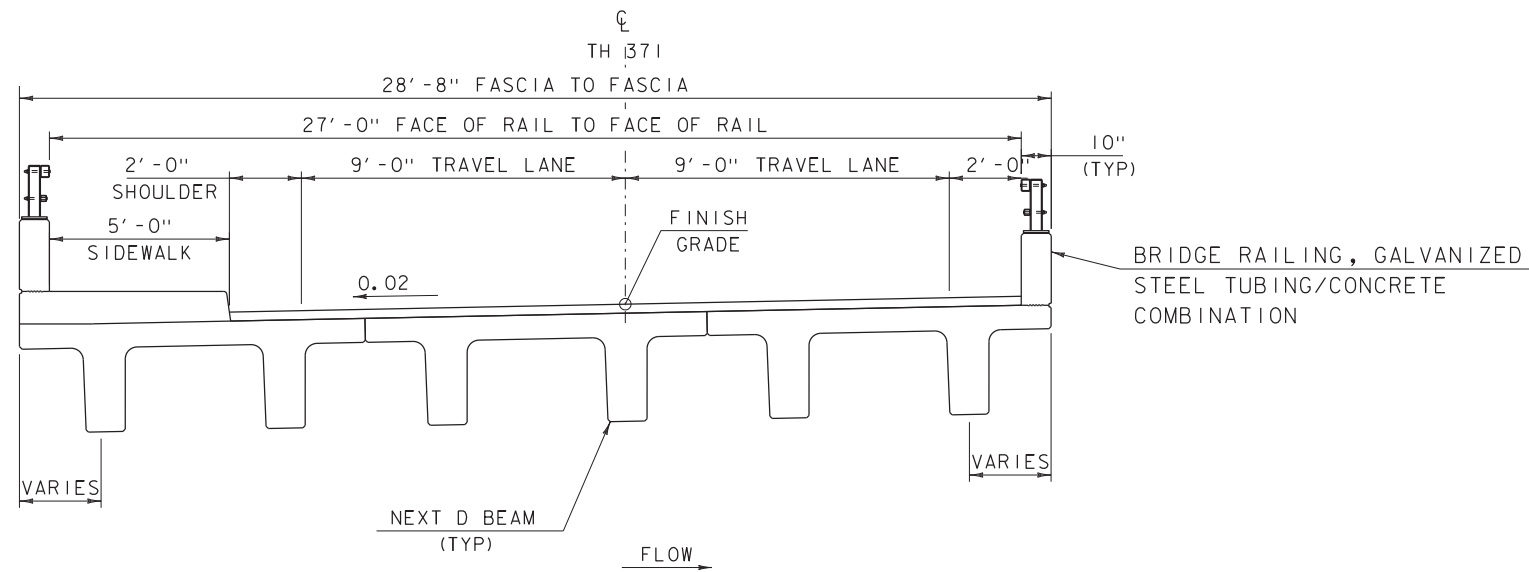
BRIDGE TYPICAL SECTION

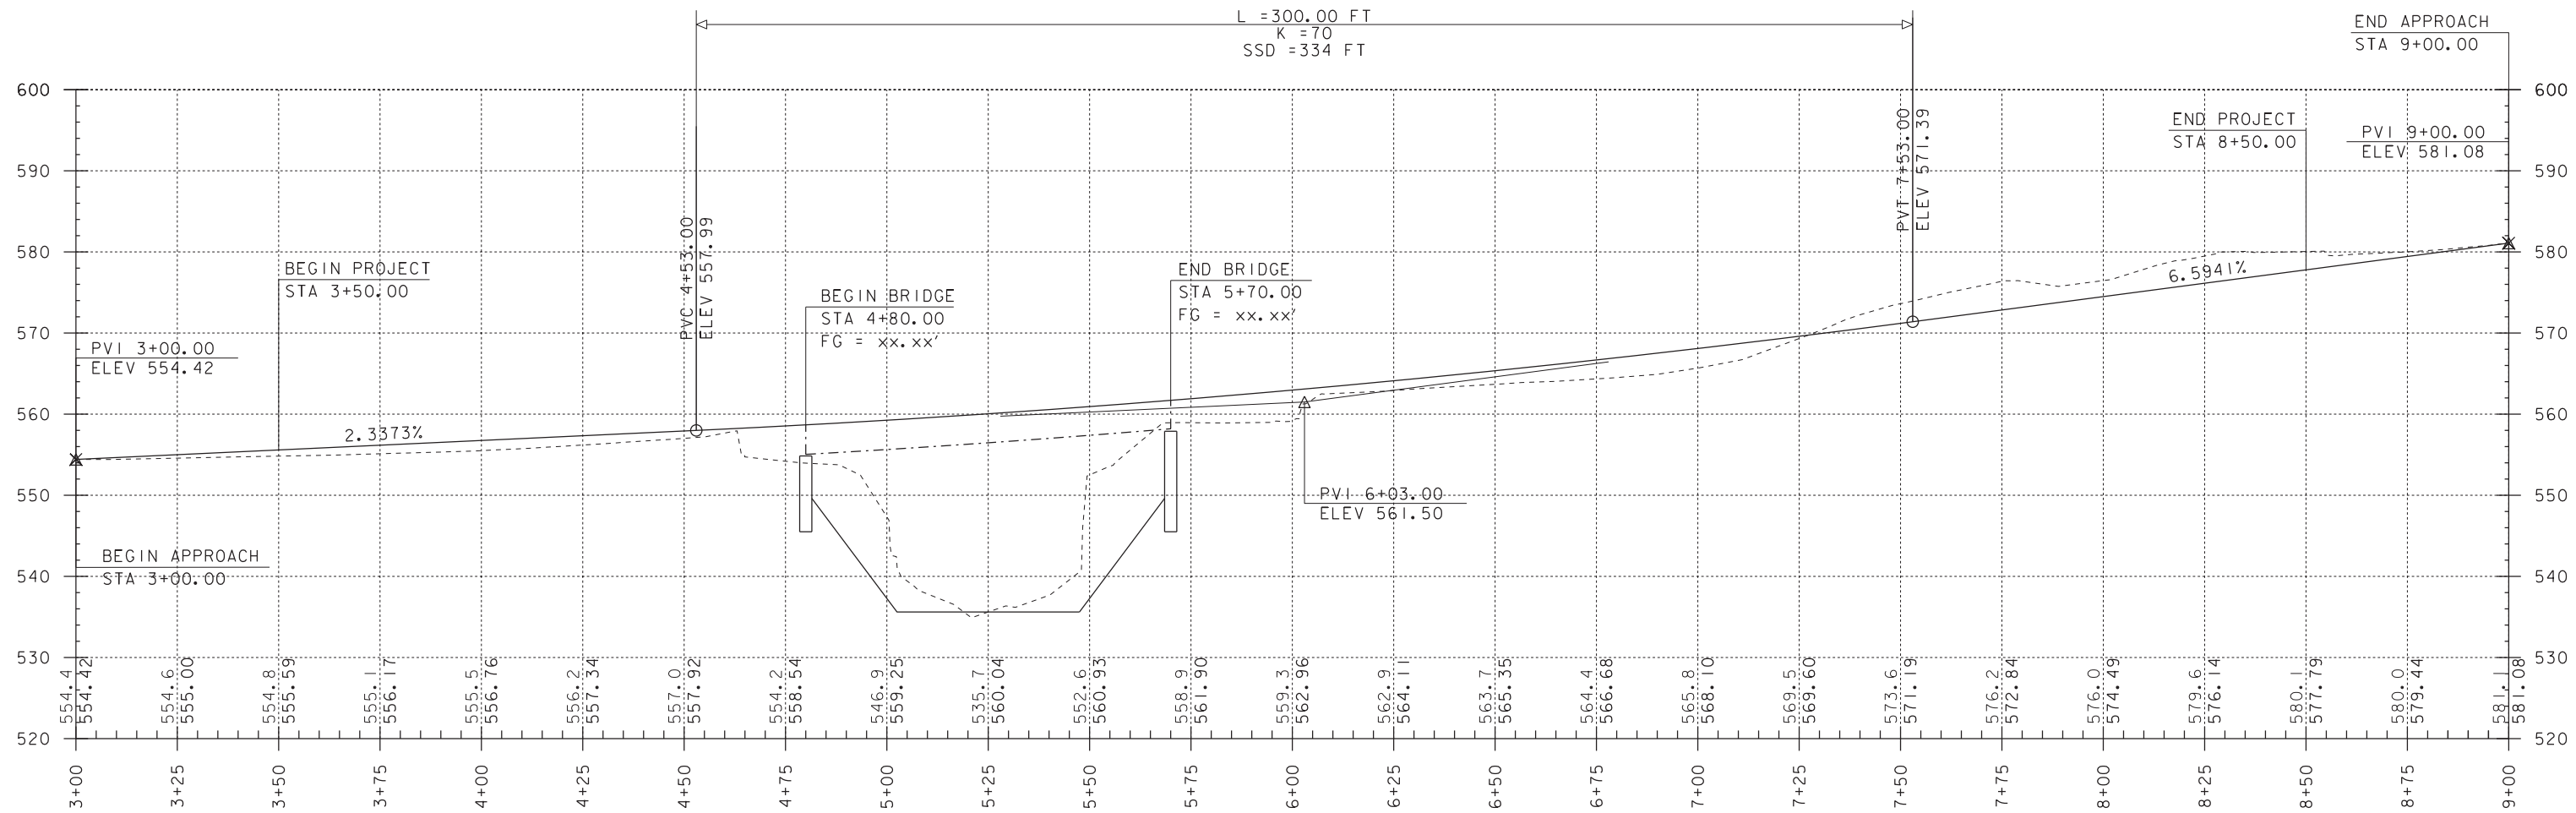
TH 371 (OLD US 5) PROFILE FOR OFF ALIGNMENT FULL BRIDGE REPLACEMENT

NOTE:
 GRADES SHOWN TO THE NEAREST TENTH ARE EXISTING GROUND ALONG ℓ
 GRADES SHOWN TO THE NEAREST HUNDREDTH ARE FINISH GRADE ALONG ℓ

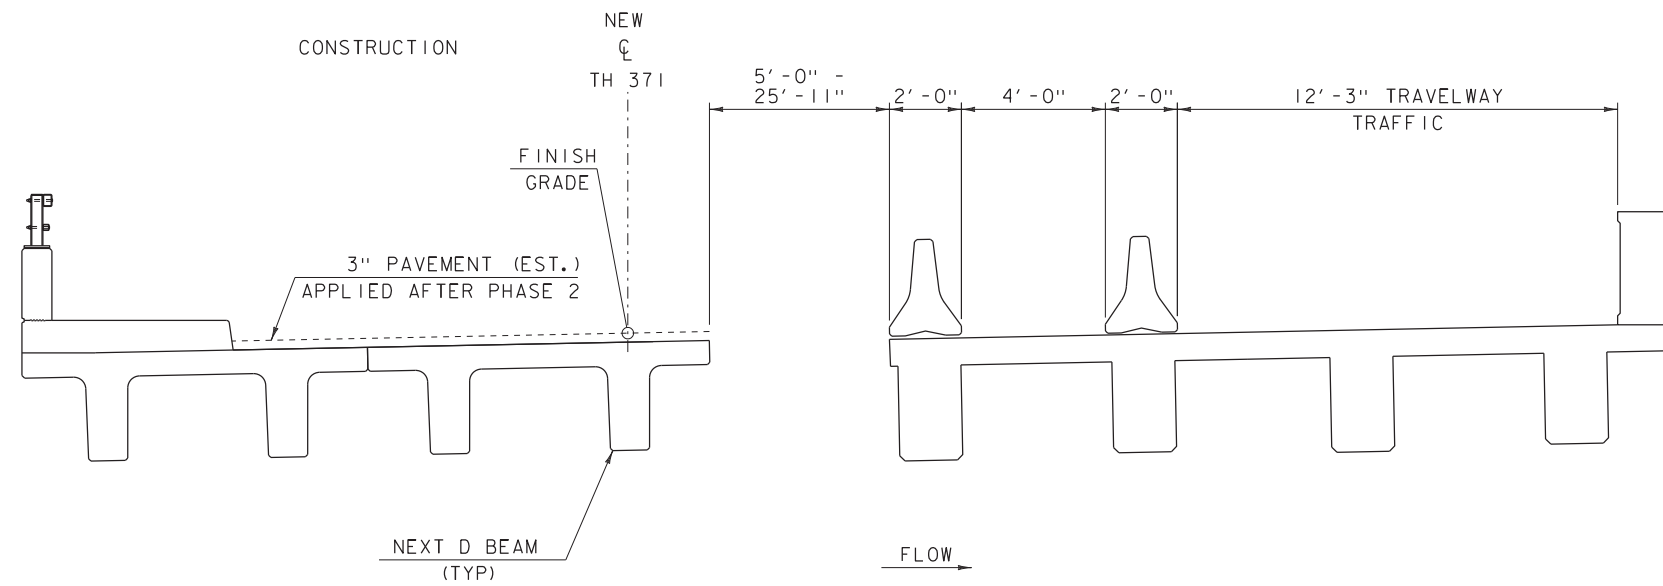
FULL BRIDGE REPLACEMENT PHASE #1 TYPICAL SECTION

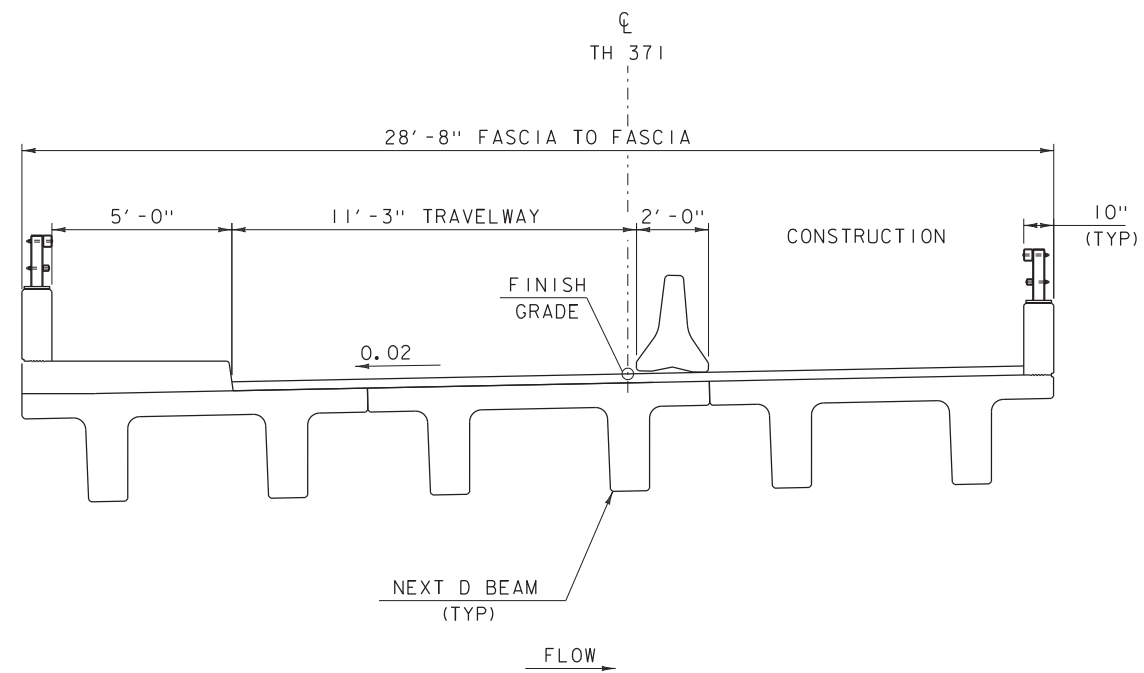
FULL BRIDGE REPLACEMENT PHASE #2 TYPICAL SECTION

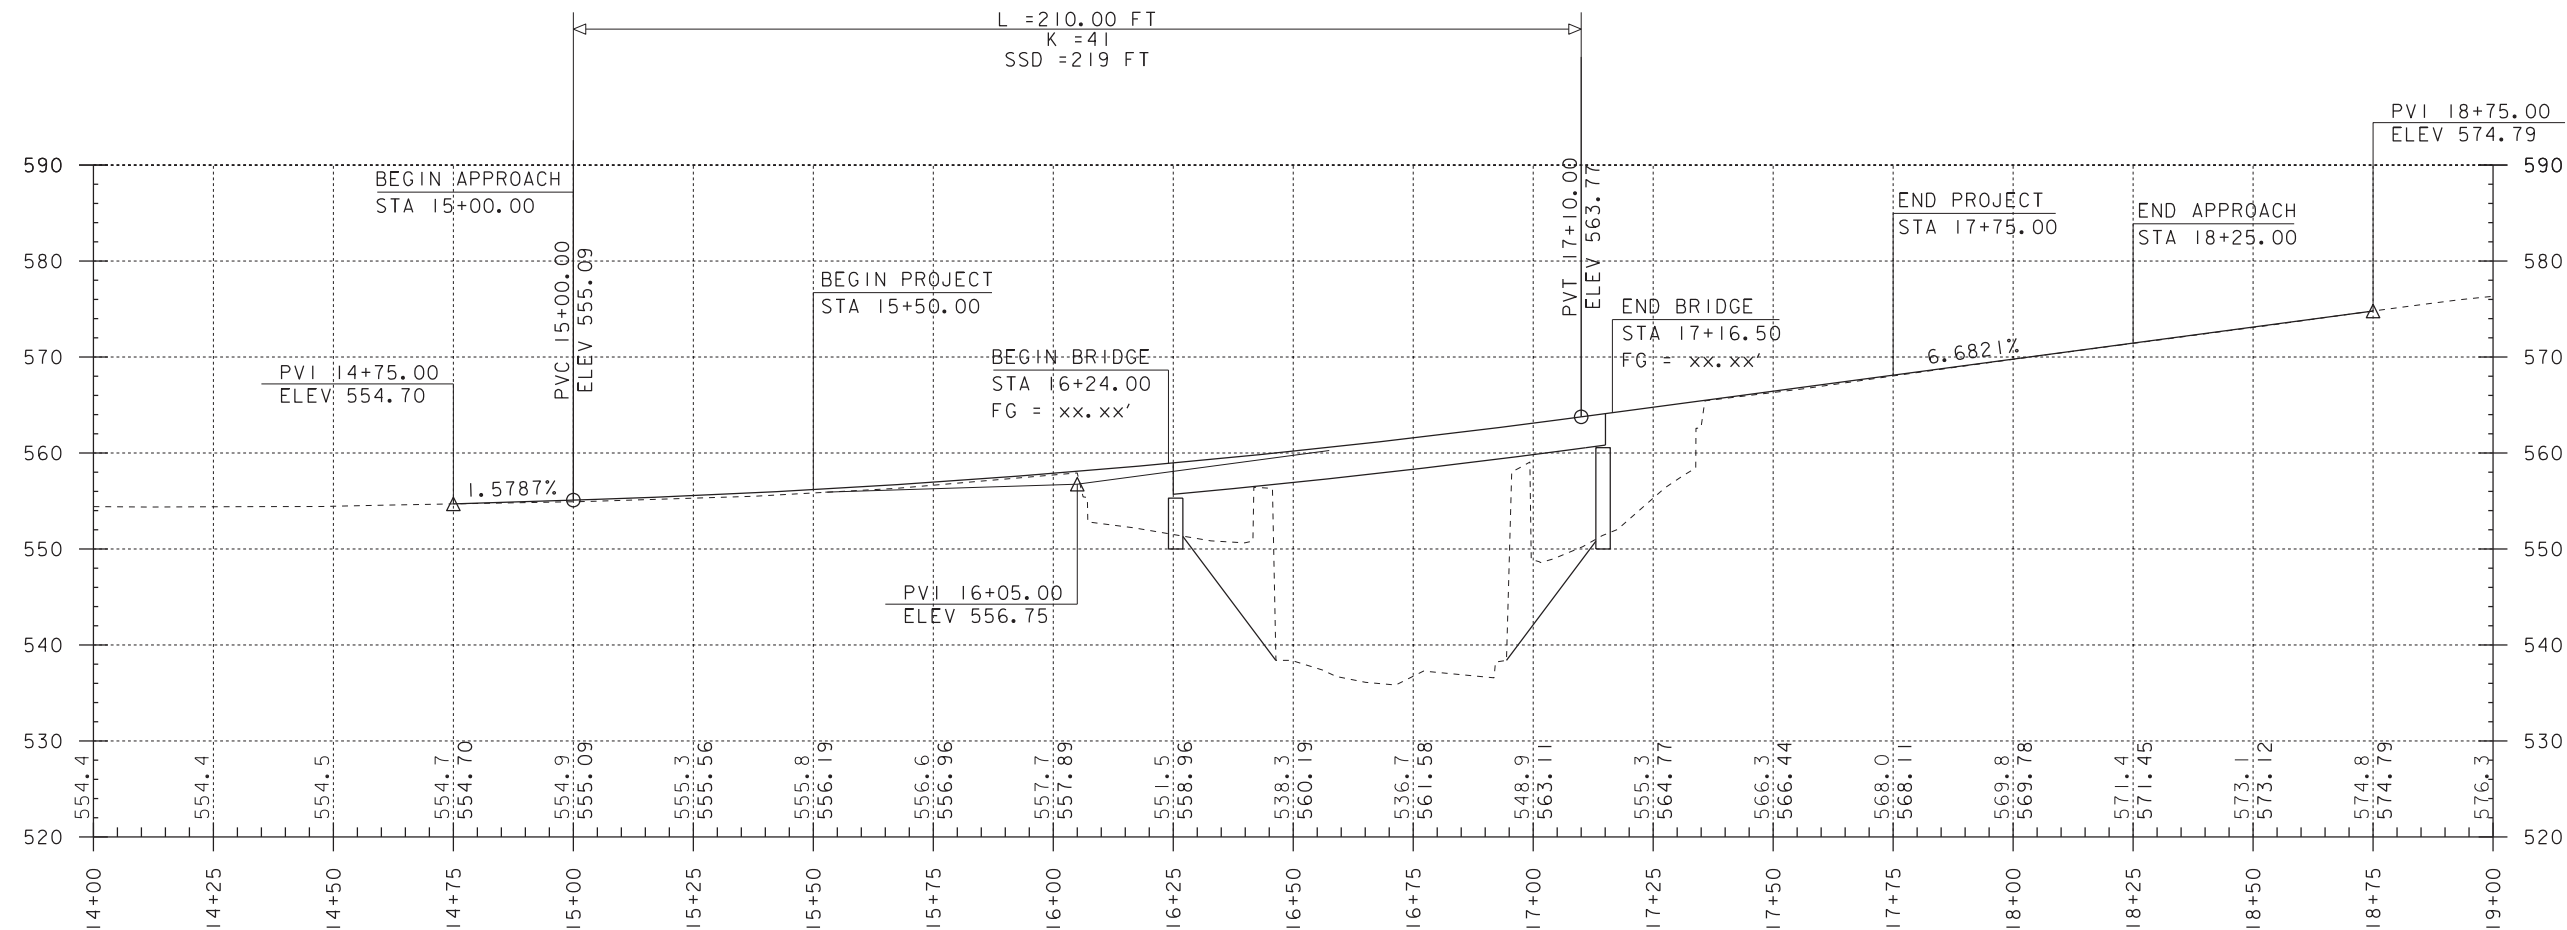
TH 371 (OLD US 5) PROFILE FOR ON ALIGNMENT FULL BRIDGE REPLACEMENT

GRADES SHOWN TO THE NEAREST TENTH ARE EXISTING GROUND ALONG ϕ

GRADES SHOWN TO THE NEAREST HUNDREDTH ARE FINISH GRADE ALONG ϕ
