# VILLAGE SAFETY STUDY

## Lowell, Vermont

September 2012

# VT 100 Village Safety Study-Lowell

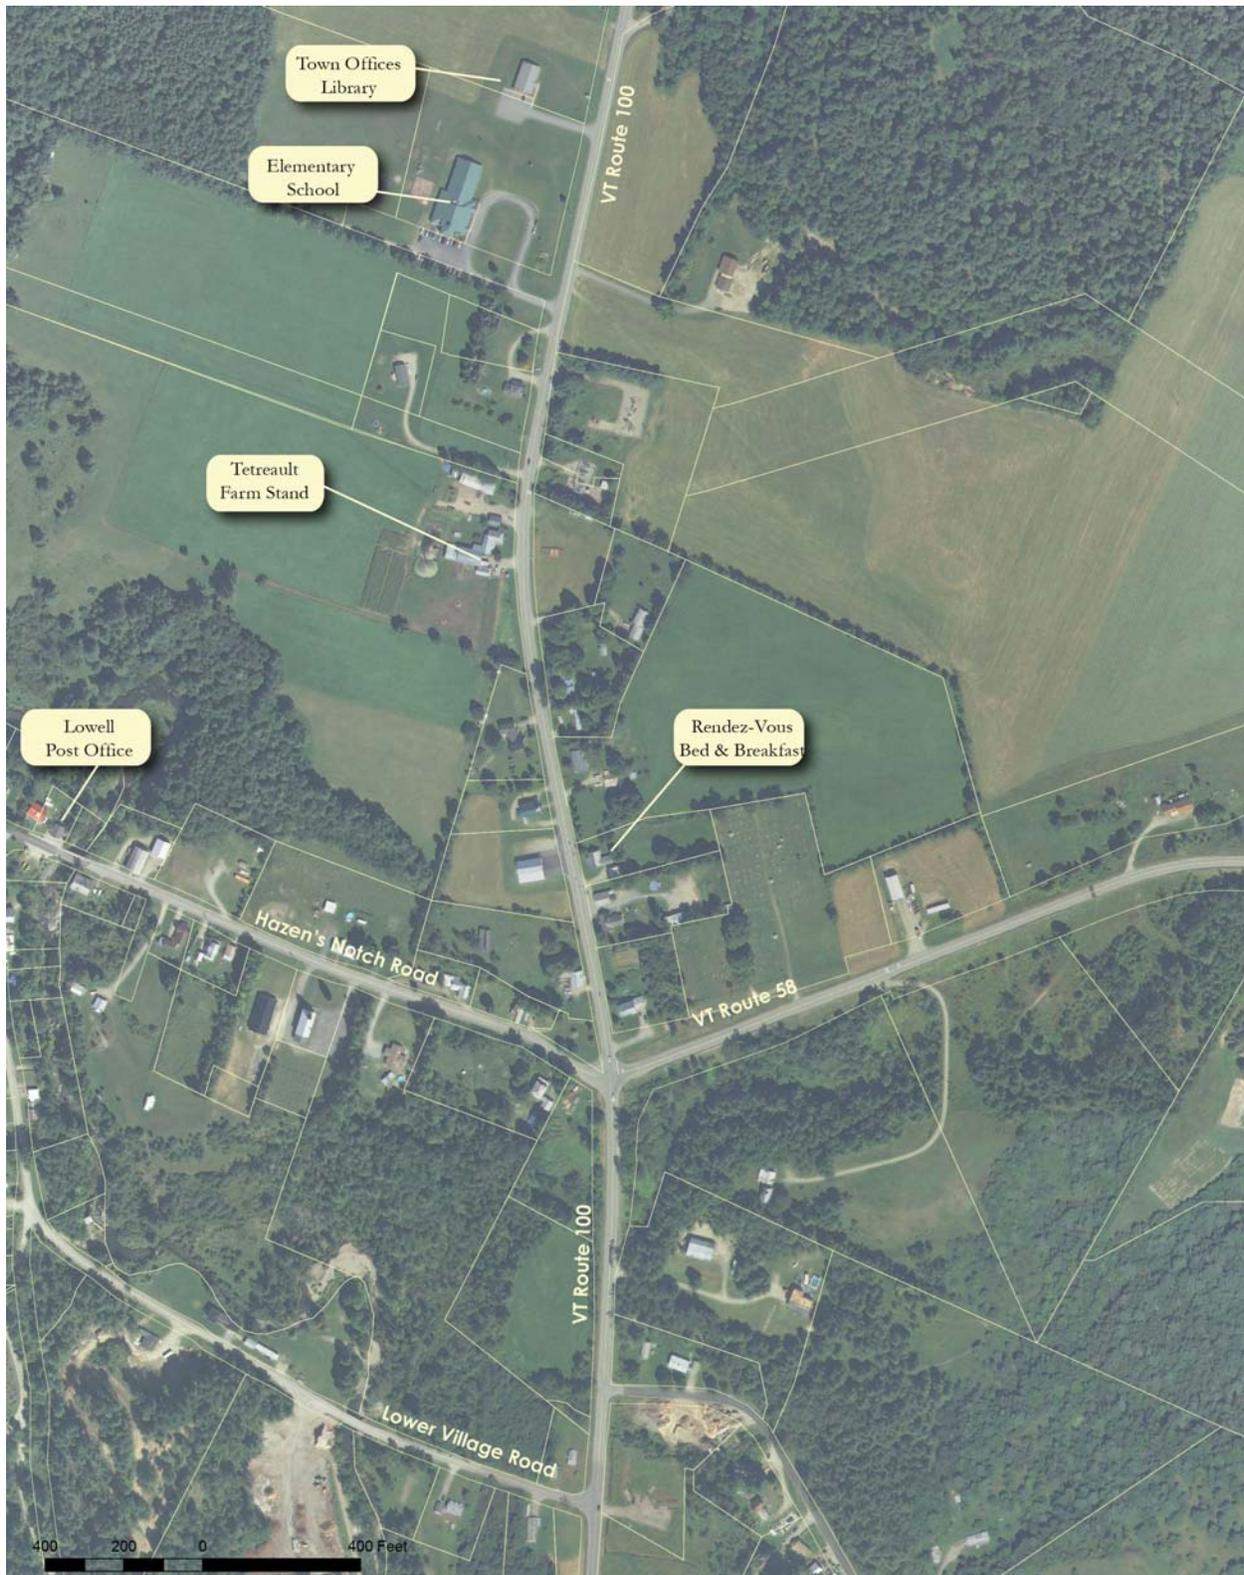
Figure 2: Project Area Map

Lowell is a very rural town with a village center that has a concentration of land uses and activities along Hazen's Notch Road and VT 100 (Figure 2). VT 100 is a state owned and maintained highway, and has a speed limit of 35 mph. The road's width is typically 26 to 28 feet through the study area, with 12 foot travel lanes and 2 foot shoulders. The shoulders are mostly too narrow to safely accommodate pedestrians. There are utility poles along the west side of the road right-of-way.

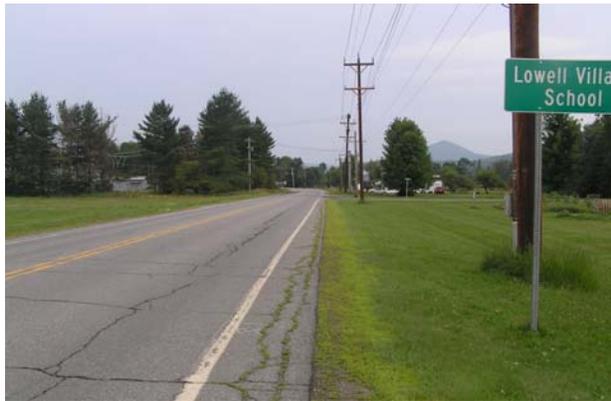
Southbound between town offices and school

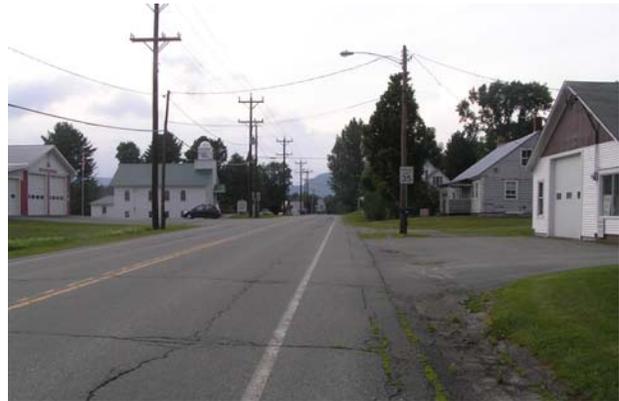
Southbound between school and fire station

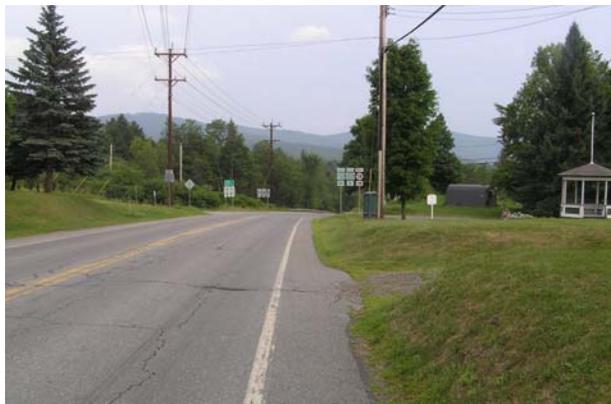
Approaching VT 58/Hazen's Notch Rd Intersection

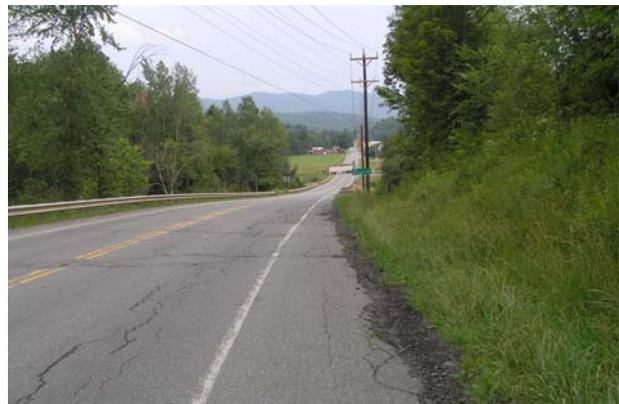
Southbound South of VT 58 Intersection

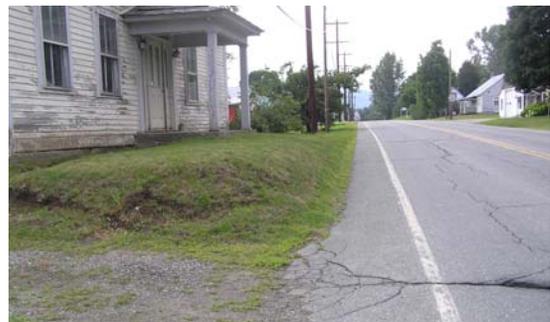
- The sidewalk would result in impacts to a historic home and property adjacent to road (see photo to right).
- The Town would need to provide winter maintenance of the sidewalk.
- Utilities in the VT 100 right-of-way would have to be considered in the sidewalk alignment.

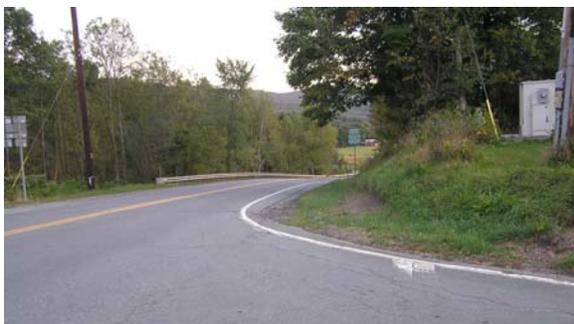
View to South from Hazen’s Notch Road

The photos on the following page show the views from each side of this intersection. Sight distance along VT 100 is restricted to the north of the intersection due to a vertical curve in the road. There are no affordable options to address this other than further lowering of the road in order to improve sight lines. This type of improvement would be prohibitively costly, have impacts to historic structures, and require utility re-location.

Sight distance to the south from VT 58 and Hazen’s Notch Road could be improved by cutting back the bank on the southwest quadrant of the intersection. Marginal improvements could result from shaving the slope and more frequent mowing and cutting brush. More substantial improvements would require right-of-way acquisition, relocating the utilities located at the top of the bank, and phase 1B archaeological investigations, making this also a costly option.

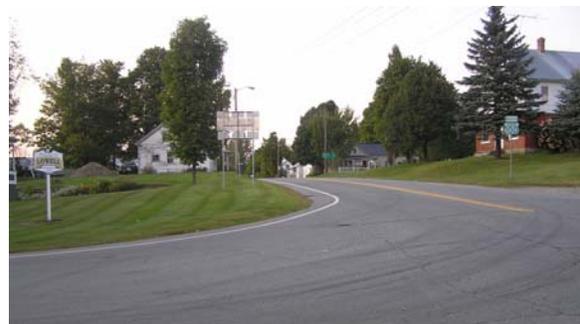
View to North from Hazen’s Notch Road

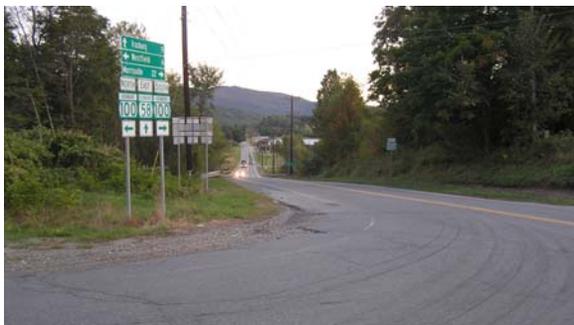
View to South from VT 58

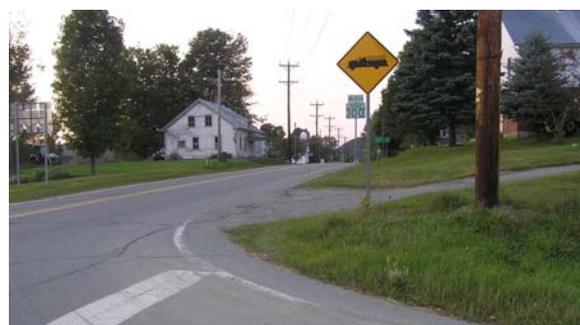
View to North from VT 58

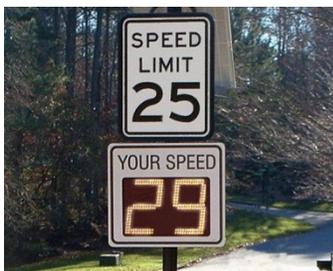
Radar Feedback Signs

The following photos show some of the elements that can be used in gateway transitions.

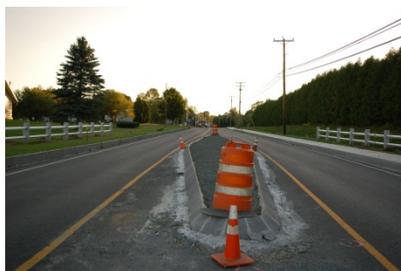
Splitter Islands (under construction in Danville)

Some of these elements, such as splitter islands or optical striping, should be considered for implementation in combination with the future resurfacing project, Troy-Lowell STP 2934 (). Other items could be implemented sooner by the town through the VTrans Transportation Alternatives funding program, which will likely require local matching funds between 10% to 20%. The table on the following page shows the estimated cost of these items.

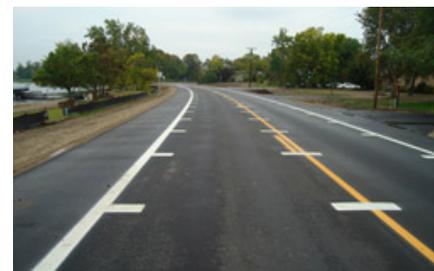
Optical Striping

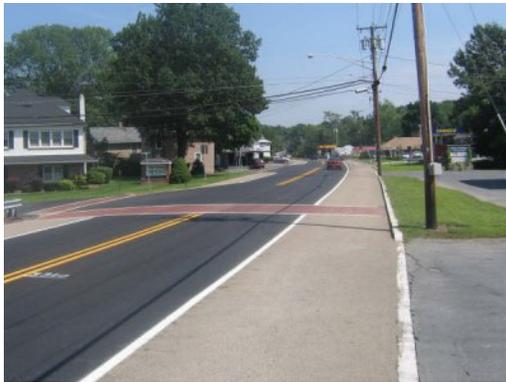
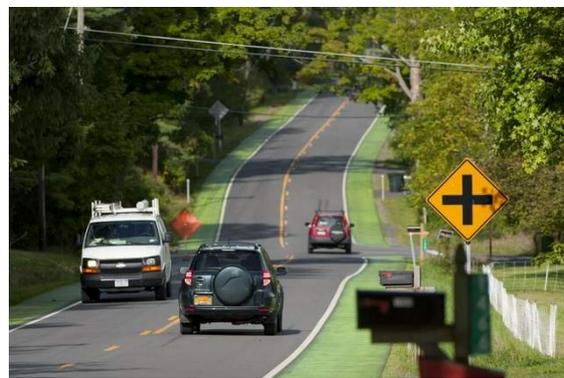
There are several measures that could help narrow the road's appearance to drivers, resulting in lower speeds. The travel lanes should be maintained at 11 feet or possibly narrowed to 10 feet. Colored asphalt could be used on the shoulders in the village's reduced speed zone to reinforce the perception that the road is narrow and speeds should be low. The following photos show examples of colored shoulder treatments. A variety of materials and techniques have been used in other states.

Implementation of this treatment could be accomplished as part of the upcoming Troy-Lowell STP 2934() resurfacing project. The Town would likely be responsible for maintenance of the surface, and the cost and effort involved with that would depend on the type of treatment used. Ideally, the color would be integrated into the asphalt rather than a surface treatment that could wear off.

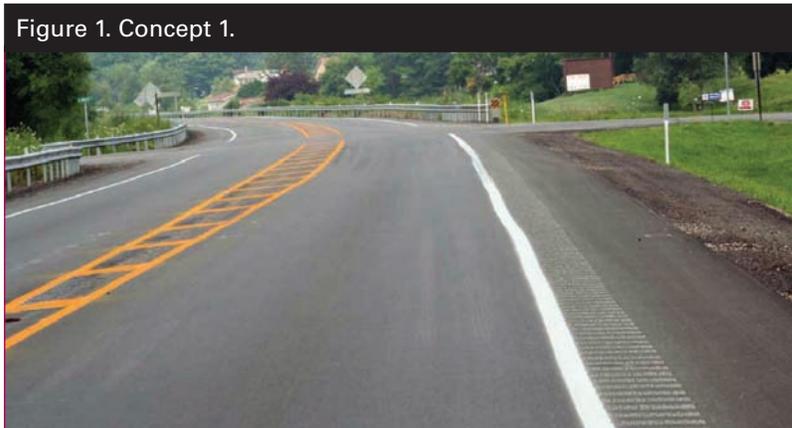
Figure 1. Concept 1.

The objective of this first concept is to induce drivers on major roads to reduce approach speeds at intersections by effectively reducing the lane width. The minor road splitter island concept (concept 2) features channelizing separator islands on the side road approaches on which supplemental STOP signs are installed (figures 3 and 4). The objective of the second concept is to provide redundancy of the STOP sign and increase driver-compliance with the STOP sign. A third concept includes the combination of concepts 1 and 2 (figure 5). The concepts have greater potential for effectiveness on intersections of high-speed roadways. However, they can also be applied to intersections with lower posted speed limits. With the cooperation of several transportation agencies, these two strategies were deployed at a limited number of sites in the United States. This paper documents an evaluation of the operational and safety effectiveness of these strategies.

Concept 1 focuses on reducing speeds on the major approaches by narrowing the lane width and will hereafter be referred to as the lane narrowing concept. While there was no literature related to this exact concept, other studies have shown that the roadway environment can affect drivers' speed. For example, one study indicated that speed perception was greater when the roadway was lined with trees, creating a narrowing effect.<sup>(5)</sup> With respect to safety, the effects of lane-narrowing techniques have not been studied thoroughly. Regarding the use of rumble strips, shoulder and centerline rumble strips have been shown to enhance safety by reducing run-off-road and cross-over crashes. However, there is a concern that centerline rumble strips could have a negative impact on safety. The shoulder rumble strip application is more common than the centerline rumble strip, and drivers may have a general a priori expectancy to steer left when encountering rumble strips while unaware of their lane position. A recent study<sup>(6)</sup> verified this concern using a simulator experiment and concluded that some drivers (about 27 percent) initially steered left when encountering centerline rumble strips while unaware of their lane position. While this concern may hold for applications of the lane narrowing concept, the rumble strips are more of a lane-narrowing device than a warning for unaware motorists. For those drivers that are aware of their lane position, the use of rumble strips as

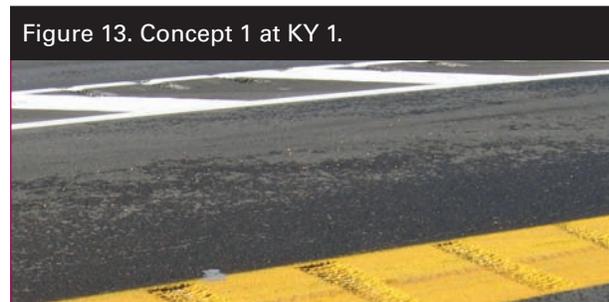
Figure 13. Concept 1 at KY 1.

Figures 13 through 15 show examples of the lane narrowing concept at two different sites in Kentucky. At both sites, the concept was implemented at intersections with left-turn lanes on the major approaches. This was accomplished by creating extra space between the left-turn lane and the opposing and adjacent through lanes. Rumble strips were then installed between the left-turn lanes and the opposing and adjacent through lanes as well as along the shoulders. A combination of milled and

- The painted median and rumble stripes end 15.25 m (50 ft) prior to the intersection and only a single dashed yellow centerline extends to the intersection. It is desirable to extend the painted median to the intersection.
- Rumble stripes cover the entire width of median. However, cross-hatching is not installed, which may have contributed to the increase in rear-end crashes.

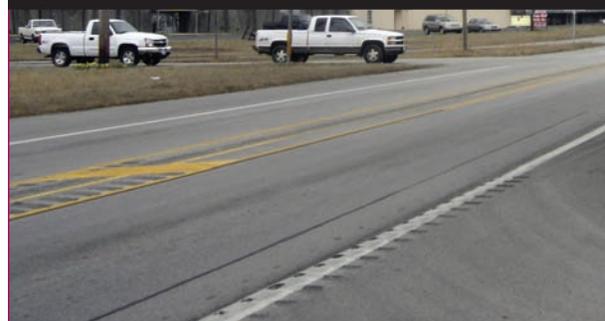
Figure 18. Concept 1 at MO 2.

At the second site (figure 18), there are several desirable characteristics:

- Median rumble stripes cover nearly the entire width of the median. All rumble stripes end 15.25 m (50 ft) prior to intersection.
- Cross-hatching is installed in the painted median, which extends to the intersection.

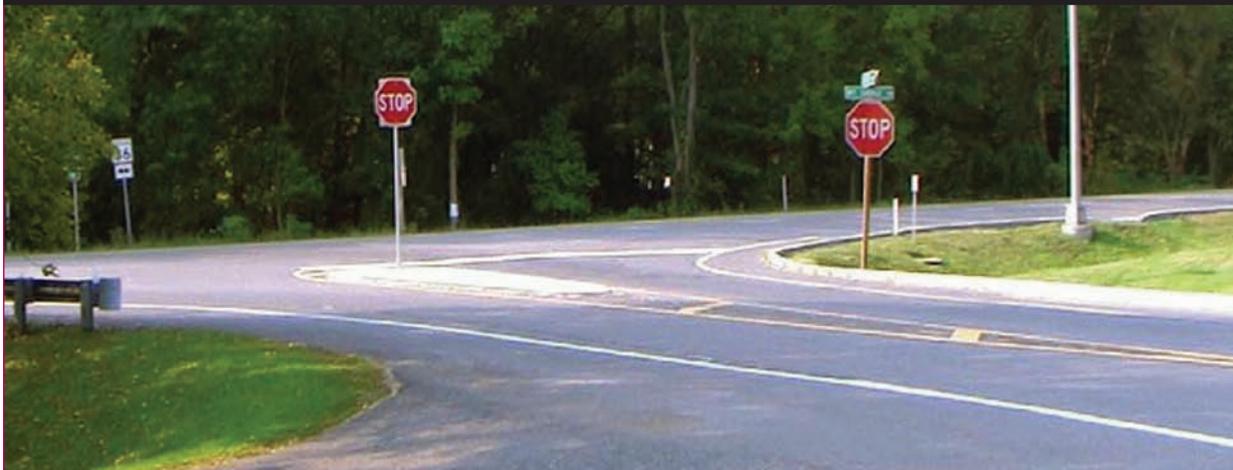
Figure 20. Concept 3 at MD 1 (minor approach).

STOP-controlled on the minor approach with a single STOP sign to the right of the traveled way. The deployment of concept 3 included the installation of a traversable separator island on the minor approach. Also, a secondary STOP sign was installed on the separator island. The lane markings are separated on the minor approach prior to the intersection and painted along both sides of the separator island. However, in this case, cross-hatching is included between the pavement markings to improve the conspicuity of the concept. The major road approaches were effectively narrowed by installing shoulder and centerline rumble stripes. Unlike the typical

implementation of the lane narrowing concept, this deployment did not include a painted median and the rumble stripes continue to the intersection, which is not desirable.

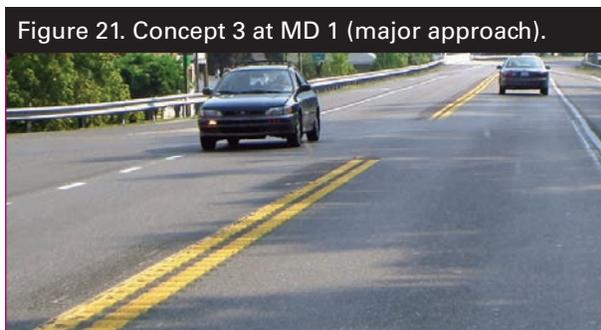
Figure 22. Illustration of concept 1 at speed data collection points.

The data collection points were different for the two strategies. For the lane narrowing concept, speed data were collected at four different locations (figure 22) along each of the major approaches to determine whether or not speed reductions were occurring as desired. The locations of the data collection points were as follows:

- Add a speed advisory plaque to the warning sign (i.e., intersection ahead or lane narrowing) located prior to point 1 in figure 22. Data from North Carolina indicated that vehicles can travel up to 72.45 km/h (45 mi/h) on highways with 2.75 m (9 ft) lanes without crossing into the opposing lane. Where the posted speed is greater than 72.45 km/h (45 mi/h), it may be appropriate to provide a supplemental speed advisory plaque of 72.45 km/h (45 mi/h) prior to the deployment of the lane narrowing concept.
