Route 100

VILLAGE SAFETY STUDY

Westfield, Vermont

September 2012

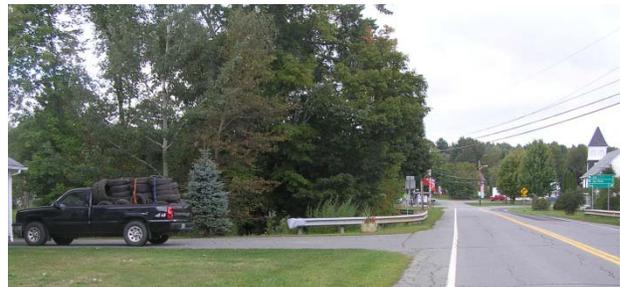
Looking north at Mill Brook Bridge from library

- The bridge over Mill Brook would need to be evaluated to determine if it could accommodate a sidewalk on its west side. If not, either the bridge would need to be widened or a separate pedestrian bridge would need to be provided. (see photo to right showing where sidewalk would cross the bridge)
- A Phase 1B archaeological assessment would be required for several sections of the sidewalk, as described in the attached Archaeological and Historic Resource Assessment.
- If state or federal funds are used to construct the sidewalk, the Town of Westfield would likely be required to provide winter maintenance of the sidewalk.

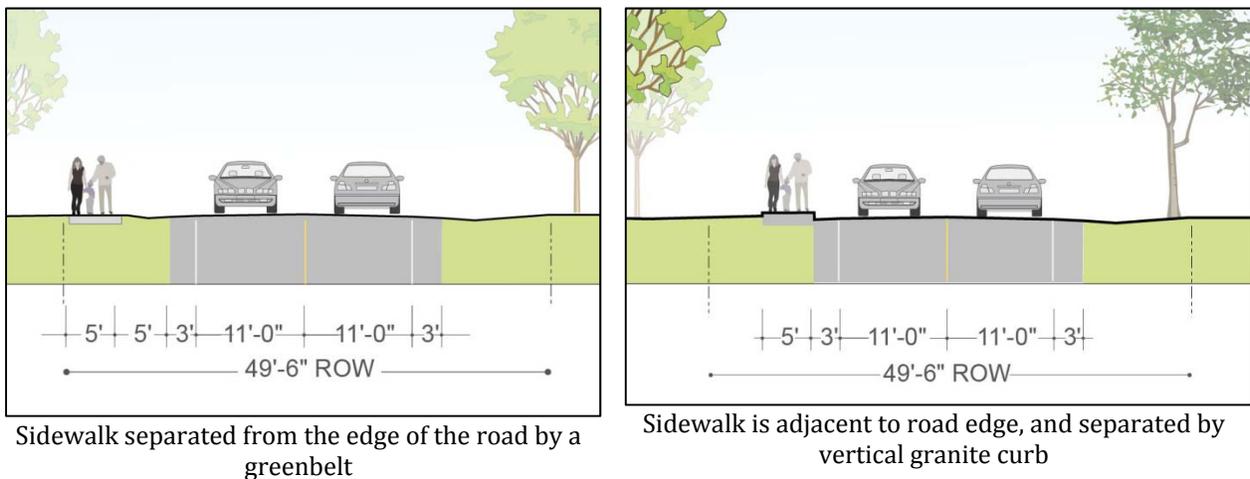
Figure 3: Sidewalk Cross Sections

The sidewalk should be at least 5 feet wide, and the cross section will vary along the length, depending on the utility locations and other features. Several options are shown below. In locations where the utility poles are not on the same side as the sidewalk, there is greater flexibility in the location and alignment of a sidewalk. It could either be adjacent to the road shoulder edge with a vertical granite curb, or separated from the road’s edge by a greenbelt. The following graphics show these options in cross-section.

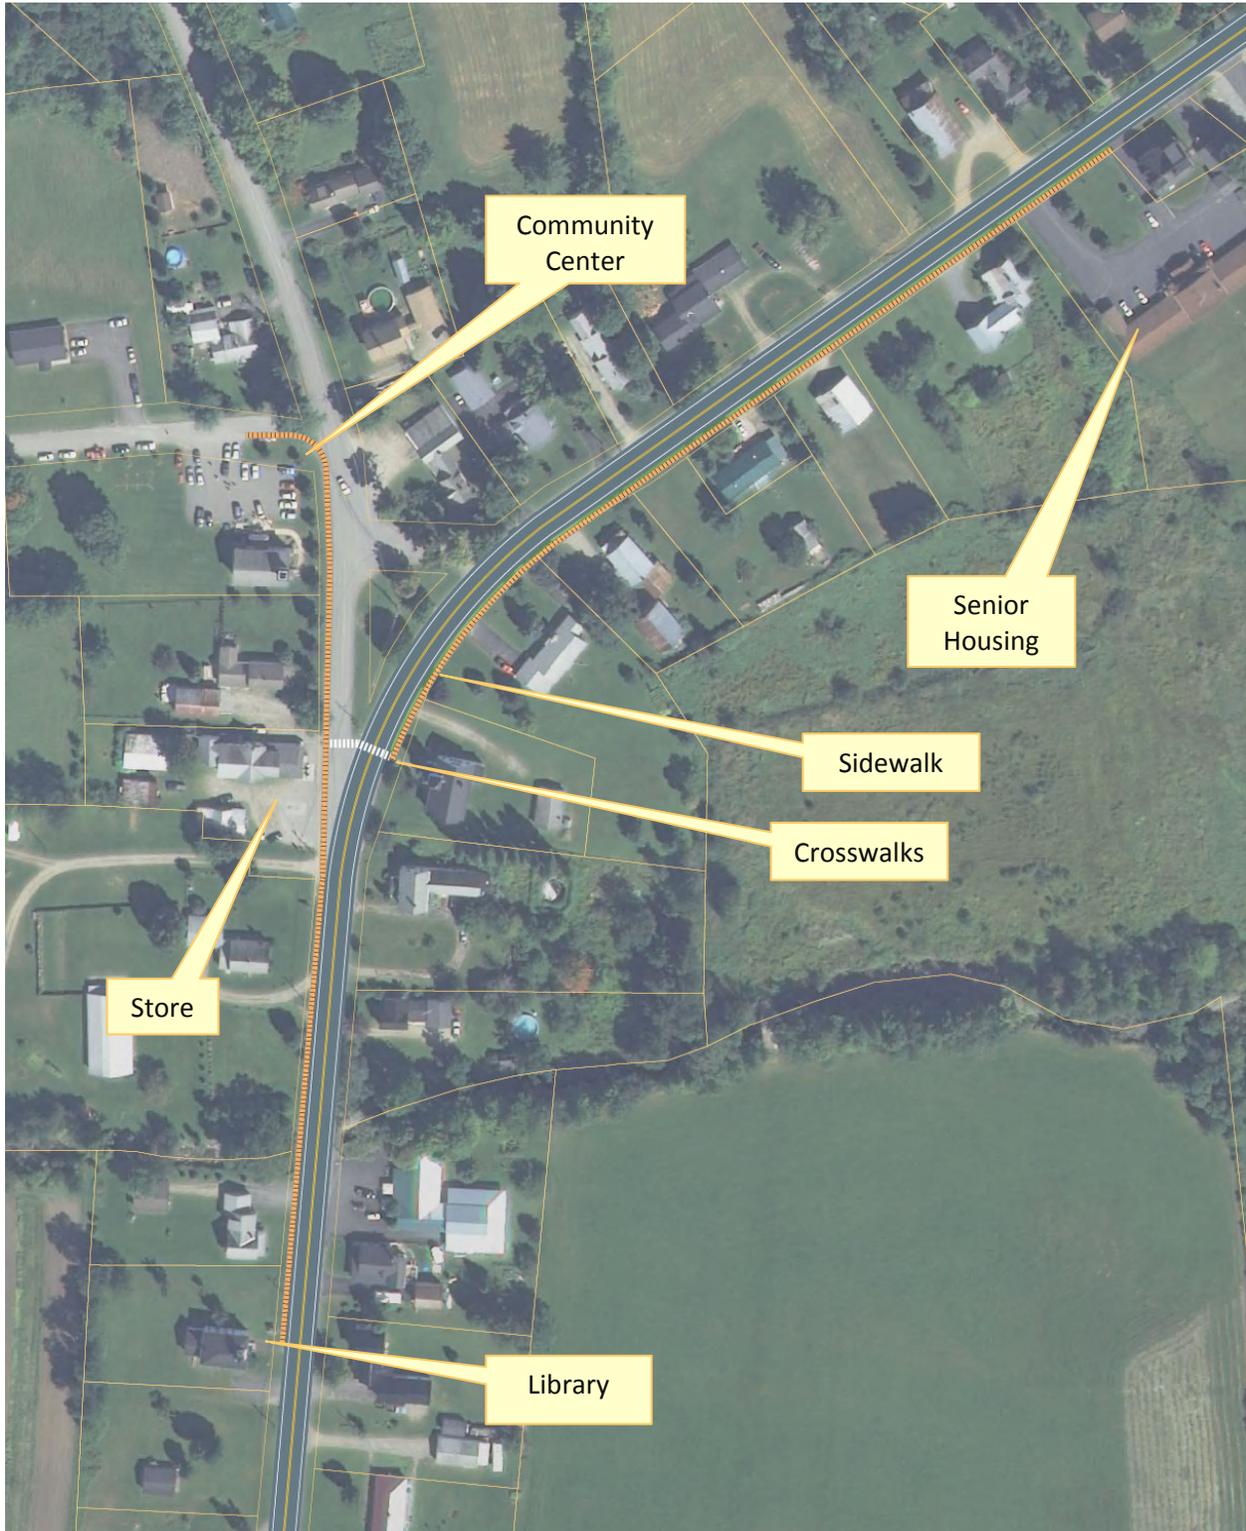
Figure 4: Proposed Sidewalk

Pedestrians could be accommodated in Westfield’s village center with a sidewalk and a marked crosswalk that will provide a safe route between the senior housing and the store and library. A sidewalk separates pedestrians from the traffic with either a vertical or horizontal buffer. Figure 4 shows a proposed alignment of a sidewalk that would essentially connect the primary land uses shown above. The crosswalks are shown at the south end of the green, which provide adequate sight distance for the pedestrians.

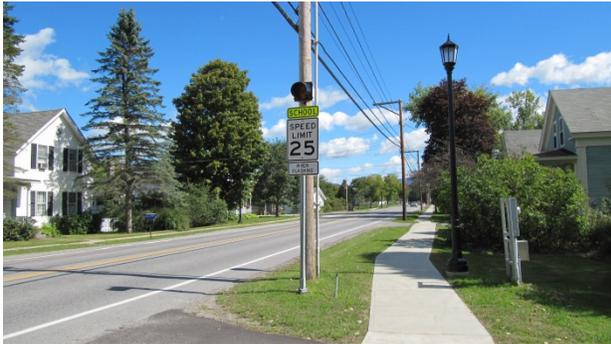
Sidewalk separated by uncurbed greenbelt

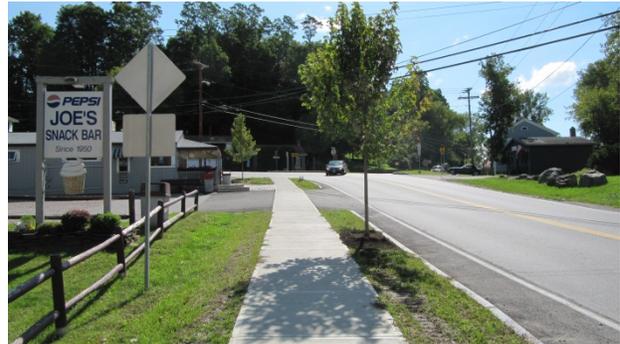
Sidewalk separated by curbed greenbelt and trees

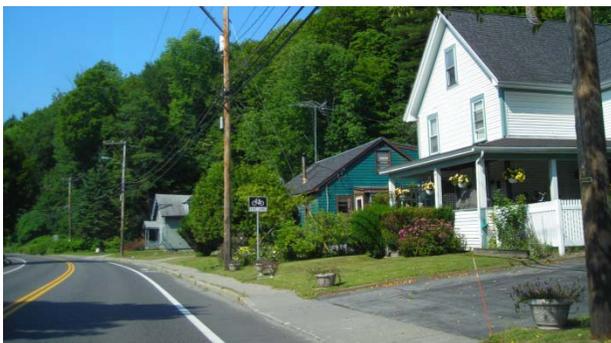
Sidewalk with curb adjacent to shoulder

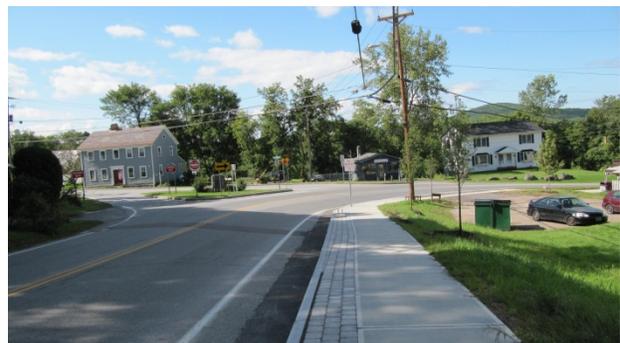
Sidewalk with curbed edge next to shoulder

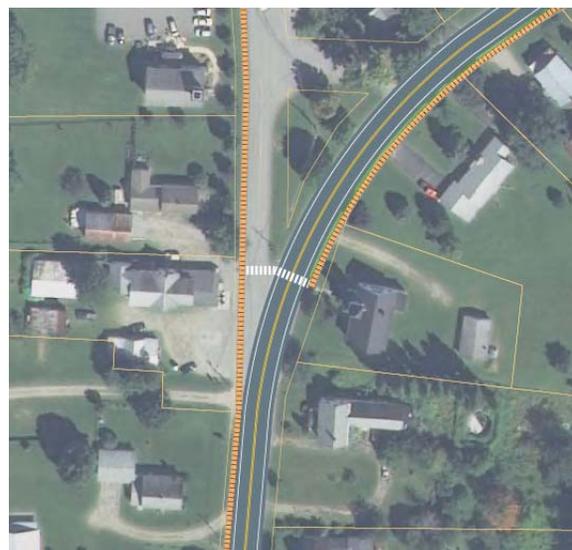
Due to the regular travel patterns of seniors in the village, a marked crosswalk should be considered. The location shown to the right is recommended, as it provides adequate sight distance and convenient routing between the senior housing and the store. The crossing of North Hill Road will be protected by the existing stop sign. The crosswalk safety could be further enhanced by the following:

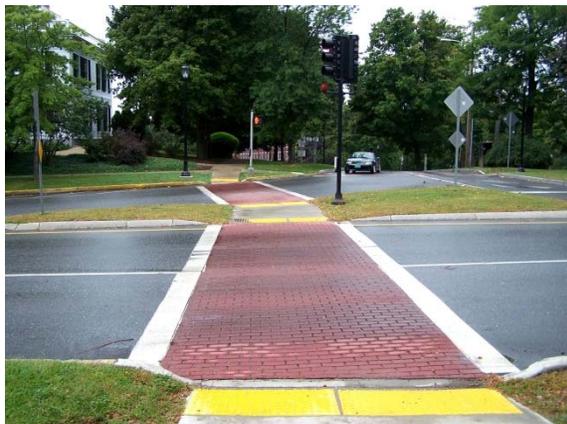
Example of a textured/colored crosswalk

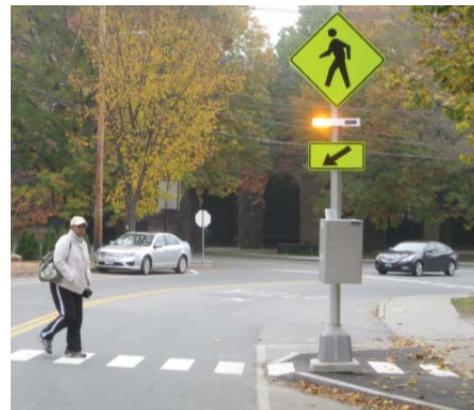
Rapid Flashing Beacon at Crosswalk

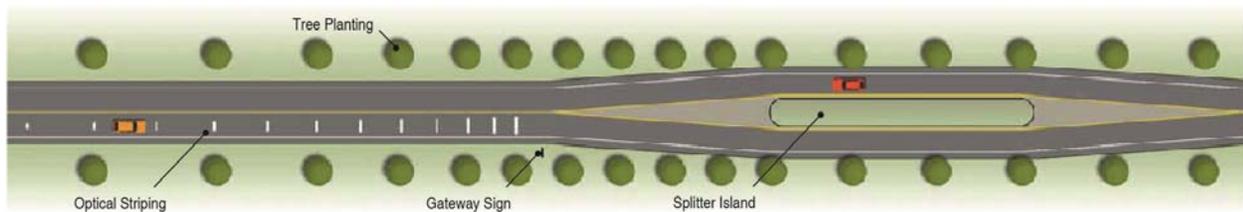
The following figure shows a schematic of how these types of elements can be combined to form a speed transition area.

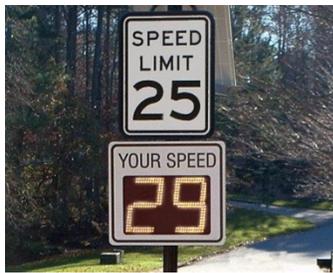
Radar Feedback Signs

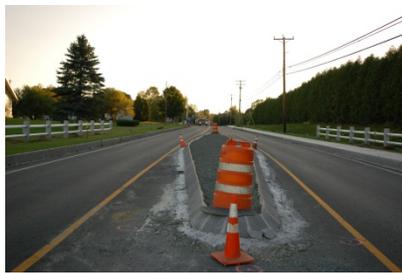
Splitter Islands (under construction in Danville)

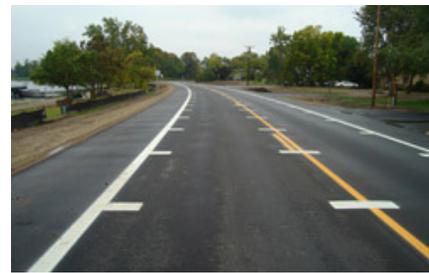
Optical Striping
