APPENDIX E:

Site Restoration Plans for High Priority Stormwater Mitigation Sites

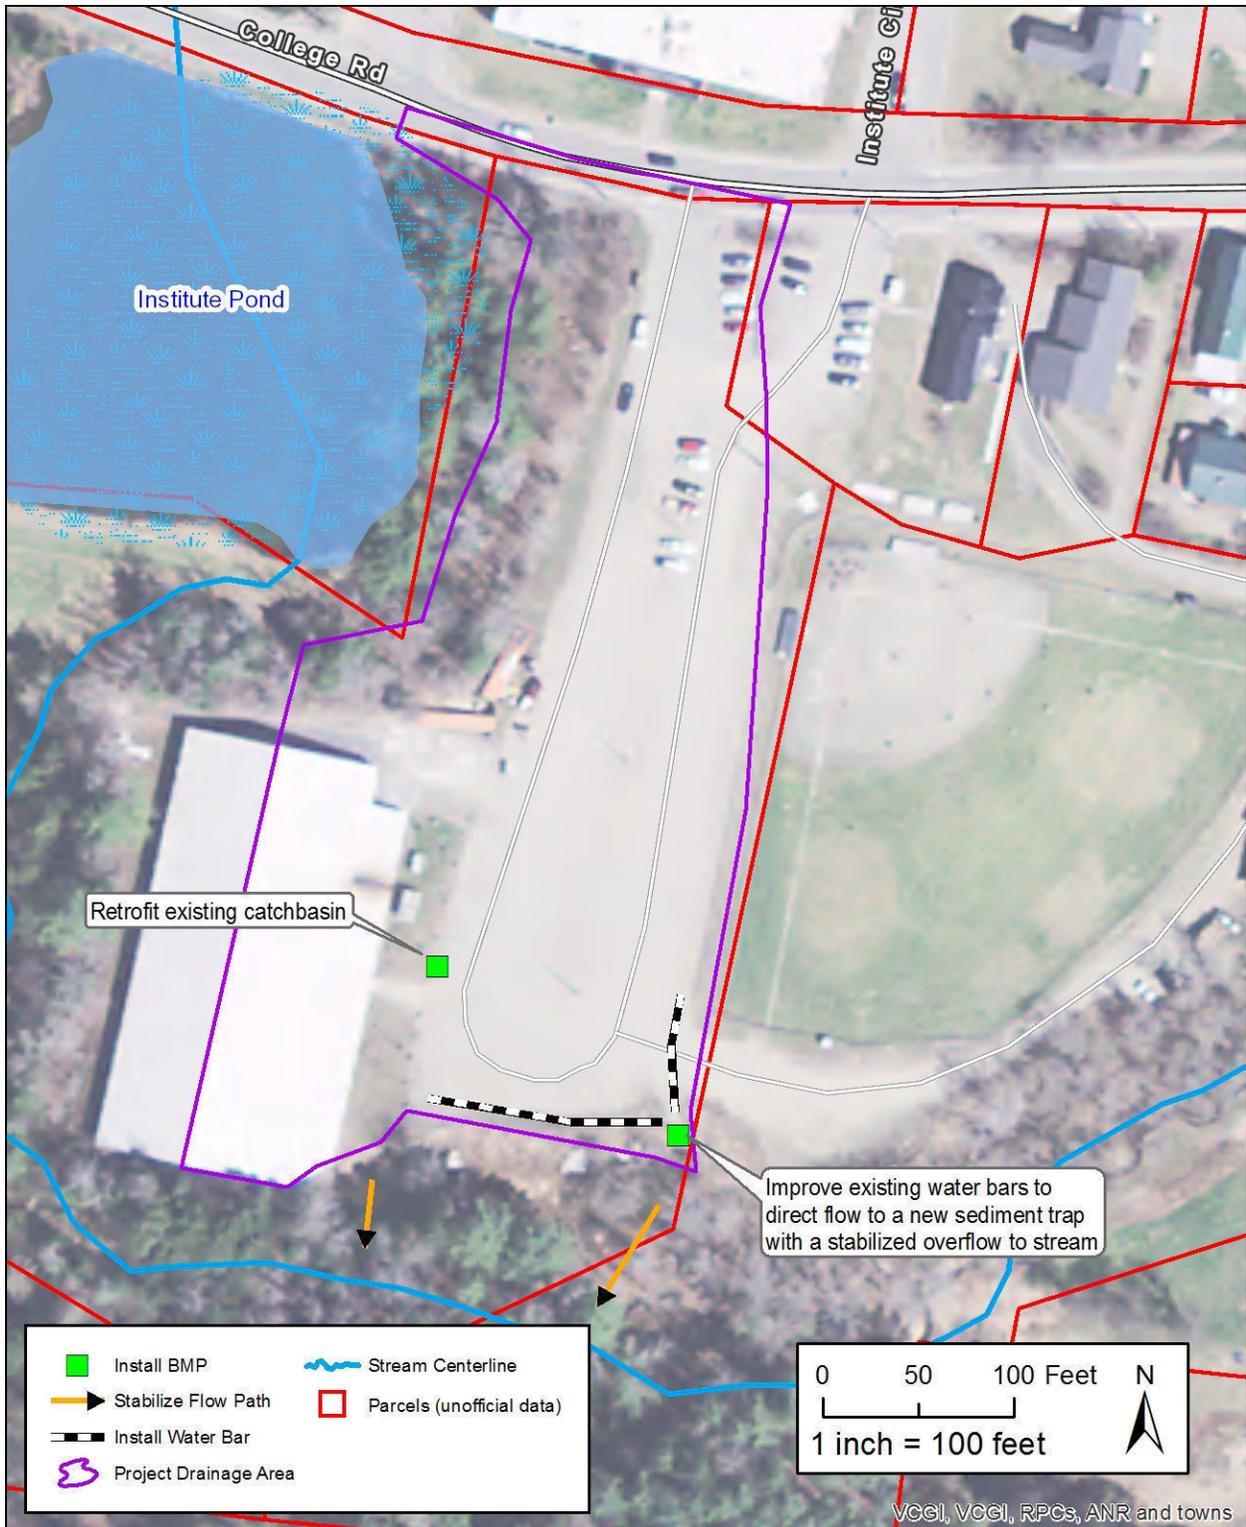
Project: LI-6 & LI-7		Site Restoration Plan
Location:	Parking area for the Fenton Chester Arena

Latitude:	44.5363 N	
Longitude:	-72.0157 W	
Land Ownership:	Town (Maintained by Lyndon Institute)	
Drainage Area (acres)	2.4	
Impervious (acres)	1.6	
<p>Site Description: Runoff from the large gravel parking lot drains south and is collected by a water bar and directed to a small buffer strip on top of a steep bank leading down to a stream. Deep rills are visible on the parking surface in concentrated flow areas, and several small gullies have formed along the steep bank. The buffer strip provides some potential for sediment removal, however the sediment loading to the stream channel is extremely high. A catchbasin by the arena entrance collects runoff from a portion of the parking lot (0.5 acres), and the outlet is piped directly to the stream.</p>		
<p>Proposed Scope of Work</p>		
Install BMP	<ul style="list-style-type: none"> • Install sediment trap along edge of parking lot along existing flow path. • Retrofit the existing catch basin to include a small BMP with a water level control structure as necessary.

Improve Site Drainage	<ul style="list-style-type: none"> • Install water bars to collect flow along the southern edge of the parking lot and direct all runoff to the BMP installations. 	
Stabilize Flow Path	<ul style="list-style-type: none"> • Stabilize the overflow from the BMP with a rock lined swale extending to ordinary high water (OHW) along the stream. 	
Improve Winter Maintenance	<ul style="list-style-type: none"> • Work with the Town and Lyndon Institute to create a snow plowing and snow stockpiling plan that will protect the drainage and BMP features and reduce sediment loading to the stream. 	
<p>Additional Design/Permitting Requirements: Some additional survey and modeling is required to correctly size the catch basin BMP and the water bars along the parking lot. VTANR should be notified of this project that will require work within 100ft of a stream channel, however we do not expect any additional permitting requirements. We estimate that design and permitting efforts will cost \$1,500 - \$2,500 to cover a design-build arrangement similar to the LI and LSC projects completed by North Woods.</p>

<p>Next Steps:</p> <ul style="list-style-type: none"> • Confirm project support from the Town and from Lyndon Institute • Confirm all project implementation tasks can be completed by the Town Highway Department • We recommend 1 day of technical field oversight during construction to assist with BMP sizing, location, layout, grading, and outlet structure configuration. 		
<p>Project Benefits: This project is primarily designed to mitigate a significant sediment source to the adjacent stream. Installation of a sediment trap treating runoff from the primary flow path and the proposed BMP retrofit at the catchbasin inlet will significantly reduce sediment transport from the arena parking lot.</p>

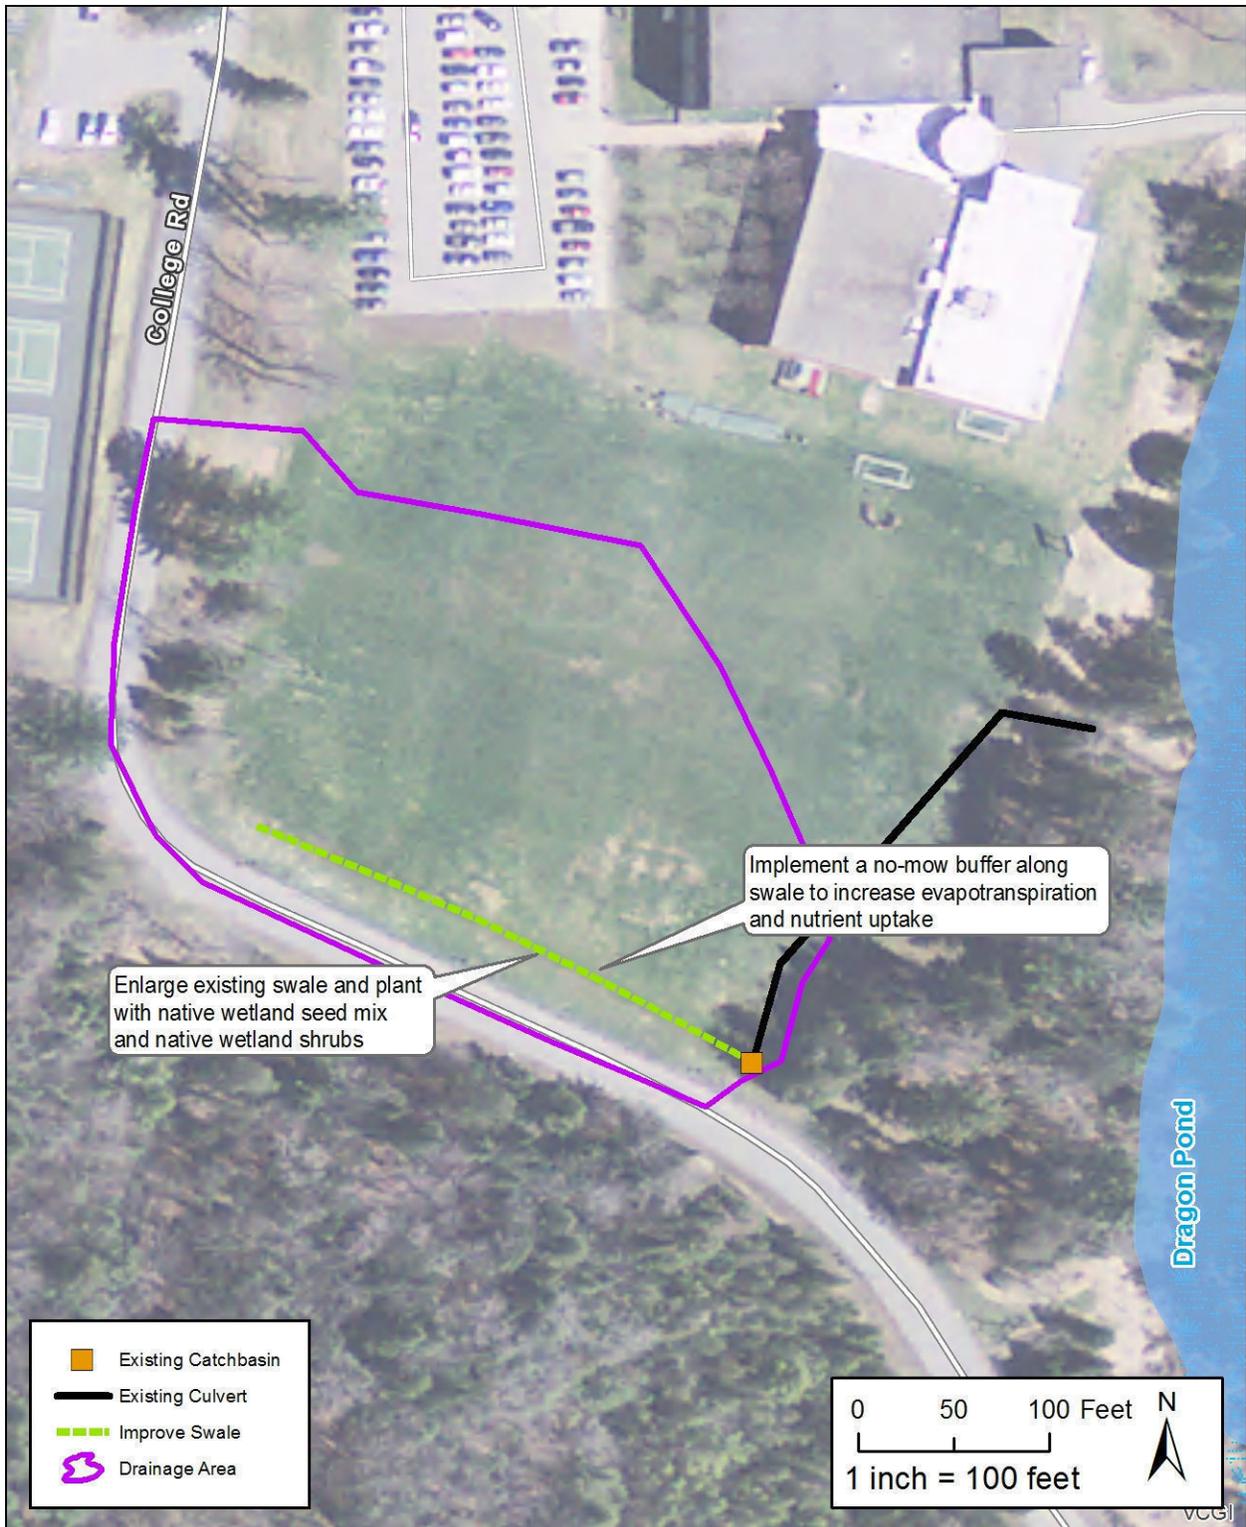
Project: LSC-2		Site Restoration Plan
Location:	LSC Varsity Field

Latitude:	44.5324N	
Longitude:	-72.0256 W	
Land Ownership:	Lyndon State College	
Drainage Area (acres)	2.5	
Impervious (acres)	0.25	
<p>Site Description: A mowed grass swale along the south edge of the varsity field collects runoff from the field and a small portion of College Road. The swale drains to a catchbasin which flows directly to Dragon Pond. The underlying soils are very heavy and wet and portions of the field close to the swale are problematic for field maintenance. Fertilizer application to the field likely results in excess nutrient loading to the pond. LSC Public Safety is interested in adding a pedestrian footpath along College Road through this area, and the swale restoration will not interfere with this potential project.</p>		
<p>Proposed Scope of Work</p>		
Install Bio-swale BMP	<ul style="list-style-type: none"> • Widen and deepen the existing swale to increase water retention and improve field drainage • Wetland seed mix and shrub plantings within swale

Site Maintenance	<ul style="list-style-type: none"> • Mowing along the swale only under dry soil conditions • Bio-swale may require intermittent weeding and cleanout 	
<p>Additional Design/Permitting Requirements: The site has hydric soils and was likely a historic wetland; however, the site is not currently functioning as a wetland and should not require any additional permits, however VTANR wetland ecologist Julie Follensbee should be notified of the project to confirm this assumption. A site visit should be completed to better inform swale layout and grading. We anticipate that design efforts will cost less than \$1,000.</p>		
<p>Next Steps:</p> <ul style="list-style-type: none"> • Confirm project support with Lyndon State College • Determine available footprint for project (discuss with athletic coordinator) • No technical oversight is necessary during project implementation 		
<p>Project Benefits: This project is designed to improve drainage along the playing field and enhance the existing grassed swale to improve nutrient retention. The site is likely a significant nutrient source to Dragon Pond.</p>

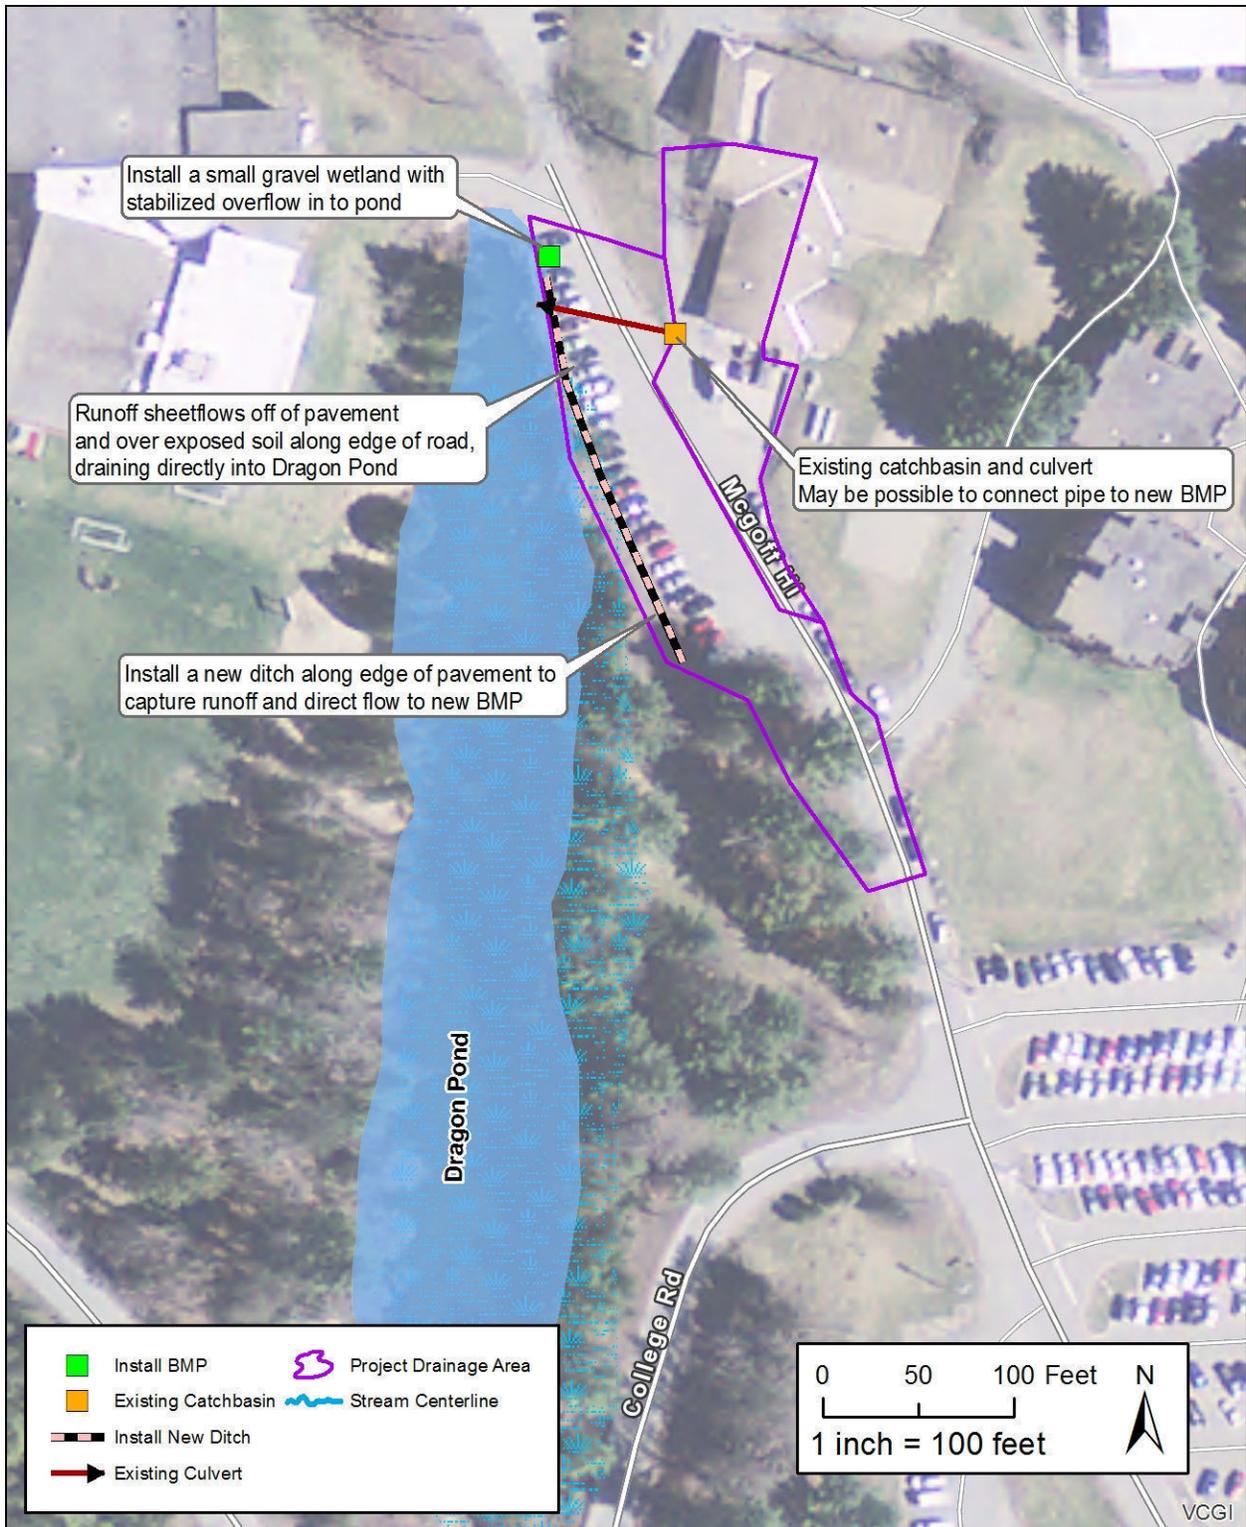
Project: LSC-4		Site Restoration Plan
Location:	McGoff Hill at Stevens Dining Hall

Latitude:	44.5335 N	
Longitude:	-72.0243 W	
Land Ownership:	Lyndon State College	
Drainage Area (acres)	0.8	
Impervious (acres)	0.5	
<p>Site Description: Runoff from McGoff Hill is causing erosion along the road edges and flows directly in to Dragon Pond near the outlet. Winter plowing along the road and parking lot is likely a significant sediment source to the pond.</p>		
<p>Proposed Scope of Work</p>		
Install Ditch	<ul style="list-style-type: none"> • Install a grassed ditch between the edge of pavement and slope to the pond 	
Install BMP	<ul style="list-style-type: none"> • Install a gravel wetland or similar treatment feature with a sediment trap forebay at the bottom of the slope near the pond outlet <ul style="list-style-type: none"> ○ This will require the loss of up to 4 parking spaces 	
Drainage Retrofit	<ul style="list-style-type: none"> • May be possible to redirect pipe from catchbasin along road to new BMP

Improve Winter Maintenance	<ul style="list-style-type: none"> • Work with the LSC maintenance staff to create a snow management plan that will prevent plowing directly into the pond, protecting the ditch and BMP. 	
<p>Additional Design/Permitting Requirements: Additional survey and modeling is required to correctly size the treatment BMP and to work around the design constraints at the site. VTANR should be notified of this project that will require work within 100ft of a waterbody, however we do not expect any additional permitting requirements. We estimate that design and permitting efforts will cost \$3,000 - \$5,000.</p>		
<p>Next Steps:</p> <ul style="list-style-type: none"> • Confirm project support and site changes (loss of parking spaces) with Lyndon State College • Complete site survey and modeling • We recommend 2 days of technical field oversight during construction to assist with BMP sizing, location, layout, grading, and outlet structure configuration.

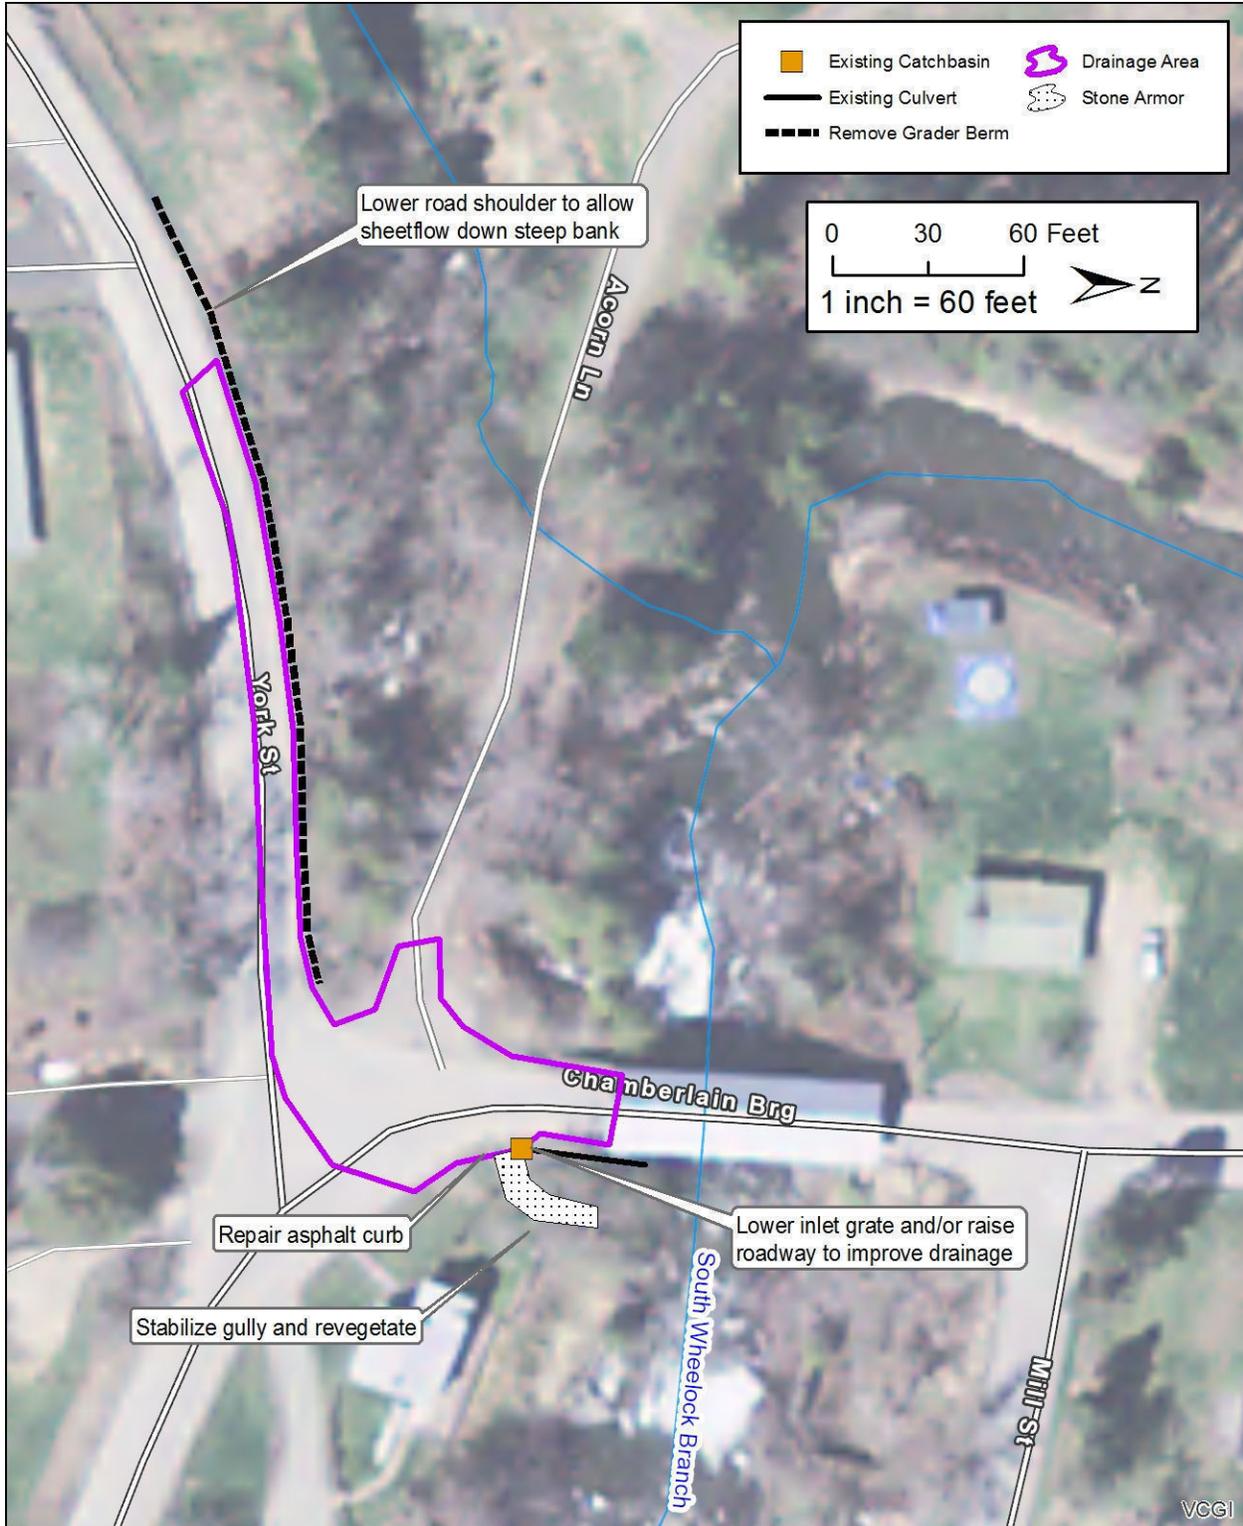
Project: LY-4		Site Restoration Plan
Location:	Chamberlain Bridge

Latitude:	44.5163N	
Longitude:	-72.0166 W	
Land Ownership:	Town/Private	
Drainage Area (acres)	0.25	
Impervious (acres)	0.25	
<p>Site Description: A small drop inlet grate on the southeast approach to the covered bridge is not situated at the low point along the road edge. Runoff is flowing off of the road approximately 10ft south of the inlet and has eroded a large gully down the embankment and through the lawn of the adjacent house. The gully is actively eroding and is contributing sediment and nutrients directly into South Wheelock Branch. Previous attempts to reconfigure the inlet and to add an asphalt curb along the road edge have failed to address the issue.</p>		
<p>Proposed Scope of Work</p>		
Reconfigure Drop Inlet	<ul style="list-style-type: none"> • Lower the drop inlet approximately 6 inches and/or raise the adjacent roadway elevation and rebuild the asphalt curb to protect the gully area <ul style="list-style-type: none"> ○ It may be feasible to move the drop inlet to the current low point at the head of the gully.

Reduce Runoff Volume	<ul style="list-style-type: none"> • Lower the grassed strip along the north edge of York St to allow for sheetflow down the steep forested bank, reducing runoff to the drop inlet 	
Site Maintenance	<ul style="list-style-type: none"> • Ensure that drop inlet is cleaned on a regular basis • Protect curb during plowing 	
<p>Additional Design/Permitting Requirements: Additional site assessment is required to inform design options. We expect that a design-build approach with the Town Highway Department will be appropriate for this project. We estimate that additional assessment and design efforts will cost \$1,000 to \$2,000.</p>		
<p>Next Steps:</p> <ul style="list-style-type: none"> • Confirm project support with private landowner • Assess the size and location of existing drop inlet • Limited technical oversight may be necessary depending on the preferred alternative 		
<p>Project Benefits: This project is designed to address an ongoing erosion issue that also threatens the long-term stability of a Town road shoulder. The gully drains directly in to the South Wheelock Branch and is likely a significant sediment and nutrient source. The project should be relatively simple to implement and will not require increased maintenance.</p>

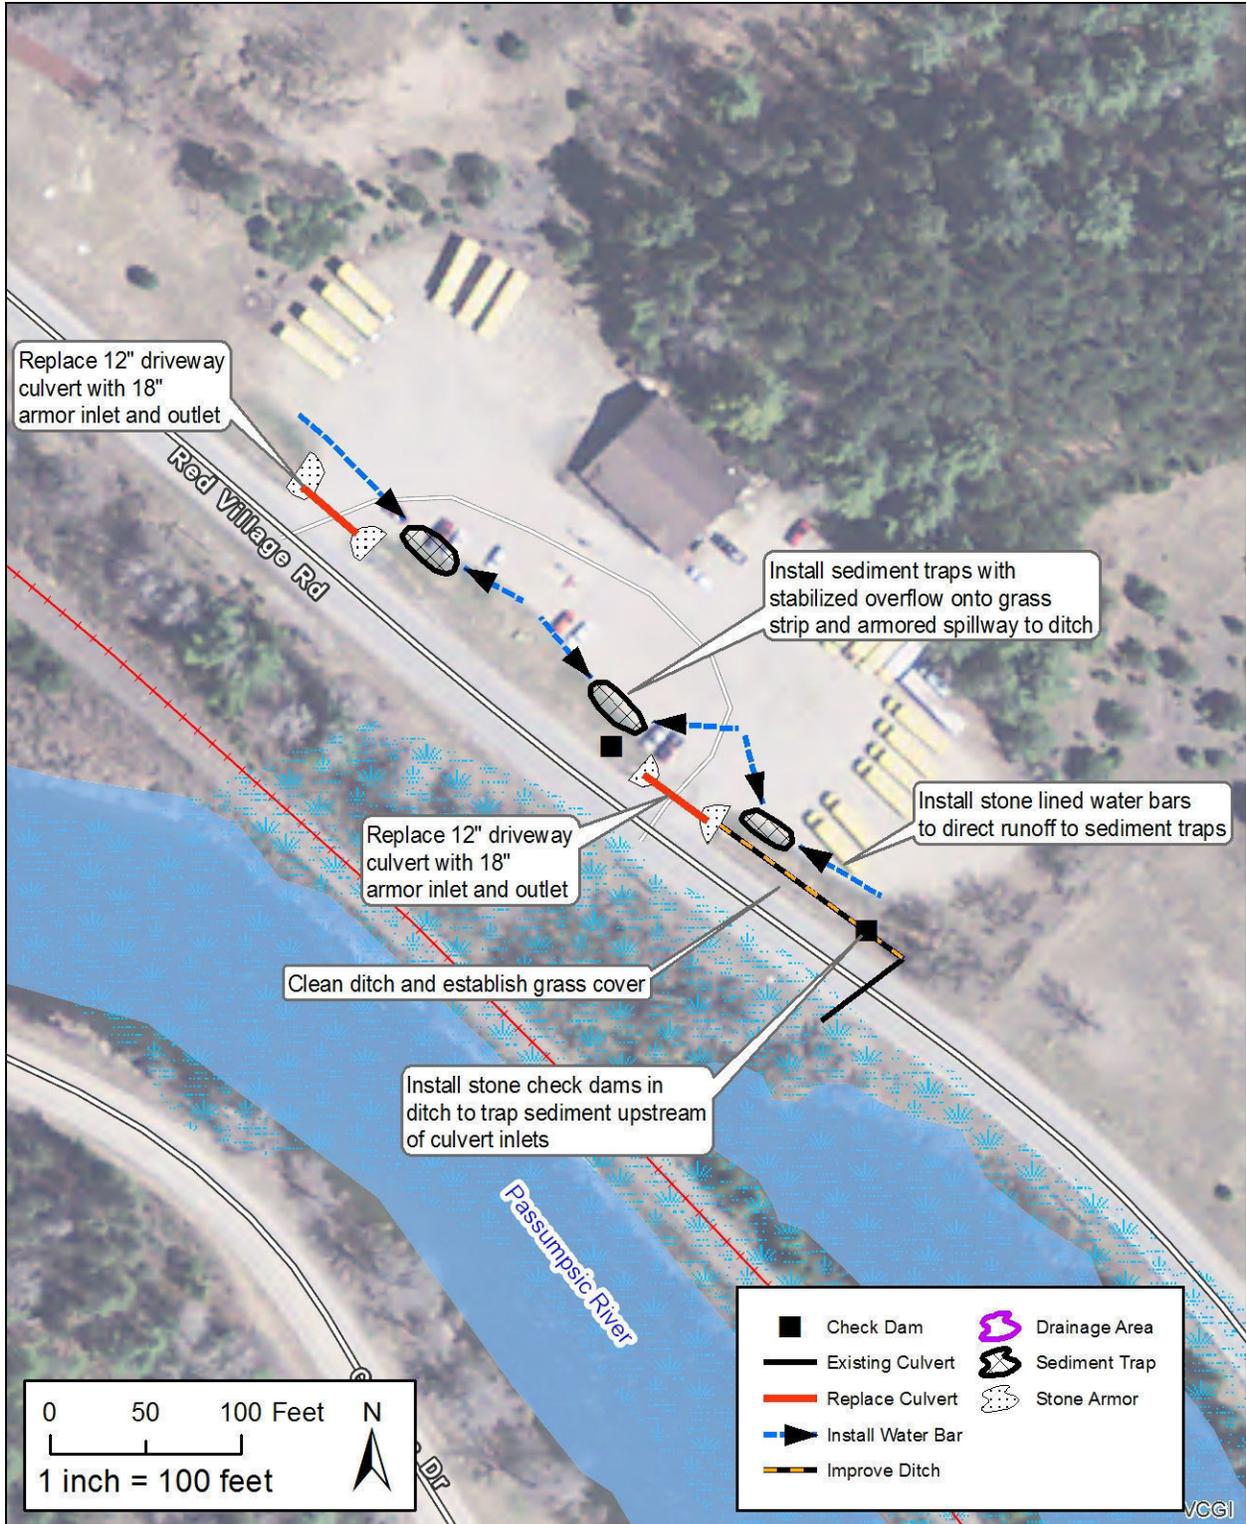
Project: LY-6		Site Restoration Plan
Location:	Butlers Bus Service (Red Village Rd)

Latitude:	44.5437 N	
Longitude:	-71.9856 W	
Land Ownership:	Town and Private	
Drainage Area (acres)	2.0	
Impervious (acres)	1.6	
<p>Site Description: A large gravel parking area and rooftop drain to a roadside ditch with severe gullying along several flow paths. The ditch is filled with sediment and drains directly into a side channel of the Passumpsic River.</p>		
<p>Proposed Scope of Work</p>		
Culvert Improvements	<ul style="list-style-type: none"> • Replace the two 12" driveway culverts with 18" culverts • Stabilize the embankment at the inlet and outlet of the driveway culverts 	
Install Check Dams	<ul style="list-style-type: none"> • Install stone check dams in the roadside ditch to trap sediment and facilitate cleanout 	
Improve Flow Paths	<ul style="list-style-type: none"> • Install water bars to direct runoff to new sediment traps

Install Sediment Traps	<ul style="list-style-type: none"> • Install sediment traps near each driveway culvert <ul style="list-style-type: none"> ○ Overflow from the sediment traps should be directed to the existing grassed filter strip ○ Provide a rock lined spillway to the ditch ○ Ensure that sediment traps are routinely inspected and cleaned 	
<p>Additional Design/Permitting Requirements: Some additional survey and design work is recommended to inform sediment trap location, design, and sizing. We estimate that design and permitting efforts will cost \$1,500 to \$2,500.</p>		
<p>Next Steps:</p> <ul style="list-style-type: none"> • Confirm project support with the private landowner • Complete site survey and drainage area mapping • Hydraulic analysis and sediment trap designs • We recommend 2 days of technical field oversight during construction to assist with sediment trap sizing, location, layout, grading, and overflow configuration.

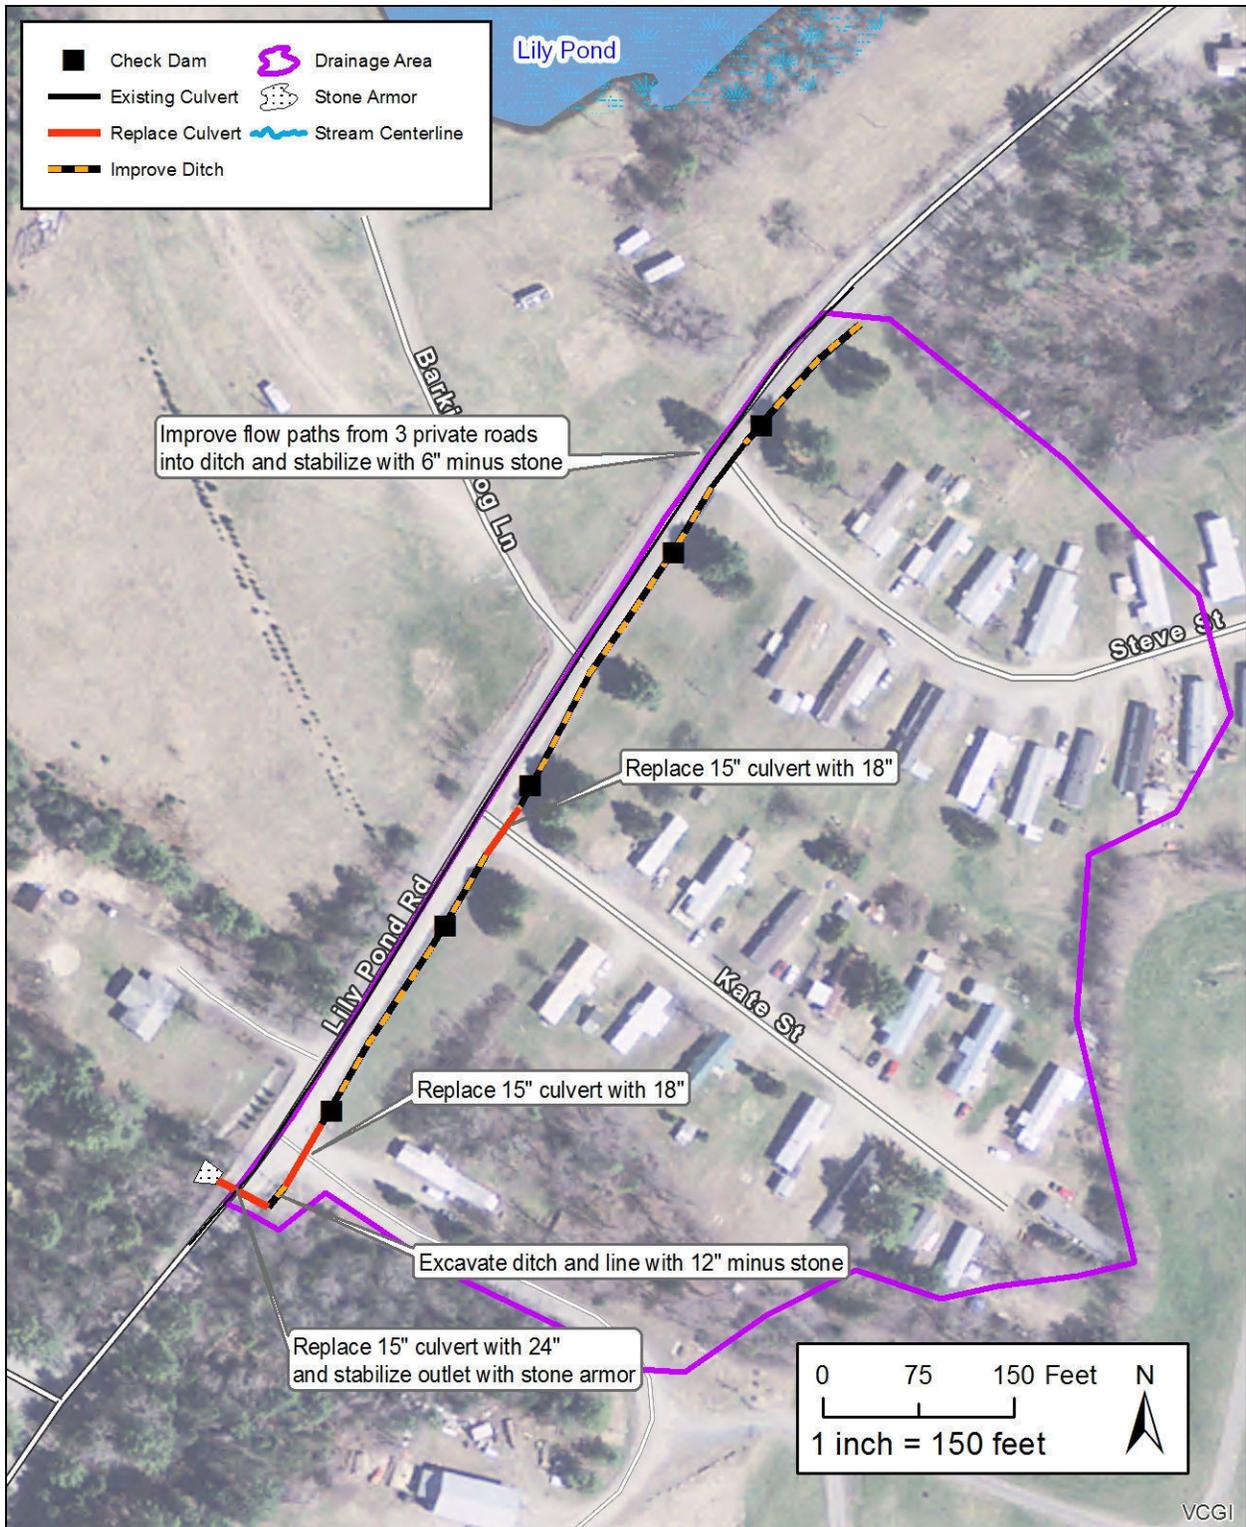
Project: LY-8		Site Restoration Plan
Location:	Lily Pond Road

Latitude:	44.5198 N	
Longitude:	-71.9931 W	
Land Ownership:	Town	
Drainage Area (acres)	7.5	
Impervious (acres)	2.0	
<p>Site Description: The ditch along the east side of the road is badly eroded and is sending large volumes of sediment into the adjacent intermittent stream. Several areas of gully erosion along the road edge upslope. The cross-culvert outlet is unstable and has a large gully along the road edge.</p>		
<p>Proposed Scope of Work</p>		
Improve Ditch	<ul style="list-style-type: none"> • Excavate and enlarge the existing ditch and establish grass cover • Install a stone lined ditch for the short section upslope of the cross-culvert • Install rock to stabilize flow paths from Steve St., Kate St., and the driveway 	
Install BMP	<ul style="list-style-type: none"> • Install check dams to trap sediment for easier removal 	
Stabilize Culvert	<ul style="list-style-type: none"> • Install an outlet header and armor the steep bank with heavy stone armor

Improve Maintenance	<ul style="list-style-type: none"> • Work with the Highway Department to improve grading practices to minimize disturbance of the grass-lined ditch and ensure appropriate sediment cleanout. 	
<p>Additional Design/Permitting Requirements: We do not anticipate any additional design or permitting requirements.</p>		
<p>Next Steps:</p> <ul style="list-style-type: none"> • Verify culvert sizes and contributing drainage area • Identify any additional erosion areas that require stabilization 		
<p>Project Benefits: This project is designed to address a major sediment source piped directly into an intermittent stream along Lily Pond Road. Improving the shape and capacity of the ditch and establishing grass will reduce erosion within the ditch. We also recommend installing a series of stone check dams to help trap additional sediment from the road and the neighborhoods. Check dams will concentrate sediment deposits and facilitate cleanup. Stabilizing the culvert outlet will further reduce sediment runoff and maintenance requirements.</p>

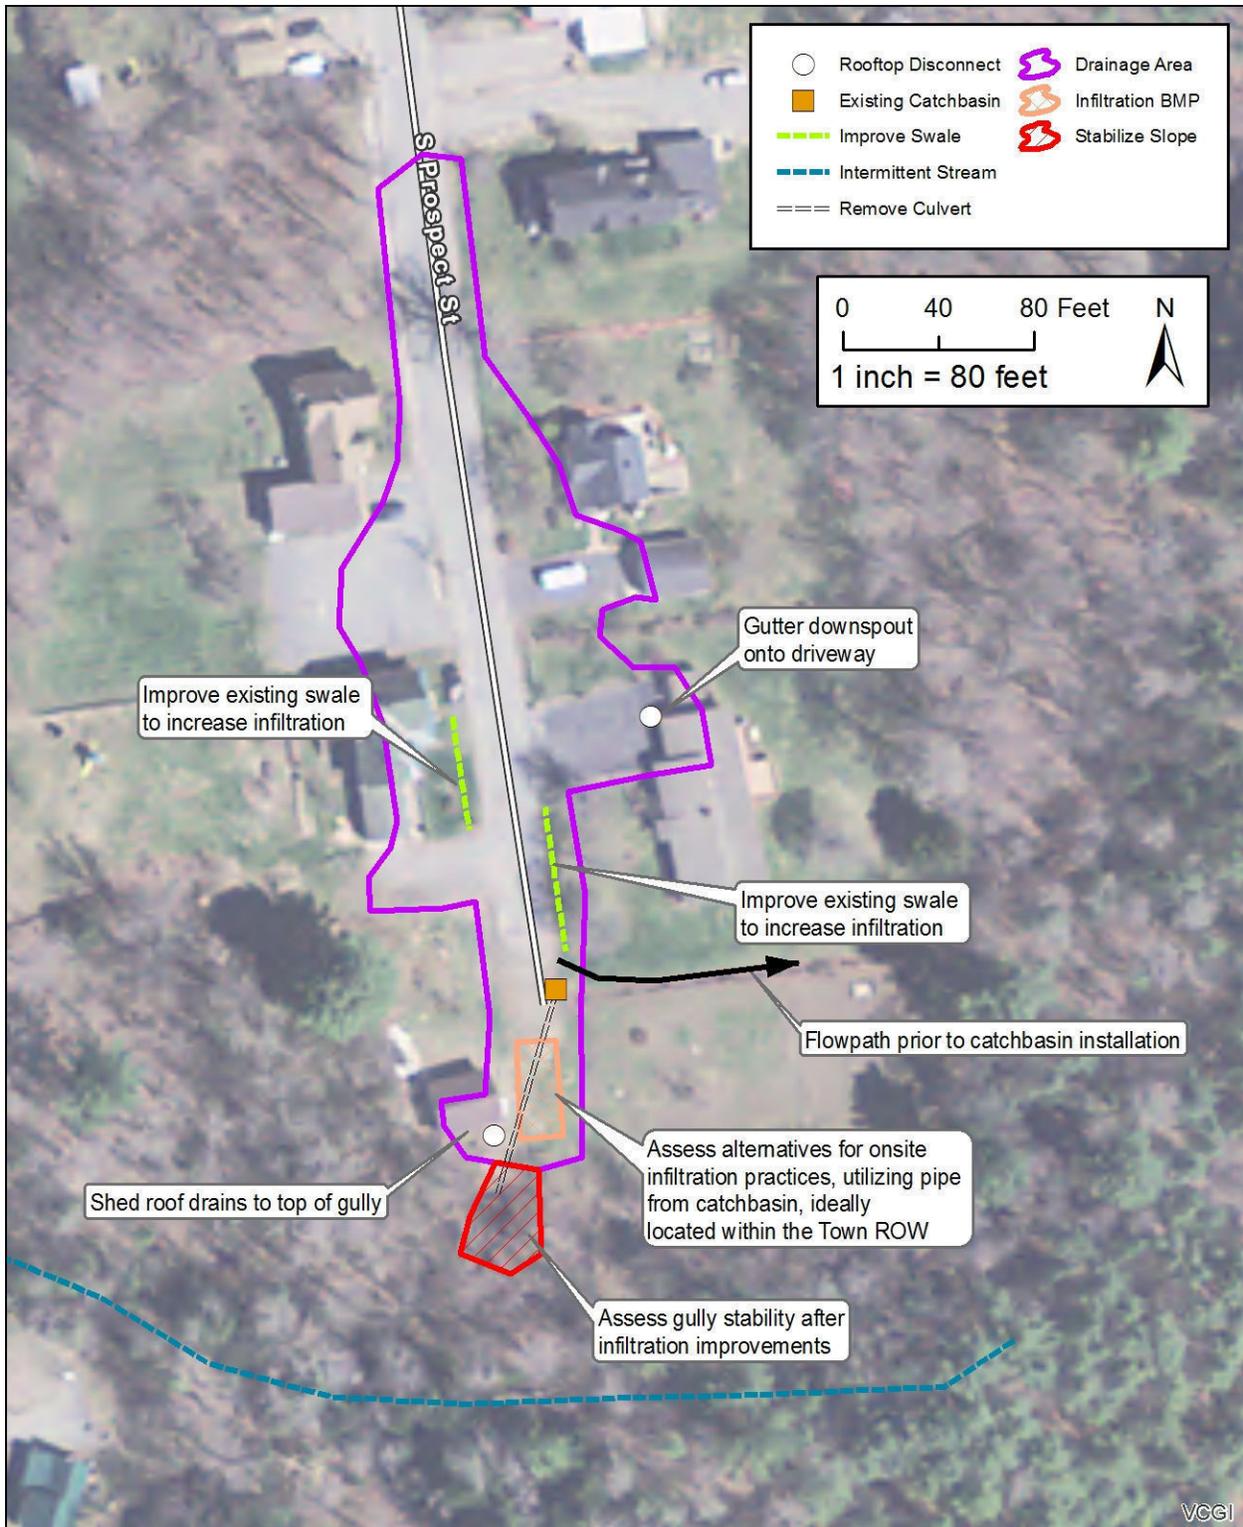
Project: LY-12		Site Restoration Plan
Location:	South Prospect St

Latitude:	44.5167 N	
Longitude:	-72.0100 W	
Land Ownership:	Town and Private	
Drainage Area (acres)	1.0	
Impervious (acres)	0.5	
<p>Site Description: A very large and steep gully has formed along the steep valley wall leading down to an intermittent stream. The gully is actively advancing into the slope and is threatening a large shed. A stormwater pipe from a recently installed catchbasin at the end of South Prospect St is likely contributing to erosion along the toe of the gully. We did not observe any significant surface flow paths to the gully.</p>		
<p>Proposed Scope of Work</p>		
Non-Structural BMP Implementation	<ul style="list-style-type: none"> • Assess opportunities for rooftop disconnection • Improve existing swales to increase infiltration <ul style="list-style-type: none"> ○ May require some grading and/or excavation of compacted soils

Install Infiltration BMP	<ul style="list-style-type: none"> • Tie in to existing pipe from catchbasin • Utilize existing catchbasin as pre-treatment sediment trap • Assess BMP options for underground infiltration • BMP within Town ROW 	
Stabilize Gully	<ul style="list-style-type: none"> • Slope stability should be assessed following infiltration improvements <ul style="list-style-type: none"> ○ Assess alternatives for stabilization ○ May require moving the shed 	
<p>Additional Design/Permitting Requirements: Professional survey is required to determine drainage area to the site. Hydrologic modeling and soil infiltration testing will be required to inform BMP selection and sizing. We do not anticipate any additional permitting requirements for the infiltration practices. We estimate that design and permitting efforts will cost \$3,000 to \$5,000.</p>		
<p>Next Steps:</p> <ul style="list-style-type: none"> • Confirm parcel boundaries • Confirm project support with adjacent private landowners • Complete site survey and drainage area mapping • Assess opportunities for non-structural BMP implementation • Hydrologic analysis and BMP selection/design • We recommend 2 days of technical field oversight during project implementation to assist with structural and non-structural BMP layout and implementation. Significant additional design and engineering time will be required for any slope stabilization considerations.

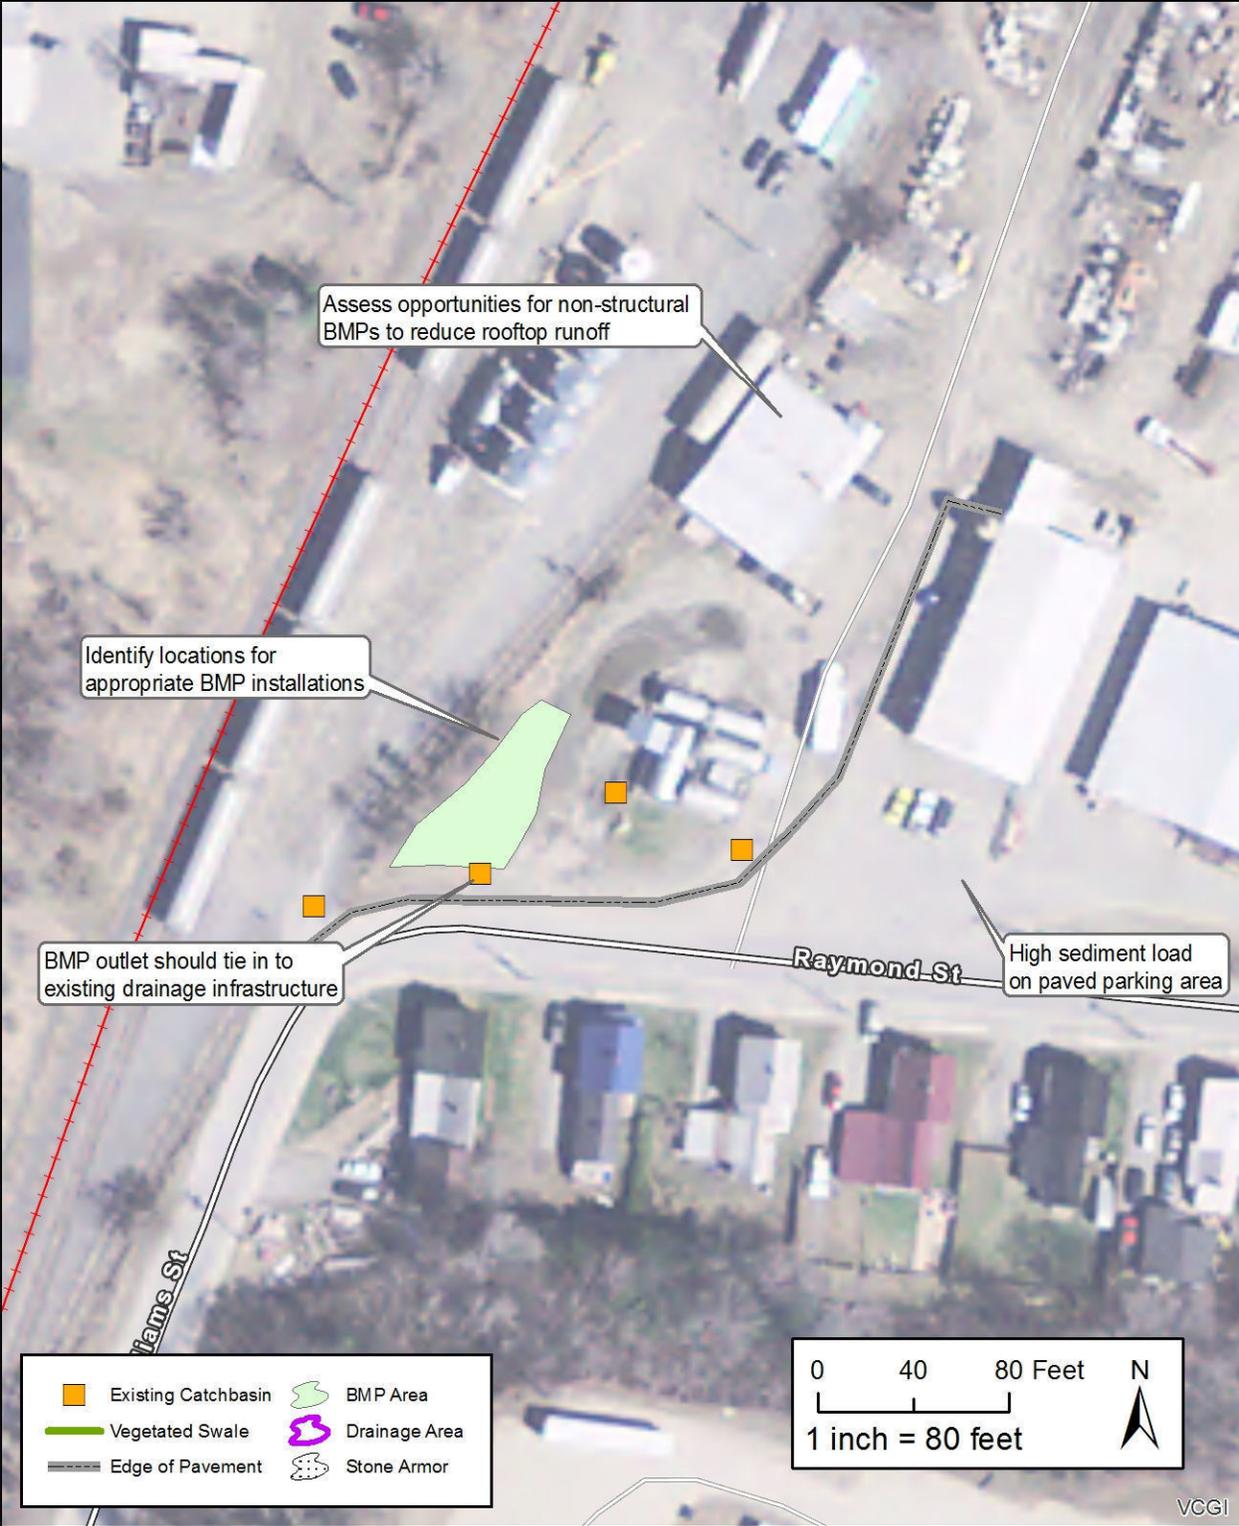
Project: LY-15		Site Restoration Plan
Location:	Commercial Complex on Raymond St

Latitude:	44.5360N	
Longitude:	-72.0011 W	
Land Ownership:	Private	
Drainage Area (acres)	2.5	
Impervious (acres)	2.5	
<p>Site Description: A large industrial/commercial complex with large dirt parking areas partially drains to the southwest corner of the property along the railroad tracks. Drainage infrastructure is not mapped for this area and all catchbasins on the site appear to be filled with sediment and non-functioning. The high sediment load and frequent heavy vehicle traffic will require special design and maintenance considerations. We expect that runoff from this site currently flows across Raymond St and into the stormwater pipes that drain into the Passumpsic River.</p>		
<p>Proposed Scope of Work</p>		
Install BMP	<ul style="list-style-type: none"> Assess BMP options based on site constraints, existing drainage infrastructure, and drainage area

Non-Structural BMP	<ul style="list-style-type: none"> Assess options for non-structural BMPs to treat rooftop runoff and driplines and reduce erosion of the gravel parking areas 	
Site Maintenance	<ul style="list-style-type: none"> Review snow management plan Ensure appropriate maintenance interval to preserve BMP effectiveness 	
<p>Additional Design/Permitting Requirements: Professional survey is recommended to determine site grading and the drainage area available for treatment. This information will be used to model the site and inform BMP selection sizing. Soil infiltration rates will likely need to be determined. The existing drainage area should be mapped, this may require a full cleanout of the filled basins and culverts. We do not anticipate any permitting requirements for this project. We estimate that survey and design efforts will cost \$3,000-\$5,000.</p>		
<p>Next Steps:</p> <ul style="list-style-type: none"> Confirm project support with private landowners Determine snow management plan for site Complete site survey and drainage area mapping Determine soil infiltration rates and capacity Alternatives analysis for BMP options We recommend 2-3 days of technical field oversight during project implementation to assist with BMP layout and outlet configuration

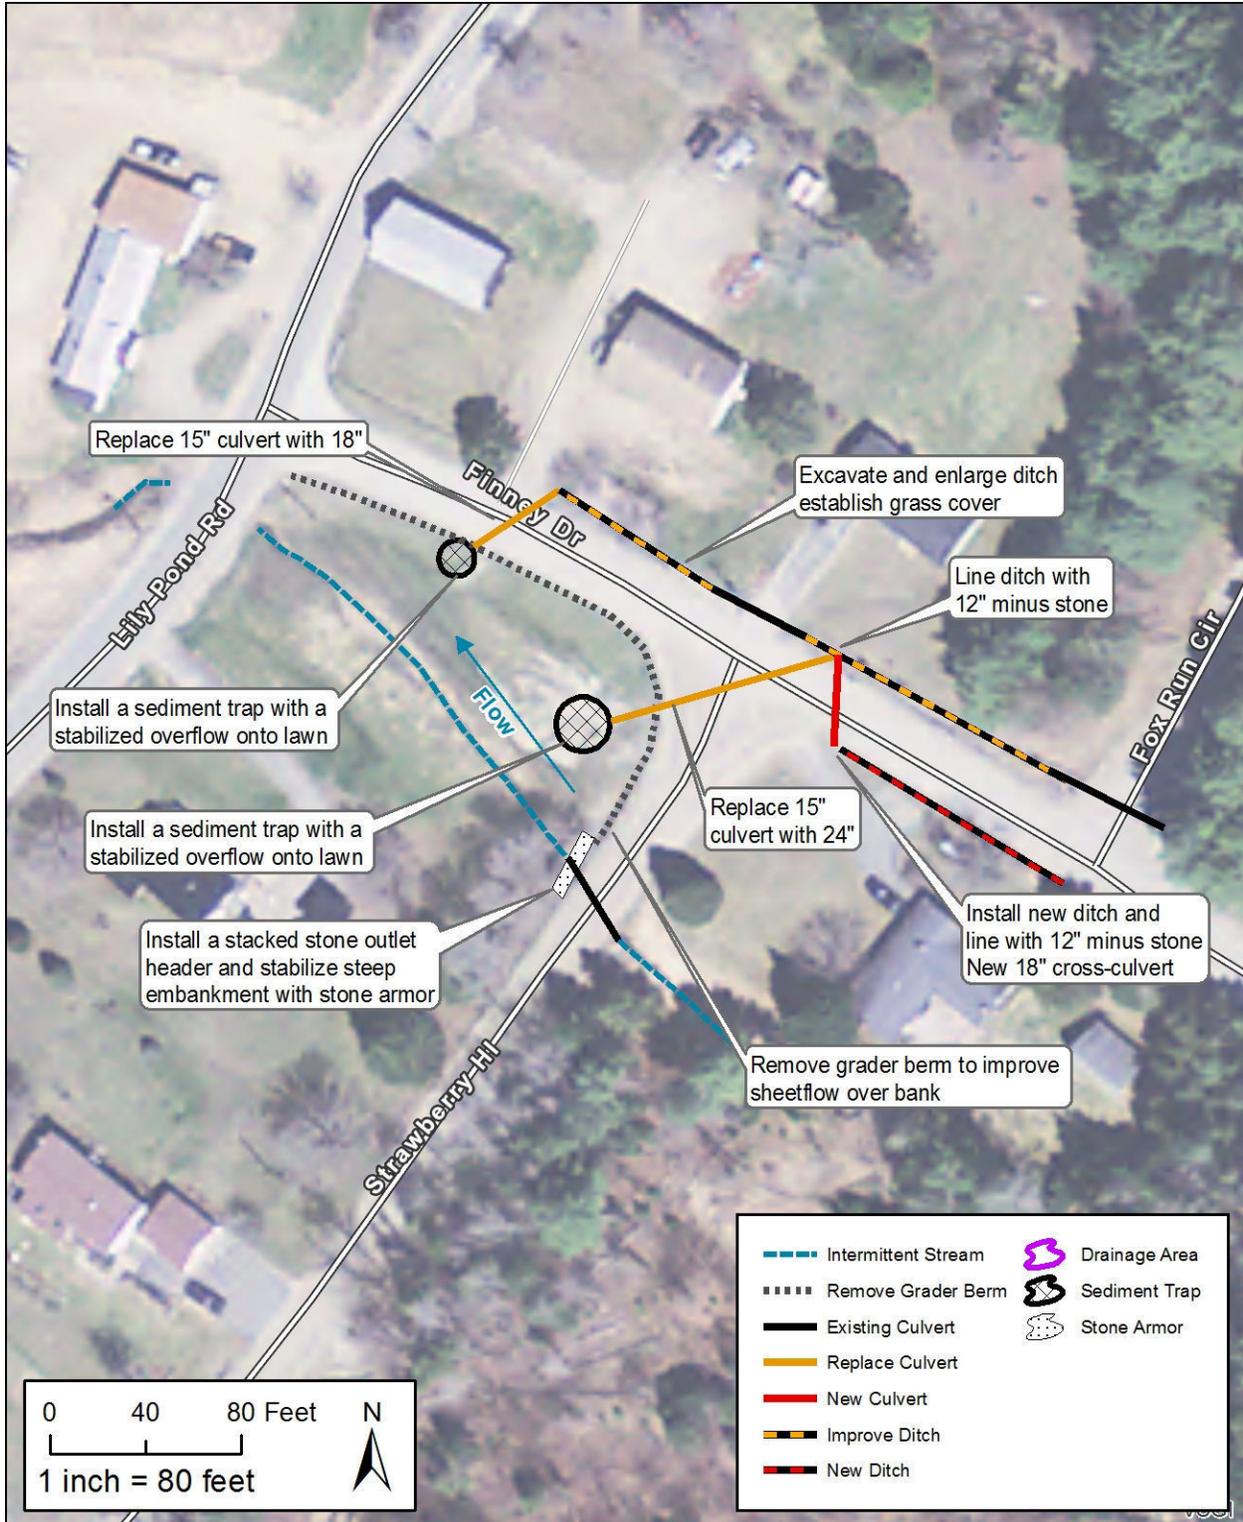
Project: LY-22		Site Restoration Plan
Location:	Finney Hill Neighborhood

Latitude:	44.5437 N	
Longitude:	-71.9856 W	
Land Ownership:	Town and Private	
Drainage Area (acres)	2.5	
Impervious (acres)	0.75	
<p>Site Description: Large volumes of gravel road material are deposited on the lawn adjacent to an intermittent stream channel. Sediment is coming from the outlets of two cross-culverts and from severe gully erosion where concentrated runoff from the road is carving into the steep embankment. Additional erosion was observed at the inlet and outlet of the 30" culvert under Strawberry Hill Road.</p>		
<p>Proposed Scope of Work</p>		
Culvert Improvements	<ul style="list-style-type: none"> • Replace the two 15" cross-culverts with larger structures (18" and 24") • Add a new 18" cross-culvert to carry ditch flow from new Finney Dr culvert • Stabilize the steep embankment at the inlet and outlet of the conveyance culvert <ul style="list-style-type: none"> ○ The outlet needs a stacked stone header and additional stone armor

Ditch Improvements	<ul style="list-style-type: none"> • Excavate and enlarge the existing ditch and establish grass cover or line with 12" minus stone where needed • Install a new ditch along Finney Dr. and line with 12" minus stone 	
Install BMP	<ul style="list-style-type: none"> • Install sediment traps at the cross-culvert outlets <ul style="list-style-type: none"> ○ Provide a level spreader outlet berm onto lawn area ○ Ensure that sediment traps are routinely inspected and cleaned 	
Remove Grader Berm	<ul style="list-style-type: none"> • Remove the grader berm to facilitate sheetflow onto grass area, stabilize any existing gully erosion locations 	
<p>Additional Design/Permitting Requirements: Some additional survey and design work is recommended to inform culvert sizing and sediment trap design and sizing. Sanitary Sewer lines are mapped near the sediment traps, these need to be located and may require design adjustments. We estimate that design and permitting efforts will cost \$1,000 to \$2,500.</p>
