APPENDIX E:

Site Restoration Plans for High Priority Stormwater Mitigation Sites

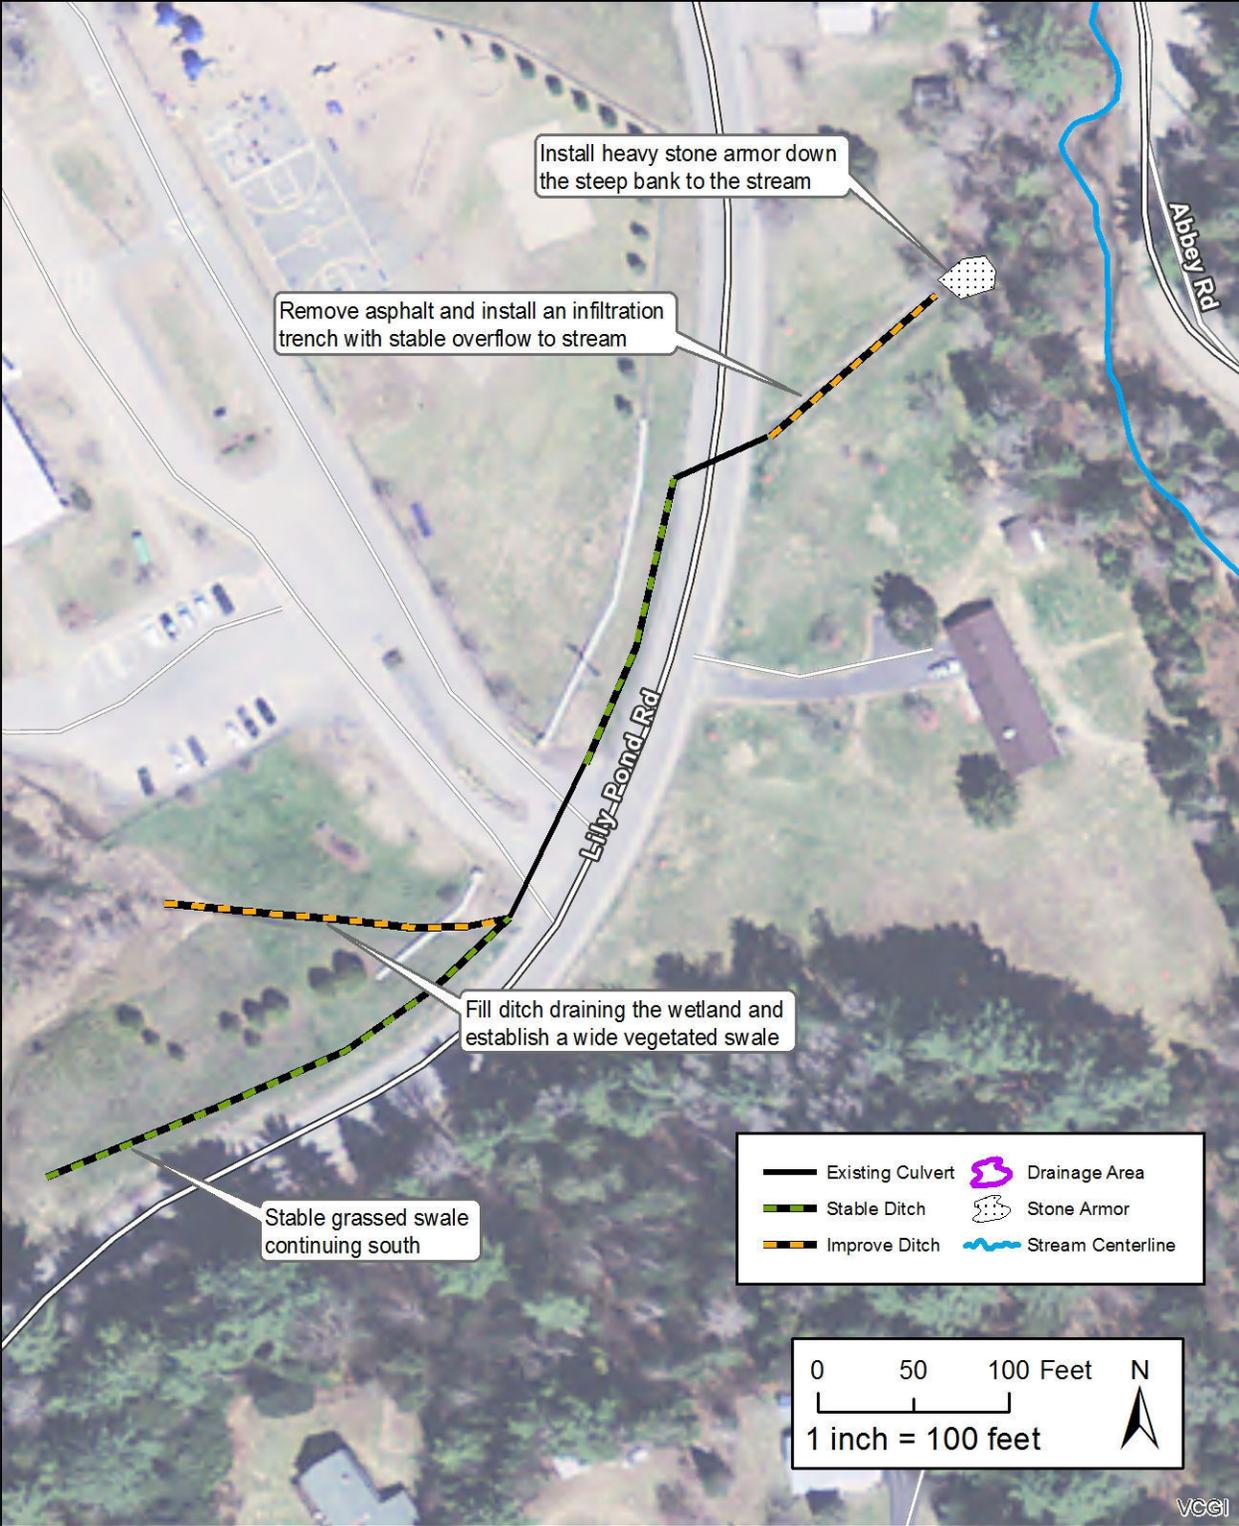
Project: LY-23 & LY-24 **Site Restoration Plan**

Site Description: The roadside ditch along Lily Pond Road drains a long stretch of the road and receives runoff from the southern portion of the School property. Portions of the runoff from the School are filtered by a forested wetland. The wetland is partially drained by a narrow ditch through the grassed area that drains into the roadside ditch. The roadside ditch crosses under Lily Pond Road and then flows through an asphalt lined swale for approximately 50' to a steep embankment down to the second order stream. Some erosion was visible along the steep embankment. Overall, we did not observe any significant sediment sources, however the drainage area does have close to 2 acres of impervious surfaces.

Restore Wetland	<ul style="list-style-type: none"> • Fill/widen the ditch to create a sinuous swale • Implement a no-mow buffer and plant wetland vegetation/seed mix as needed
Install BMP	<ul style="list-style-type: none"> • Remove the asphalt swale and compacted underlying soils • Install a gravel lined infiltration trench • Install a rock lined forebay to dissipate flow and trap coarse sediment
Stabilize Flow Path	<ul style="list-style-type: none"> • Install rock armor along the flow path to the stream

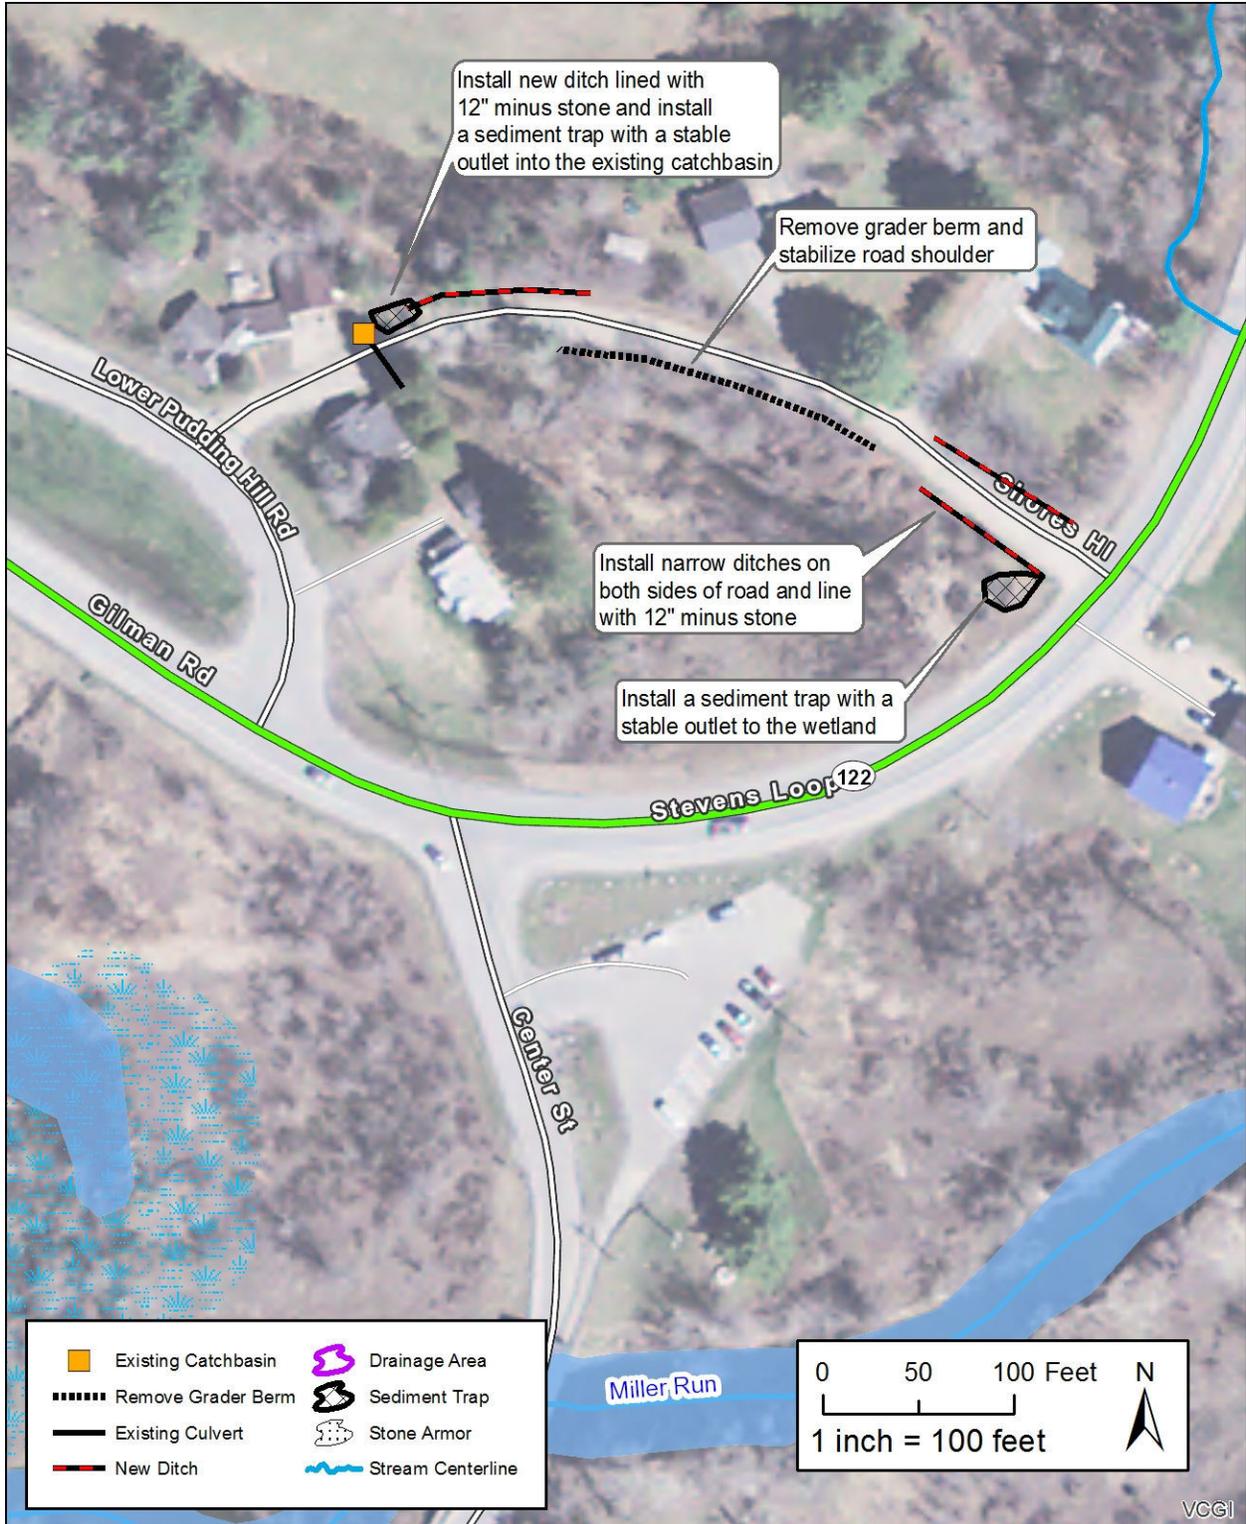
Project: LY-34 & LY-35		Site Restoration Plan
Location:	Shores Hill

Latitude:	44.5436N	
Longitude:	-72.0097 W	
Land Ownership:	Town	
Drainage Area (acres)	1.0	
Impervious (acres)	0.25	
<p>Site Description: Large volumes of sediment are washing off both sides of the approximately 500ft long road. The road does not have established ditches and the road bed is relatively soft and sandy. The eastern end of the road drains directly into a wetland with a poorly functioning sediment trap. The western end of the road drains directly into a catchbasin situated below the road grade and is piped into a dredged channel leading to the wetland. The middle portion of the road has limited areas for sheetflow down the forested bank. The road is narrow, and the adjacent banks are very steep.</p>		
<p>Proposed Scope of Work</p>		
Install Ditches	<ul style="list-style-type: none"> • Install narrow ditches and line with 12" minus stone

Remove Grader Berms	<ul style="list-style-type: none"> • Two areas of grader berms are limiting sheetflow to south side of the road down the forested slope to the wetland • Some areas of erosion are likely along the road shoulder and should be stabilized with rock 	
Install Sediment Traps	<ul style="list-style-type: none"> • Improve the existing sediment trap on the eastern end of the road • Install a sediment trap with a stable outlet to the existing catchbasin 	
<p>Additional Design/Permitting Requirements: The wetland along the south side of the road is likely Class II and may require permitting for the eastern sediment trap. No additional design is required for the project. If wetlands clearances are required, we estimate that wetland delineation and permitting efforts will cost \$1,000-\$2,000.</p>		
<p>Next Steps:</p> <ul style="list-style-type: none"> • Contact VTDEC Wetlands Ecologist (Julie Follensbee) to discuss concept plan and needed clearances • Delineate wetland and review with VTANR staff (as necessary) • Assess feasibility and cost of paving the road • We do not anticipate the need for any technical field oversight during project implementation

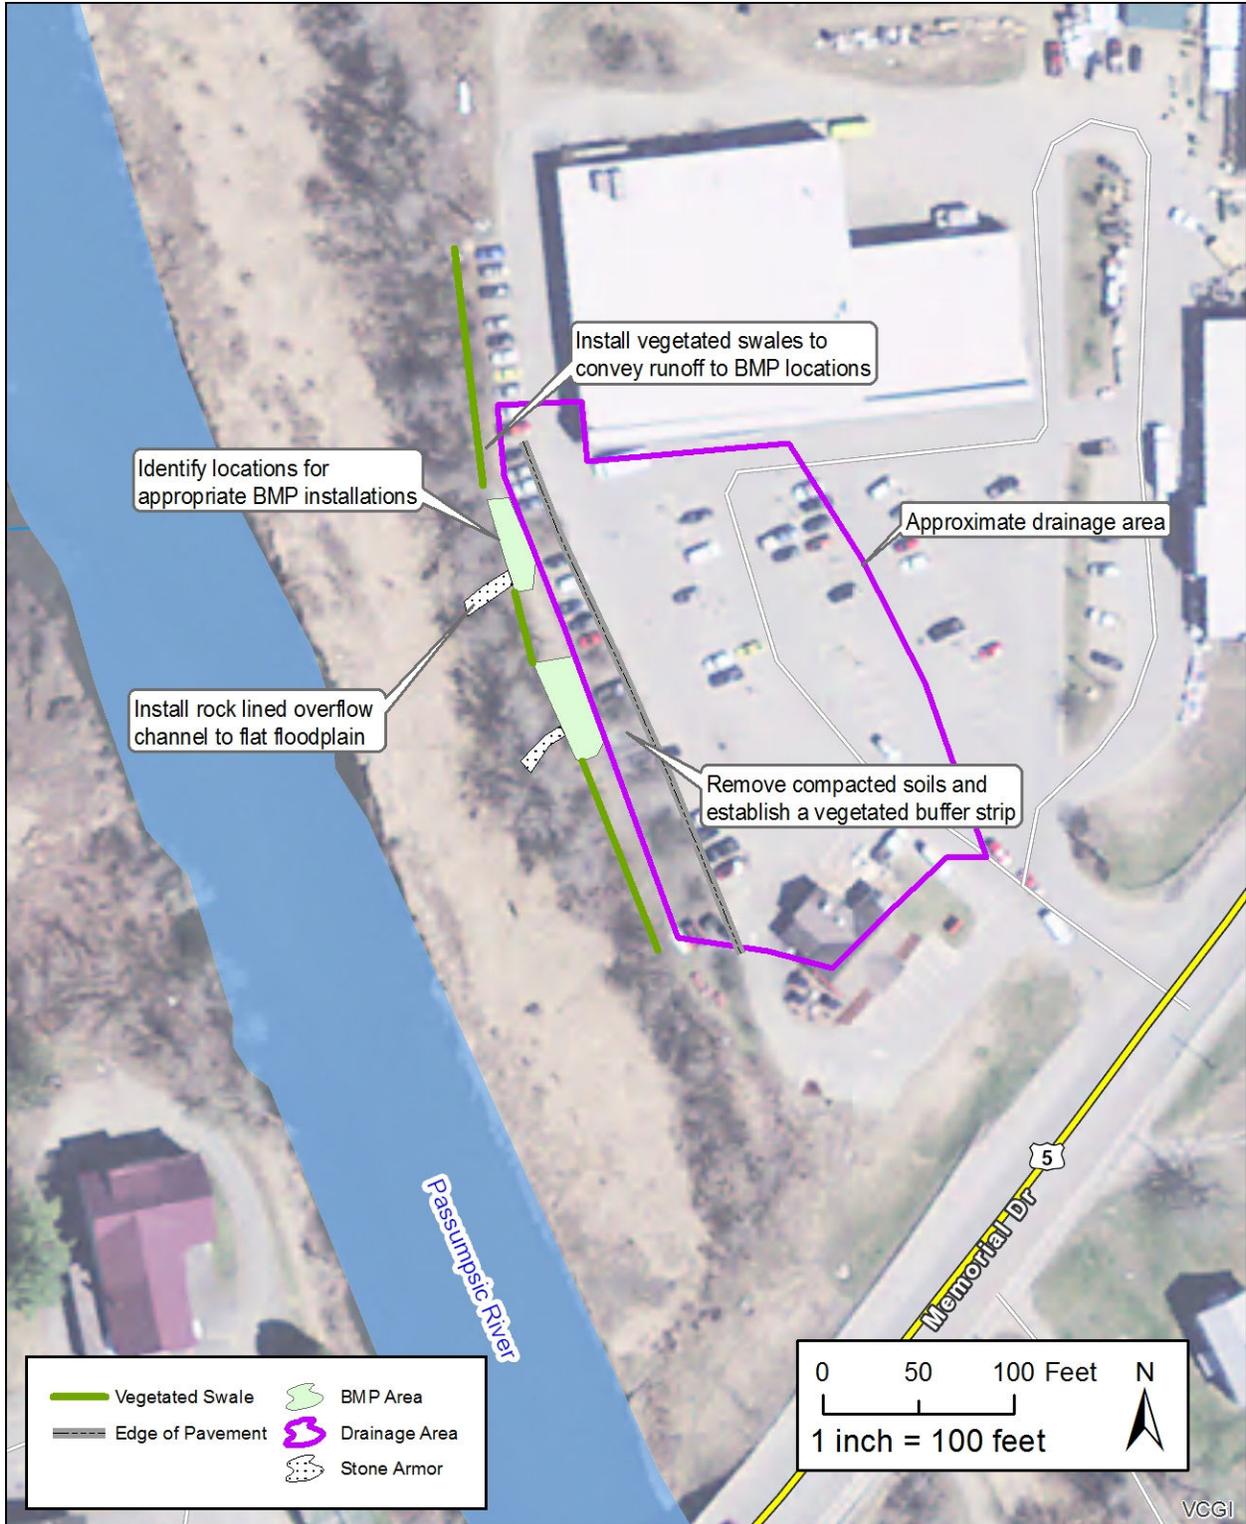
Project: Rt5-2		Site Restoration Plan
Location:	The White Market

Latitude:	44.5196N	
Longitude:	-72.0036 W	
Land Ownership:	Private	
Drainage Area (acres)	1.25	
Impervious (acres)	1.25	
<p>Site Description: The large paved parking area for Whites Market partially drains to the west to a narrow vegetated area. Several small flow paths extend down the steep bank to the Passumpsic River. Much of the vegetated area has been compacted by parked vehicles off the edge of the parking lot. This area is also used for stockpiling snow. There is a large area available for potential treatment features.</p>		
<p>Proposed Scope of Work</p>		
Install BMP	<ul style="list-style-type: none"> • Assess BMP options based on site constraints and drainage area 	
Stabilize Flow Paths	<ul style="list-style-type: none"> • Identify and stabilize any concentrated flow paths with erosion on the river bank 	
Site Maintenance	<ul style="list-style-type: none"> • Construct a barrier (fence) to protect BMP from vehicle damage • Discuss winter maintenance requirements <ul style="list-style-type: none"> ○ Create a maintenance plan that will preserve BMP effectiveness

<p>Additional Design/Permitting Requirements: Professional survey is recommended to determine site grading and the drainage area available for treatment. This information will be used to model the site and inform BMP sizing. Soil infiltration rates will need to be determined. We do not anticipate any permitting requirements for this project. We estimate that survey and design efforts will cost \$3,000-\$5,000.</p>		
<p>Next Steps:</p> <ul style="list-style-type: none"> • Confirm project support with private landowner • Determine snow management plan for parking lot • Complete site survey and drainage area mapping • Determine soil infiltration rates and capacity • Alternatives analysis for BMP options • We recommend 2 days of technical field oversight during project implementation to assist with BMP layout and outlet configuration 		
<p>Project Benefits: This project is designed to reduce runoff volume and improve water quality for a large paved parking lot adjacent to the Passumpsic River. We anticipate that Water Quality Volume (WQv) and Channel Protection Volume (CPv) treatment is possible, given the large area available for BMP implementation.</p>
