Fitzgerald Environmental Associates, LLC.

MEMORANDUM

To: Kerry O'Brien, Caledonia County Natural Resources Conservation District
From: Evan Fitzgerald and Joe Bartlett
Re: Stormwater Master Planning Library - Lyndon, VT
Date: February 21, 2017

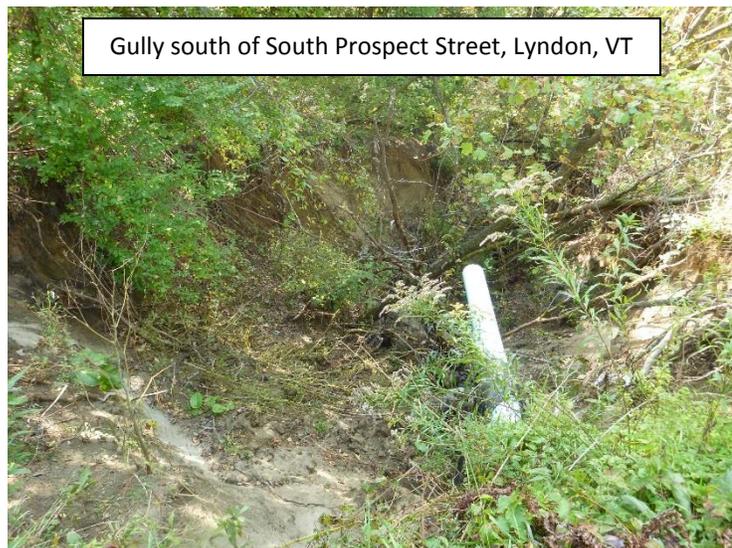
Evan Fitzgerald attended a steering committee meeting with representatives from the Village of Lyndonville, the Town of Lyndon, VTDEC, and CCNRCD to discuss specific stormwater concerns within the project area on September 28th, 2016. The Village and Town road foremen identified several areas of problematic runoff and erosion, and these areas noted on a large map during the meeting. Kerry O'Brien, Ben Copans, and Evan Fitzgerald made some field visits to follow up on a few sites east of the Village area after the meeting. The stormwater problem areas discussed during the meeting are shown on the attached map. One site off the end of South Prospect Street has a large gully created by runoff (see photograph to right).
